Evaluation of respiratory and other health concerns at a law enforcement office building with indoor environmental quality issues

HHE Report No. 2018-0157-3369

February 2020

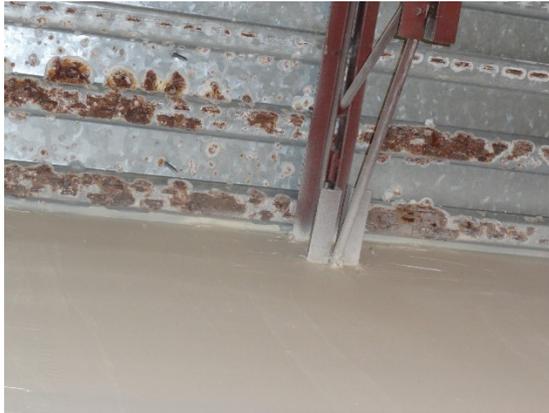
Figure 1. Rust on ceiling in the evidence room. Photo by NIOSH.

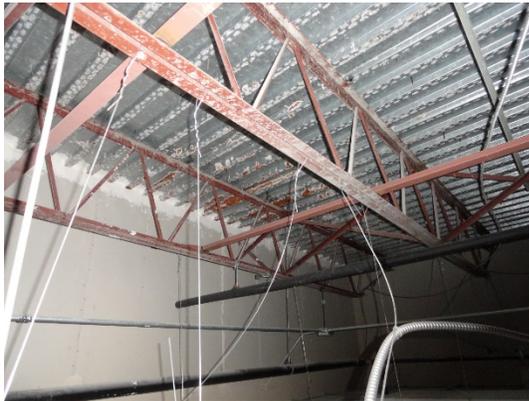
Figure 2. Rust on metal roof above the ceiling tiles in room 129. Photo by NIOSH.

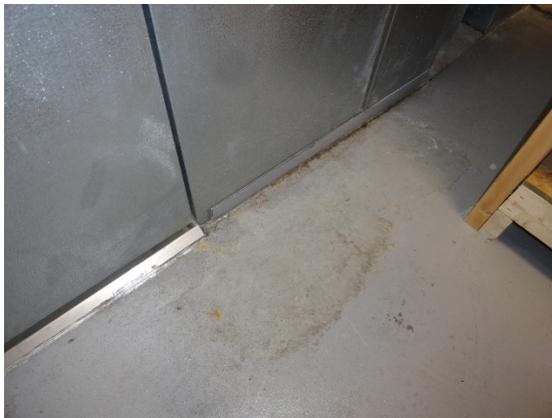
Figure 3. Visible water damage/stains in front of the walk-in refrigerator in evidence area. Photo by NIOSH.

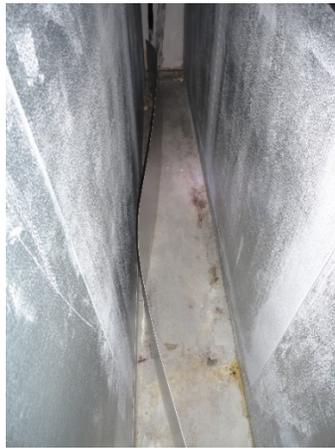
Figure 4. Visible water damage/stains between the walk-in freezer and refrigerator in the evidence area. Photo by NIOSH.

- Hidden moisture, mold, and bat droppings were found in wall cavities.
 - Mold was observed on the backside of drywall in a wall between the evidence refrigerator and freezer. Tape lift samples confirmed mold. Condensation on the coolant piping was causing mold growth on the drywall.

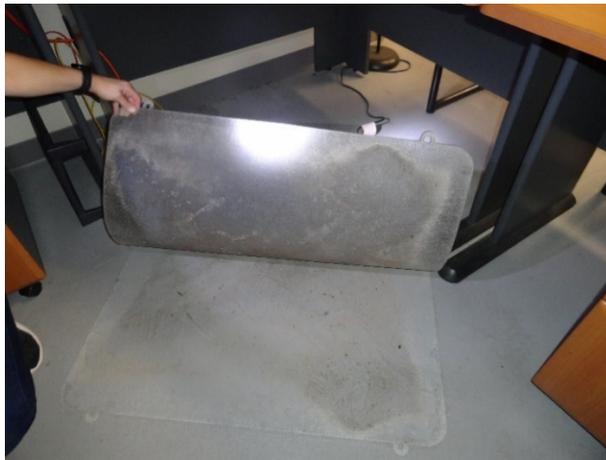
Figure 5. Visible stains and mold odor under plastic mat on concrete floor in the evidence room. Photo by NIOSH.

- Visible mold was observed below a vinyl floor tile in the southeast common hallway.
 - A musty odor and visible mold were observed below a plastic floor mat on concrete in the Evidence Reception Room 134.

- Remove mold and moisture-damaged flooring and any other damaged materials such as plastic floor mats and vinyl wall base.
- Remediate the mold on the concrete slab and old wood framing in the wall cavities according to the guidance below.

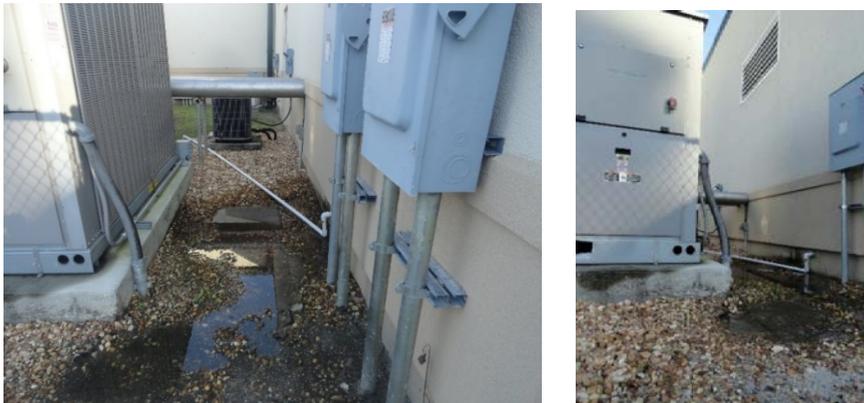
Figure 6. Water pooling under fresh air intake near the emergency generator. Photos by NIOSH.

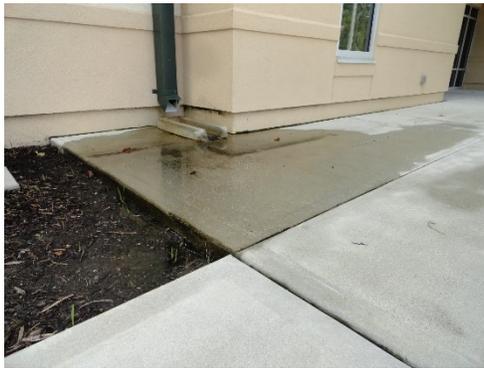
Figure 7. Water pooling in mulch and against building from downspout at front of building. Photo by NIOSH.

1. Seal penetrations through the EIFS cladding at the rear and west sides of the building.
2. Seal tops and sides of electrical boxes to prevent water intrusion.
3. Regrade the east side to provide a grade level slightly below floor level and positively sloped into the swale. Dig the swale deeper as needed. The consultant report noted the county was performing this work under a separate contract.
4. Cut in and install trench drains at the front and rear paving adjacent to the building to eliminate standing water against the building. The consultant report noted the county was performing this work under a separate contract.
5. Evaluate base of the concrete wall on the south side of the Main Evidence Storage Room and seal as necessary.
6. Evaluate gutter drainage away from the building and repair as necessary.

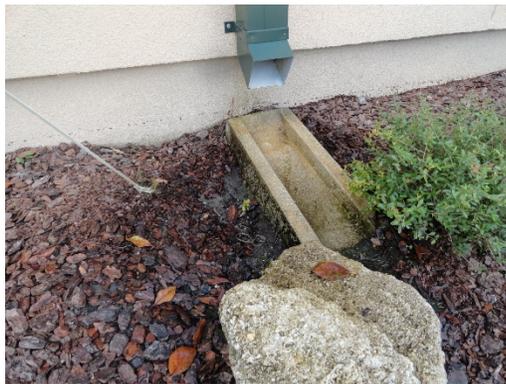
Figure 8. Water pooling in mulch and against building near outdoor patio space. Photo by NIOSH.

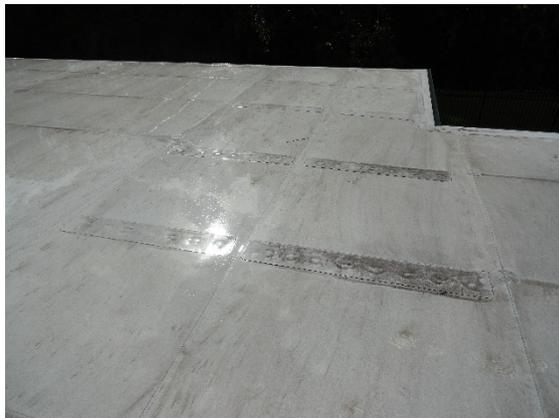
Figure 9. Patching on roof. Photo by NIOSH.

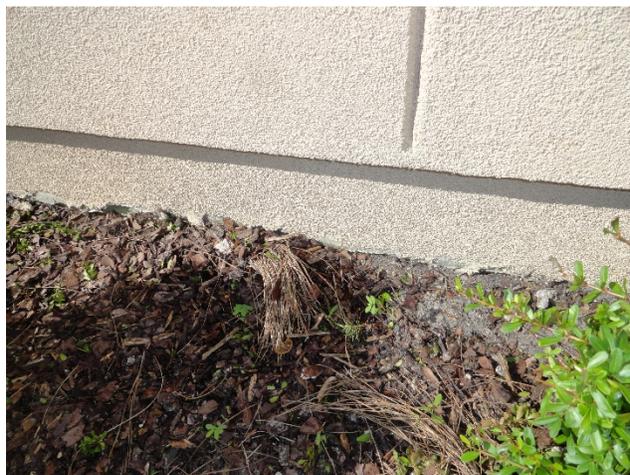
Figure 10. Exposed cement block near the base of exterior wall. Photo by NIOSH.
