Health Hazard Evaluation Report

HE 80-214-799
M&B METAL PRODUCTS, INC.
LEEDS, ALABAMA

HE 80-214-799
January 1981
M&B Metal Products, Inc.
Leeds, Alabama

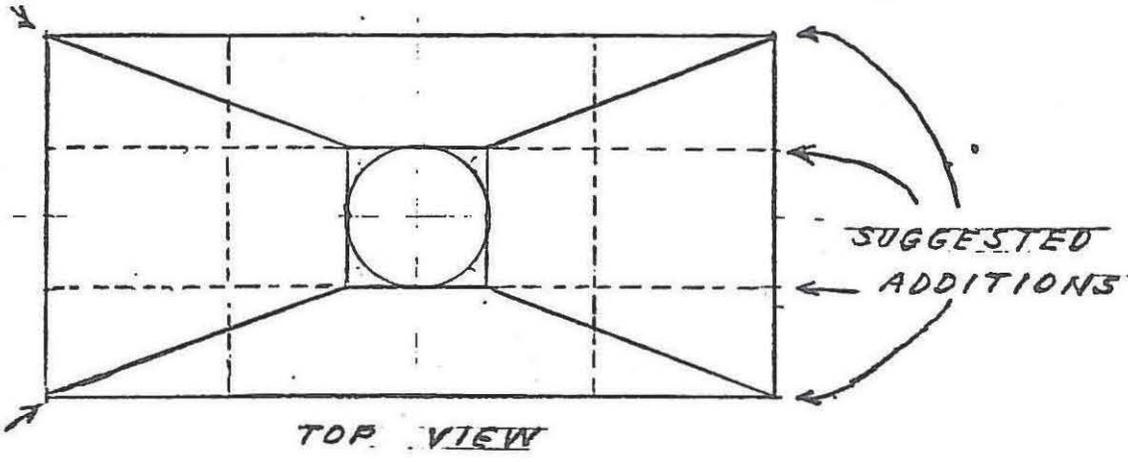
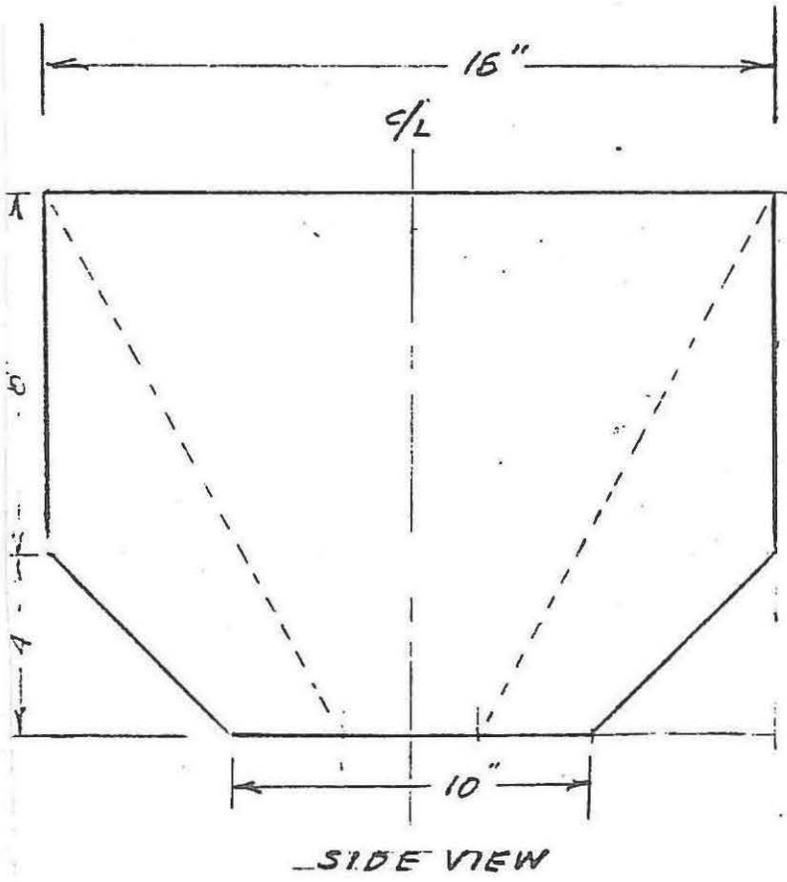
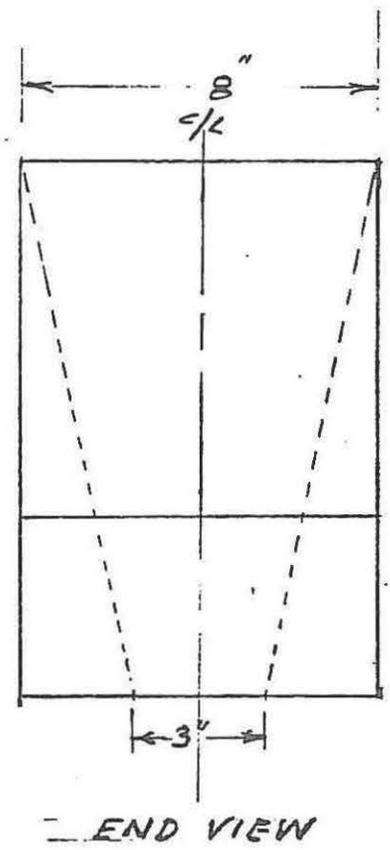
FIGURE 1

FLOCK EXHAUST INTAKE
 MODIFICATIONS
 M & B METAL PRO. INC., LEEDS, ALA.
 HE 80-214

1. All facets of the local exhaust ventilation for the primary flock exhaust and excess flock exhaust should always be in full working order. The primary flock exhaust intake should be modified according to Figure 1 to increase face velocity. Assuming a constant Q, this change would increase face velocity to 227 fpm, or 2.3 times the original value. The rough wood surfaces of the exhaust intake should be painted or replaced with smooth metal or plastic surfaces to prevent adherence and build-up of flock. The excess flock dislodger should be serviced on a preventive maintenance schedule. The machines should not be run if the dislodger is not fully functional.
