Health Hazard Evaluation Report

HETA 82-123-1258
GOODYEAR AEROSPACE CORPORATION
AKRON, OHIO

HETA 82-123-1258
FEBRUARY 1983
GOODYEAR AEROSPACE CORPORATION
AKRON, OHIO

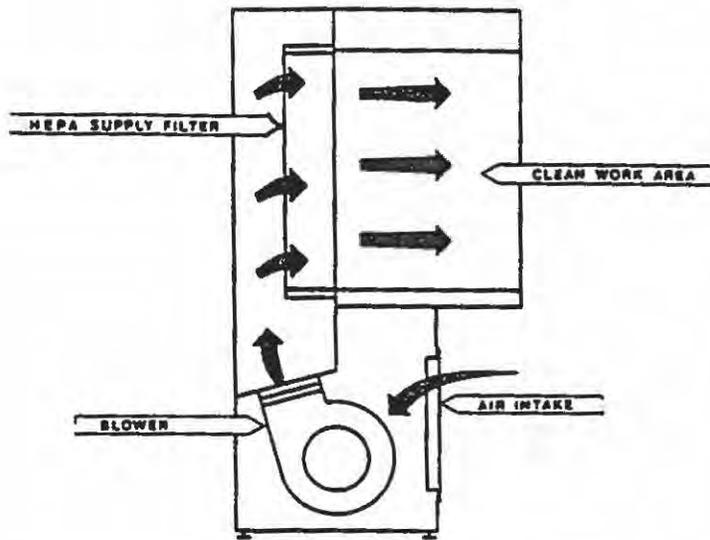
Sketch A. Horizontal Laminar Flow Clean Bench

- a. Open trays of MEK were being used in a horizontal, laminar flow, clean bench. Room air was drawn through high-efficiency particulate air (HEPA) filters in the base of the cabinet, directed up the back of the cabinet, and released through a laminar flow grill toward the face of the hood to prevent dust contamination on the parts being handled (similar to Sketch A, Figure I). HEPA filters do not remove organic vapors; therefore, the solvent vapors from the cleaning solvents are directed at the face of the worker. If solvents are to be used in these cabinets, they should be exhausted to the outside of the hangar (similar to Sketch B, Figure I).

4. Solvent cleaning of parts should be done only where the hood is exhausted to the outside.
5. All containers of solvents or other liquids should be clearly labeled as to their contents and kept covered when not in use.
