Health Hazard Evaluation Report

HETA 82-014-1057
COMPUTER SERVICES OF ROANOKE, INC.
ROANOKE, VIRGINIA

HETA 82-014-1057
March, 1982
Computer Services of Roanoke, Inc.
Roanoke, Virginia

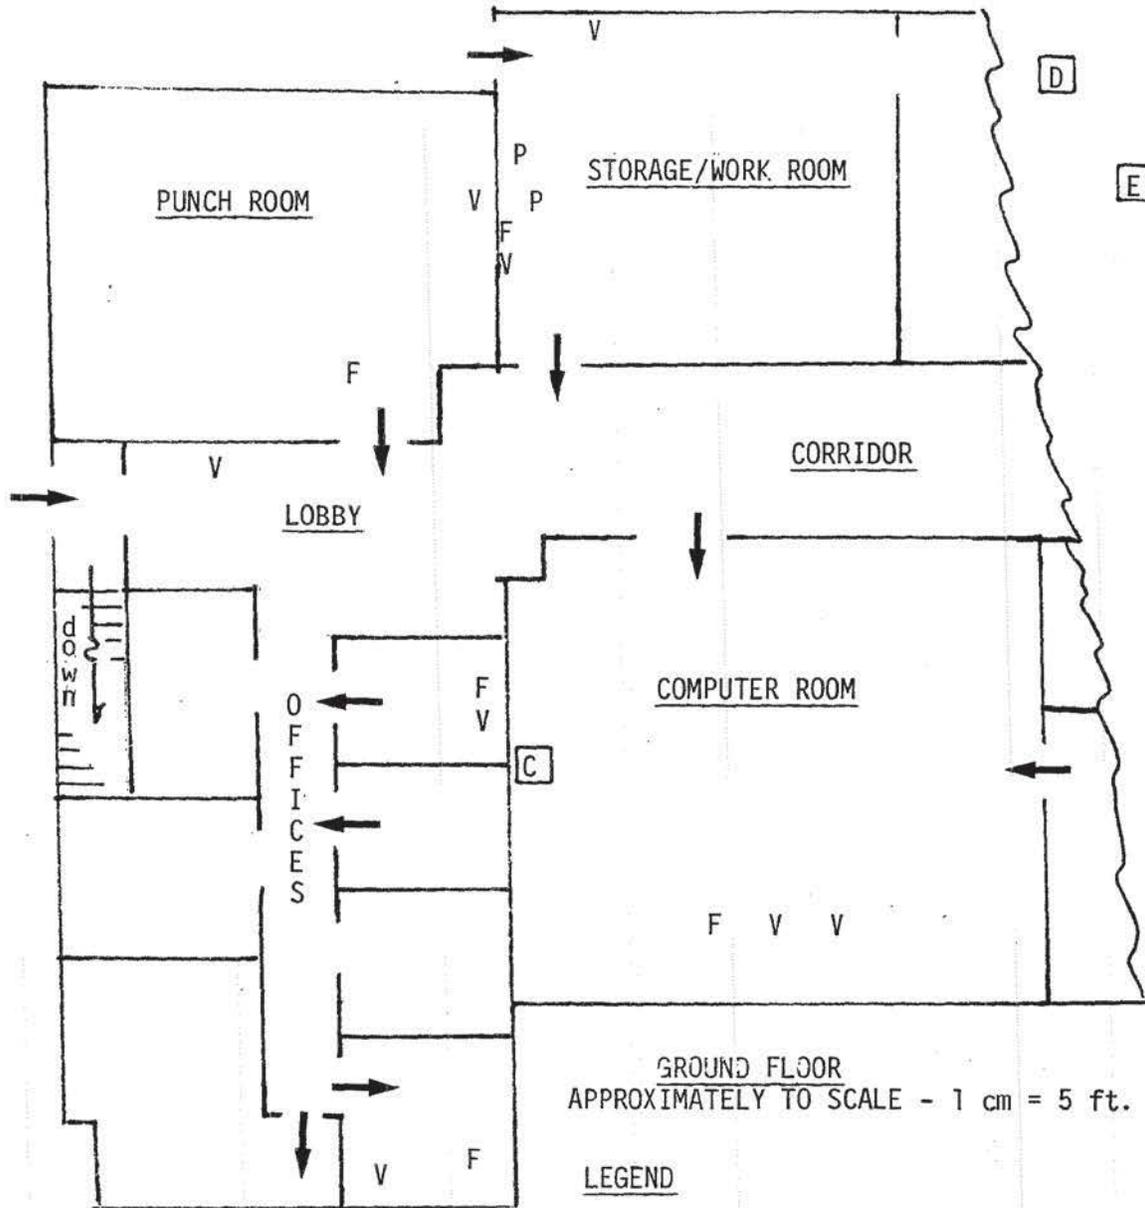
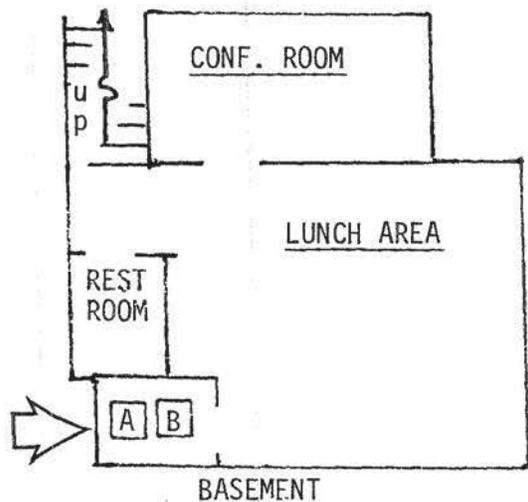
FIGURE 1 - FLOOR PLAN OF COMPUTER OPERATIONS AREA

The area of the building where effects were reported is shown in Figure 1. The employees generally move about through the several rooms, so it was not possible to correlate effects with a specific location. Employees were interviewed and reported the same symptoms (eye, nose and throat irritation, film on skin, and occasional odor) plus two additional occasional symptoms, headache and skin rash.

Air samples were taken at the locations indicated in Figure 1. All of the 23 organic vapors assayed indicated virtually zero (< 0.06 ppm) concentrations. The nuisance particulate samples indicated dust concentrations of 2.7 and 1.5 mg/m^3 in air for personal and area samples respectively, during operation of the mechanical check signing, paper perforation and carbon paper removal (decollater) operations. Particulate sampling is shown in Figure 2A.

Attention was focused on the five air conditioning/ventilation systems serving the area shown in Figure 1. These are described below using arbitrary designations A-E.

The only air exhaust found in the area surveyed (Figure 1) was 130 cfm exhausted from a basement restroom. The entire area surveyed was under negative pressure with respect to the outside. Air drift, as measured by smoke tubes, was from the storage/work room toward the main computer room and office area, and from the punch room toward the lobby and office areas, as shown in Figure 1.

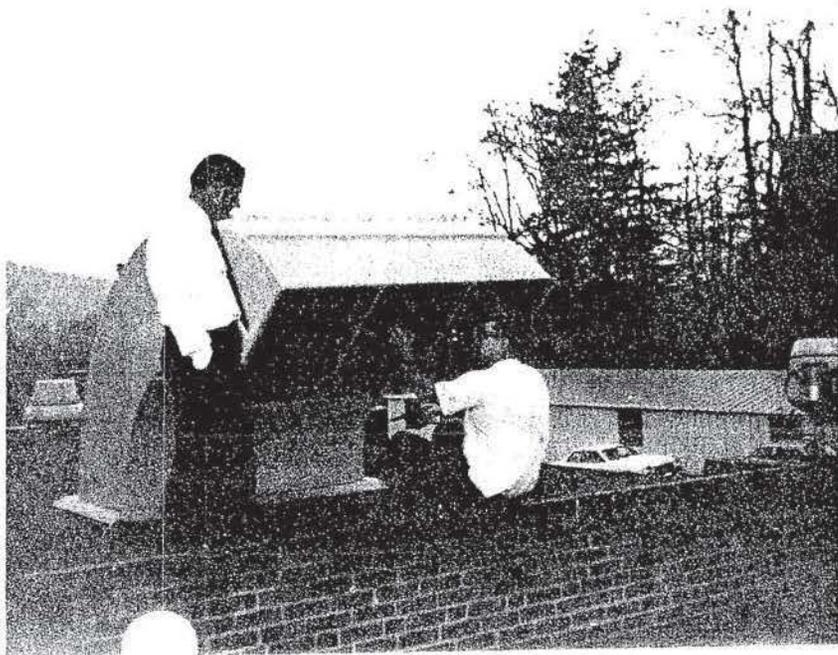
FIGURE 2C (left) - Fresh air inlet velocity being measured at main ventilation unit air intake on roof.

Unit C is the main building unit which serves the bulk of the second floor, and also the punch room and lobby of the ground floor. These latter two areas have a combined floor space of approximately 1,170 square feet. Measured recirculated air flow in the two areas was 1,130 cfm. The estimated total floor area served by unit C was estimated to be 8,000 square feet. The quantity of fresh air supplied to unit C was calculated from intake air velocity measurements to be 600 cfm. However, cross-breezes at the air intake, its large size, and low inlet air velocity made accurate measurements difficult (See Figure 2C).
