Health Hazard Evaluation Report

HETA 82-224-1336
MIAMI FIRE DEPARTMENT
MIAMI, FLORIDA

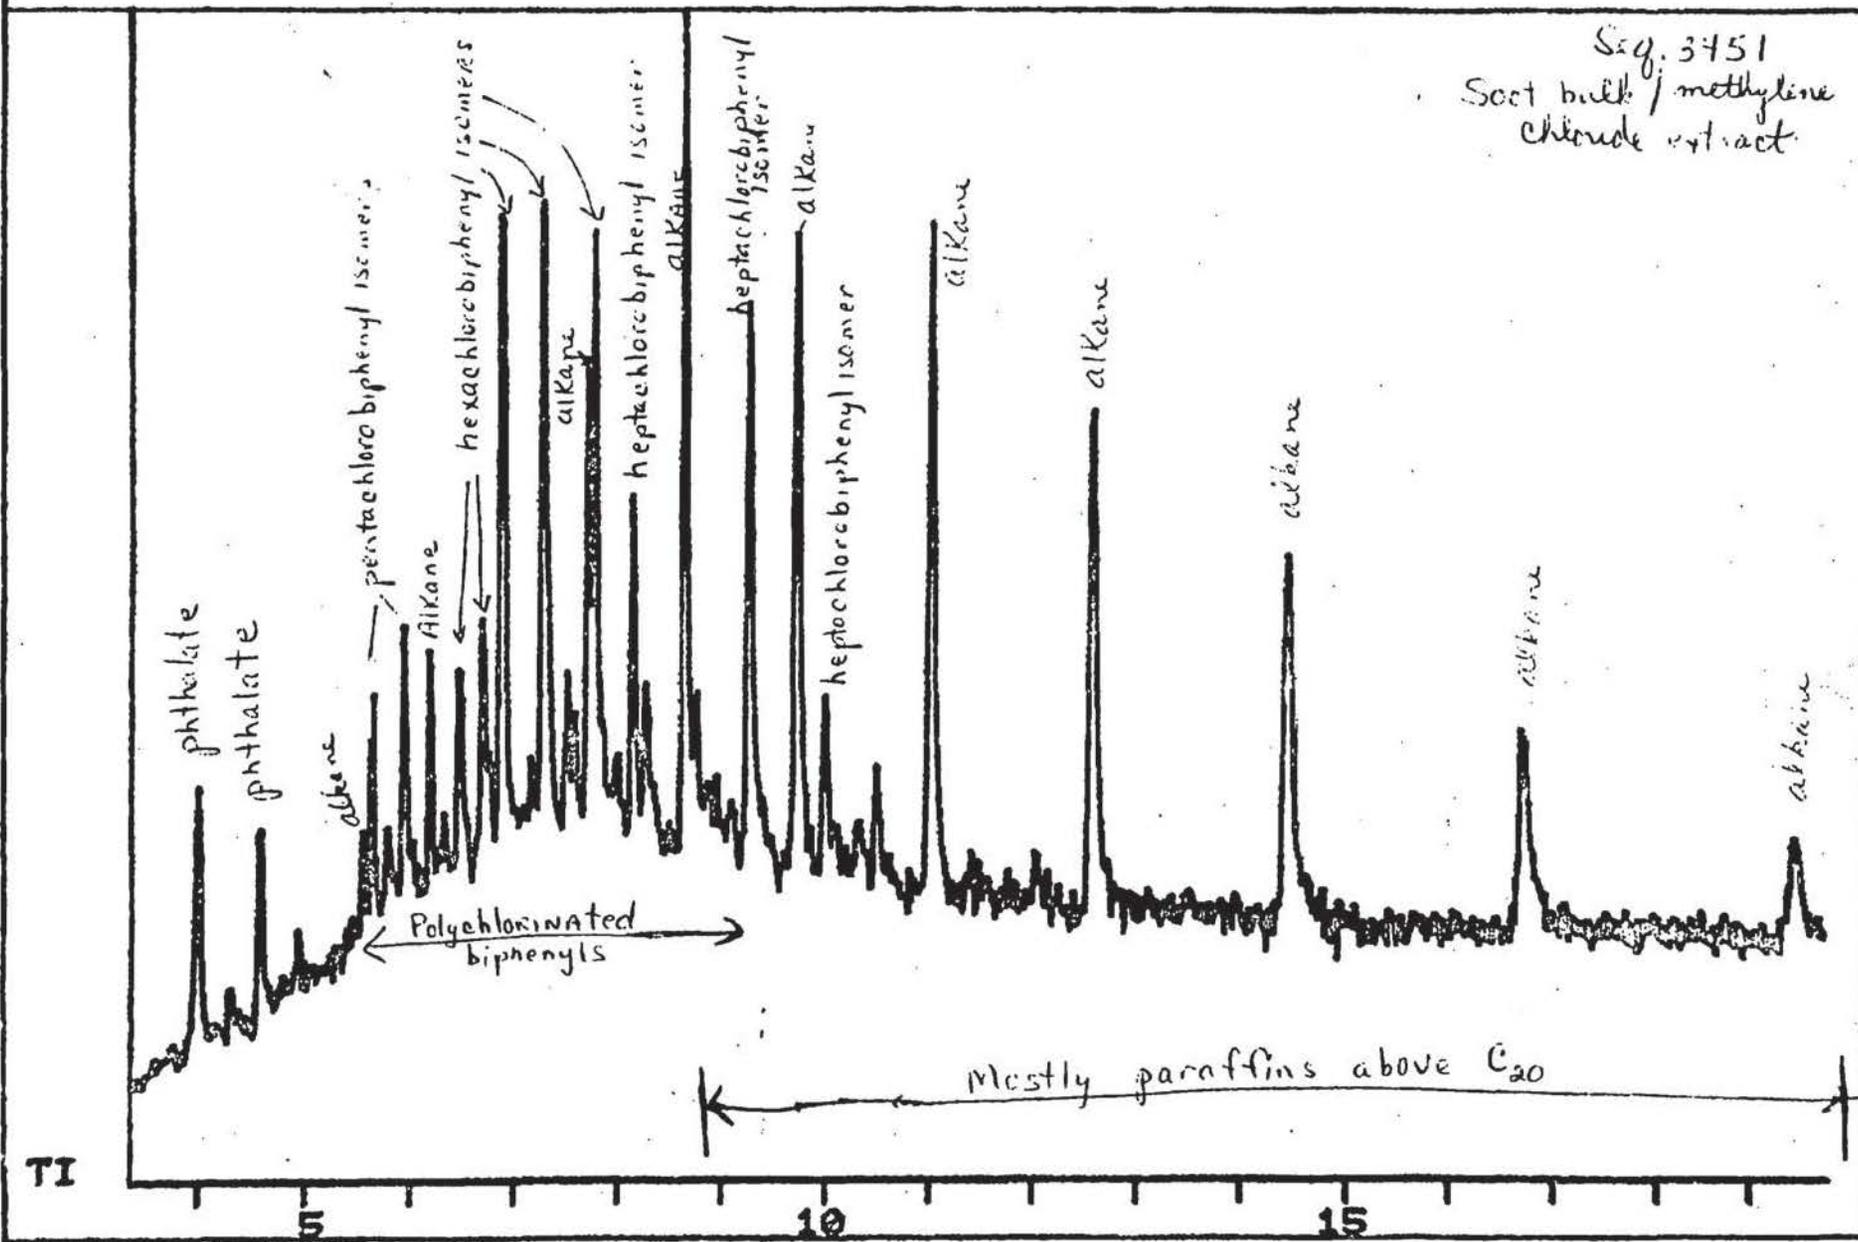
*Seq. 3451
Soot bulk / methylene
chloride extract.*

Figure 1 is the reconstructed ion chromatogram from the GC/MS analysis performed by the NIOSH laboratory in Cincinnati. The peaks identified in the sample were a series of PCBs; penta-, hexa-, and hepta-chlorobiphenyls; and numerous alkanes, mostly larger than C₂₀.
