Health Hazard Evaluation Report

HETA 82-082-1064
GEOSOURCE, INC.
DENVER, COLORADO

HETA 82-082-1064
GEOSOURCE, INC.
DENVER, COLORADO
MARCH 1982

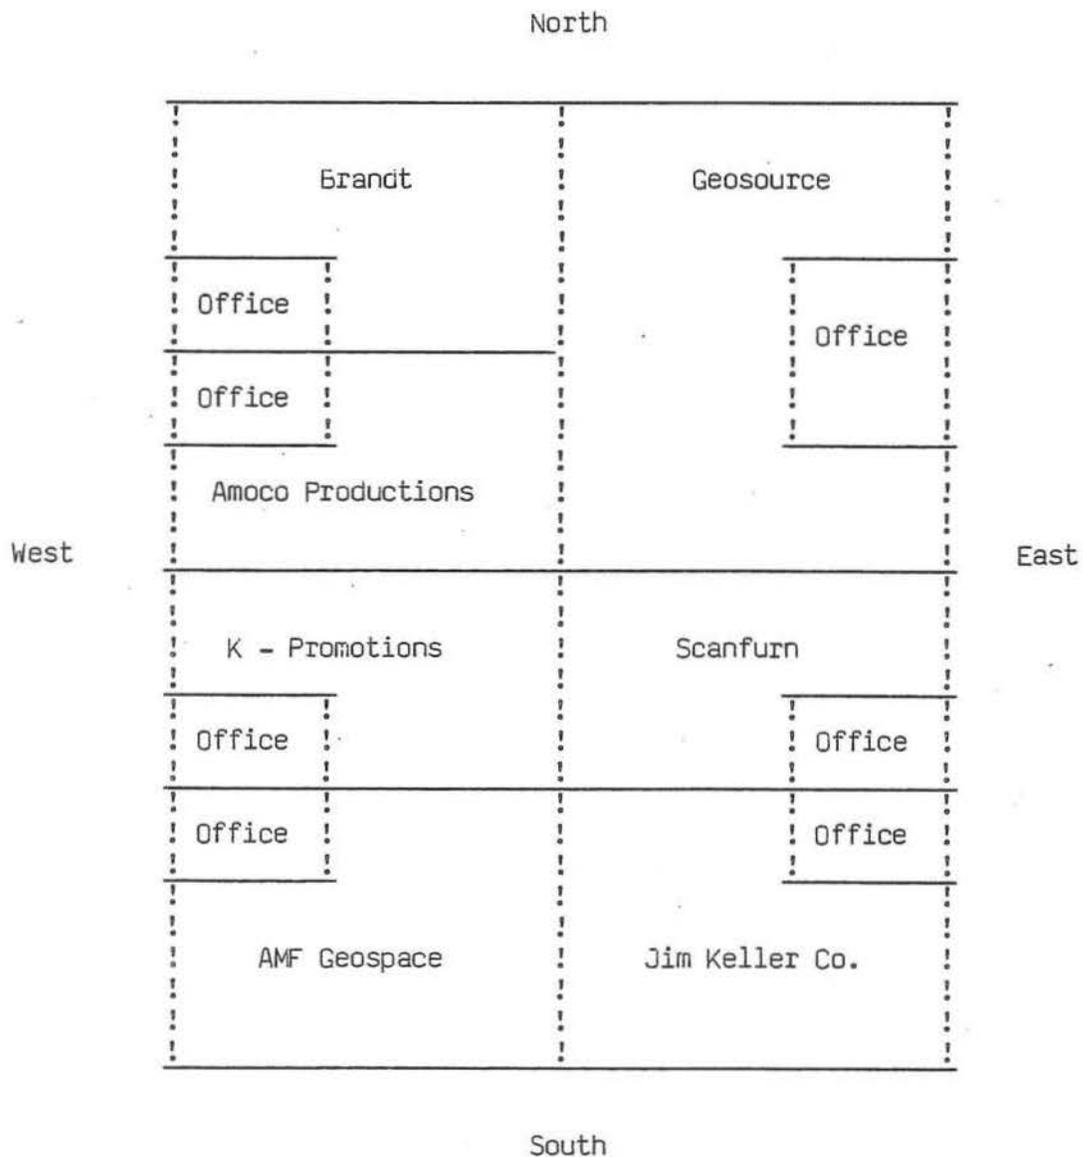
FIGURE I

As a final part of the study the NIOSH investigator stopped by every office/warehouse in the building to ask if any other of the building's tenants had had a similar problem (see Figure 1). The proprietor in the furniture warehouse (Scanfurn) immediately south of Geosource had noted the odor in the office in the morning, particularly Mondays, but not in the warehouse section. He had been in the building since December 1981. None of the other occupants of the building had noted this "gas" odor. Several mentioned the odor of "rotten eggs" or stockyards as occasionally being a problem. The occupants of the Brandt Warehouse in the northwest end of the building mentioned they had had a gas leak two months ago, but had fixed it.

Warehouse/Office Building Containing Geosource, Inc.
(not to scale)
