Health Hazard Evaluation Report

HETA 85-165-1605
ST. LOUIS POLICE AUTO BODY SHOP
ST. LOUIS, MISSOURI

HETA 85-165-1605
July, 1985
St. Louis Police Auto Body Shop
St. Louis, Missouri

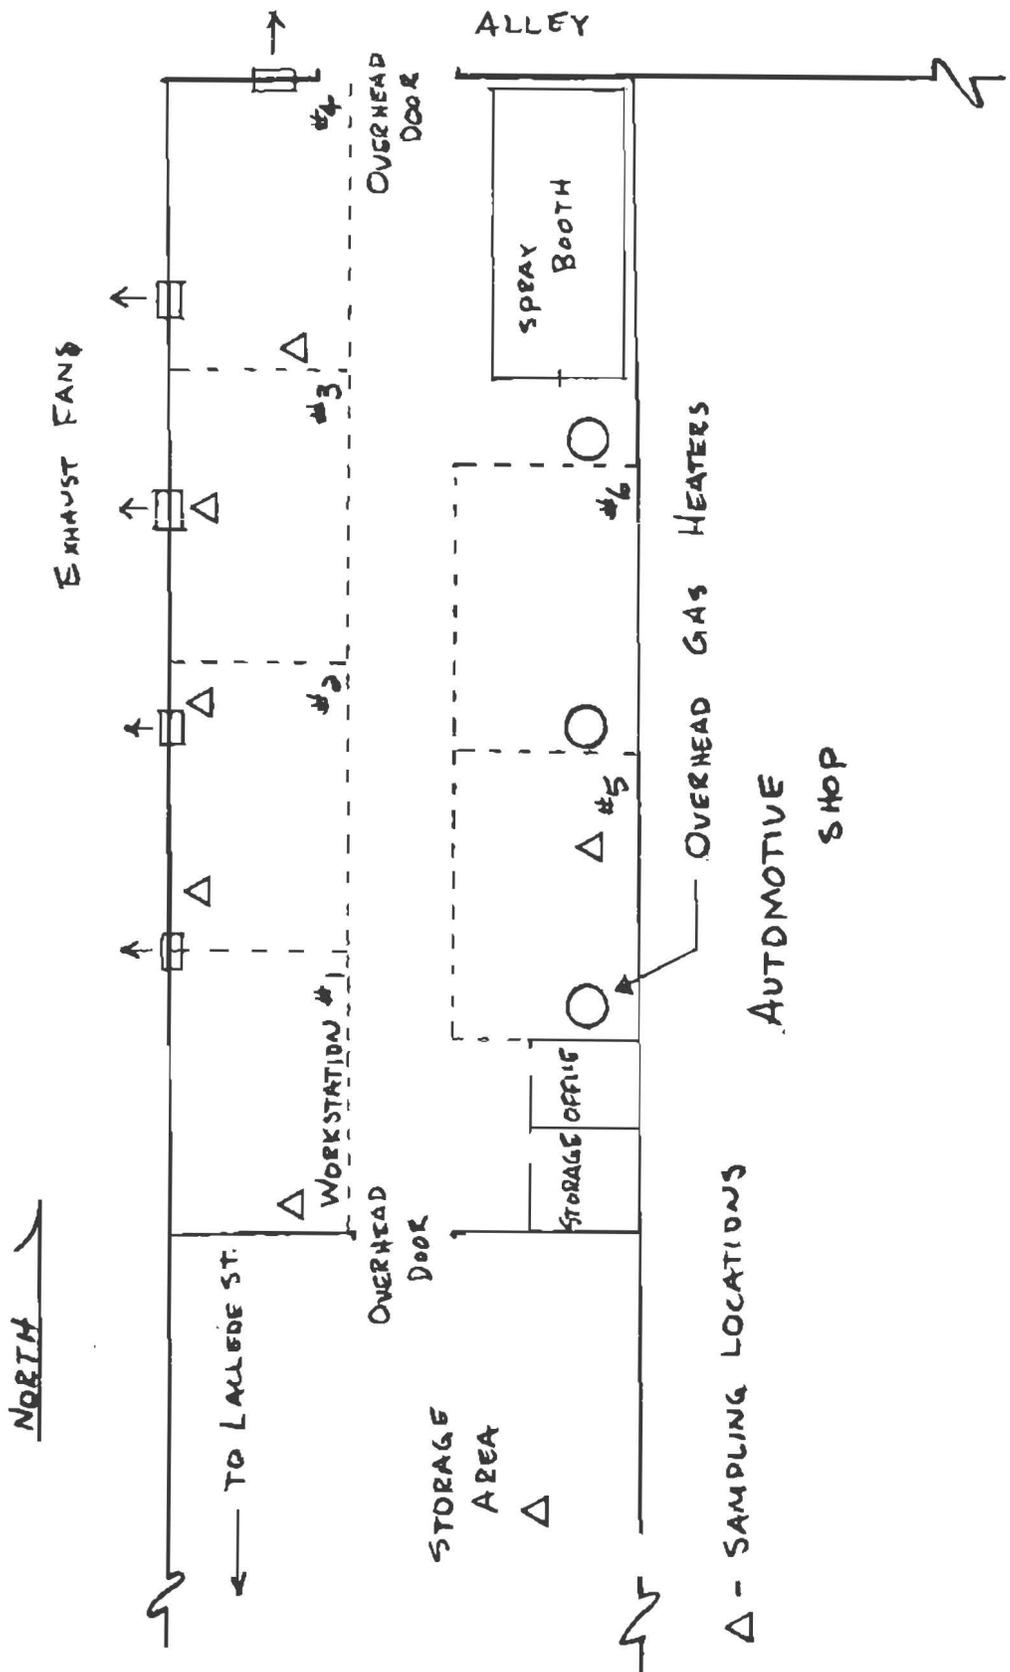
Figure 1 | FLOOR PLAN AUTOBODY REPAIR

The Auto Body Repair Shop for the St. Louis City Police Department is located within the Police Garage Complex at 3929 Laclede, St. Louis, Missouri 63103. It is located on the northwest corner of the complex and is approximately 50 by 120 ft., as shown in Figure 1. The west (120 ft.) and north (50 ft.) walls are outside walls, and the area is accessed through another part of the overall structure from Laclede Street. The roof is supported by wooden trusses and the clear ceiling height is approximately 15 ft., with an additional six-foot height between each of the trusses. Within the space, there is a 9 X 12 ft. office, an 11 X 12 ft. storage area and a 14 X 30 ft. spray booth. The floor area is divided into six work areas that are defined by painted lines on the floor. Four of the 20 X 30 ft. work areas are located along the west wall and two are along the east wall. A spray booth is located in the northeast corner of the shop and was not being used during the initial site visit but was cleaned up and being used as a paint storage area during the follow-up survey.

Area environmental samples were collected throughout the shop in the locations shown in Figure 1. One set of samples was also collected from the adjacent storage area for background comparison purposes. A wide variety of chemicals and materials are used in these operations. However, the most common contaminant is dust from the sanding and painting procedures. Some solvent odor was present but very limited. Based on this information and observations during the initial site visit, it was decided that total dust would be the best indicator of the workers exposure. Charcoal tube area samples were also collected and analyzed for toluene to obtain some indication of the presence of solvents.
