## The Explosion Hazard From Hydrogen Gas Generation Inside Sealed Frames

### Background

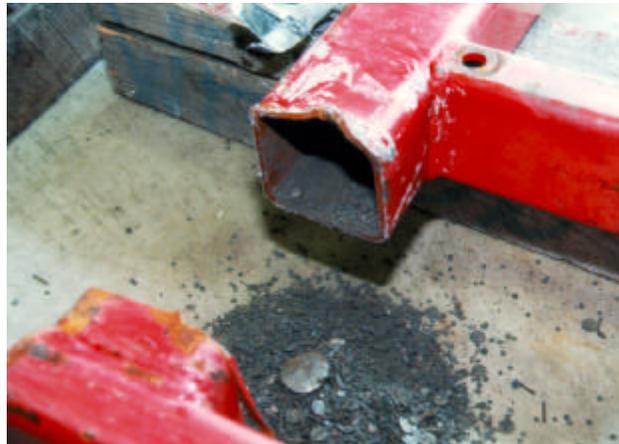
Inspection of the frame sections involved in the incidents showed discoloration, charring, or blistering of paint in the immediate vicinity of the holes. Probing the holes with a magnetized blade revealed a hard interior fill material and the presence of some metal punchings. This fill material was more extensively sampled from another section that had been cut through (figure 1). This revealed a wide range of metal punchings that was used as ballast in these steel frame sections, which had been welded shut after the filling operation. The punchings were found to consist of various forms of steel (carbon, galvanized, and stainless) and other metals, including titanium. Sealing the holes and sampling the gases present revealed the depletion of oxygen from the original air atmosphere and the presence of hydrogen. The hydrogen concentration was found to increase with time under sealed conditions. The pressure in the resealed sections also increased with time at a steady

The mechanism for the generation of hydrogen has not been definitively proven; however, all available evidence points to an electrochemical reaction involving metals of substantially different activity and electrical potential in the presence of water and oxygen. The oxygen helps provide the relatively high voltage needed to decompose water to hydrogen and hydroxide ion in conjunction with an active metal such as zinc (the coating in galvanized steel) or possibly aluminum. The origin of the water is believed to be an oil/water emulsion that is used as a cutting fluid in machine shops. Only a few tenths of a percent of water in the steel scrap can account for the hydrogen pressures that have been found in frame sections. To date, only metal-filled frame sections have shown evidence of gas formation. However, the possibility exists for the formation of hydrogen from a sealed hollow frame if acidic conditions exist in the section from an acidic flux used in fabrication or from bacterial action. Bacterial action can also produce methane under anaerobic conditions, which was found in one of the frames investigated.

Figure 1. Metal fill from exposed section of plow frame.

Eliminating this hazard will require more stringent control over the ballast material used to fill the frames to ensure that internal gas is not produced or that expansion of the fill does not rupture the frame upon strong heating, as in a welding operation. Under present circumstances, manufacturers should limit their metal scrap fill material to ordinary steel similar in composition to the steel frame; small vent holes should be provided to eliminate the possibility of gas pressure buildup inside the sealed sections.
