From Scotia to Brookwood, fatal US underground coal mine explosions ignited in intake air courses

Thomas H. Dubaniewicz, Jr.*

National Institute for Occupational Safety and Health, Pittsburgh Research Laboratory, P.O. Box 18070, Pittsburgh, PA 15236

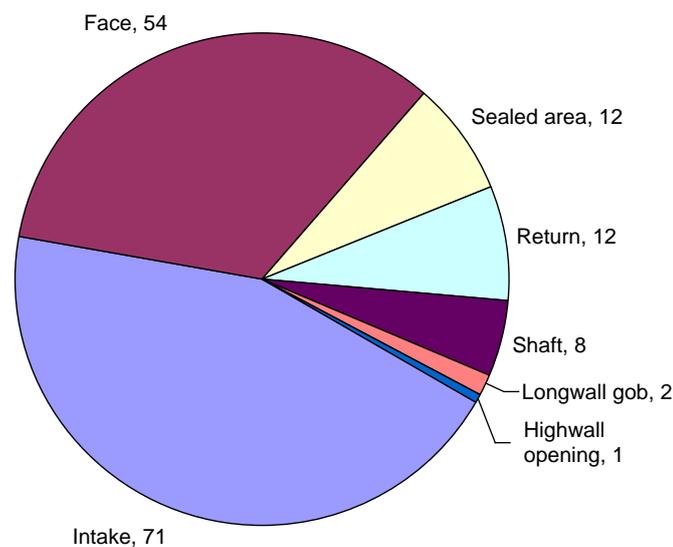
Fig. 1. 160 methane and/or coal dust explosion fatalities by location of the ignition source in underground or high wall coal mines from 1976 to 2006. Numbers of fatalities per location were weighted by the location uncertainty of the 1989 Pyro No. 9 disaster.

Fig. 1 shows that many US explosion fatalities since 1976 can be linked to ignition sources in intake air courses. In all of these accidents, the ventilation system failed or was found to be inadequate. These fatalities suggest intake air courses of gassy underground coal mines should be considered Class I Division 2 or Zone 2 locations at a minimum, i.e. locations in which flammable gases or vapors are normally prevented by positive mechanical ventilation, and which might become hazardous through failure or abnormal operation of the ventilating equipment (NEC 500.5 (b) (2); 505.5 (b) (3)).

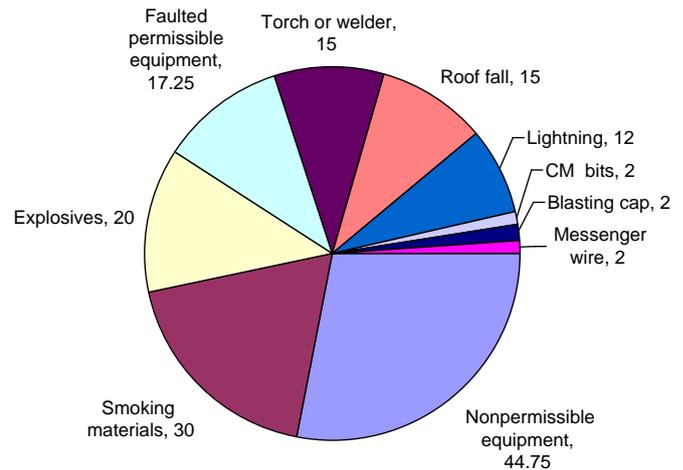
Fig. 2. Ignition sources linked to 160 methane and/or coal dust explosion fatalities in underground and high wall coal mines from 1976 to 2006. Numbers of fatalities per category were weighted by ignition source uncertainties of the 1989 Pyro No. 9 disaster and 1987 Double R explosion.

Figs. 2 and 3 show that nonpermissible equipment can be linked to more explosion fatalities than any other ignition source category, for all locations, and especially in intake air courses. Fig. 5 shows this trend continues to recent times. All of the nonpermissible equipment ignition sources linked to explosion fatalities were located in intakes. Fig. 4 shows that nonpermissible vehicles (battery and trolley powered) were linked to most intake explosion fatalities. Today, several underground vehicle manufacturers offer explosion protected locomotives and personnel carriers, track or tire, battery or diesel. Given the history of vehicle ignited fatal explosions and the availability of explosion protected vehicles, use of explosion protected vehicles in intake air courses of gassy underground coal mines is recommended to reduce this hazard.

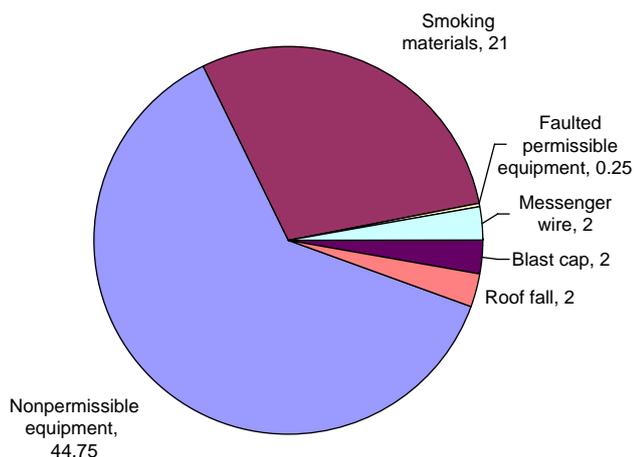
Fig. 3. Methane and methane plus coal dust explosion fatalities linked to ignition sources in intake air courses of underground coal mines from 1976 to 2006. Numbers of fatalities per category were weighted by ignition source uncertainties of the 1989 Pyro No. 9 disaster and the 1987 Double R explosion.

Most fatalities linked to cigarette lighters occurred when the miner was lighting up in intake air courses (Fig. 3). Smoking materials are prohibited in underground coal mines (30 CFR 75.1702). The smoking related fatal explosions emphasize the hazard of open ignition sources located in intake air courses of gassy mines should the ventilation system fail or become inadequate. The use of explosion protected electrical equipment in intakes of gassy mines may make the miner more aware of ignition hazards in these areas, including smoking materials.

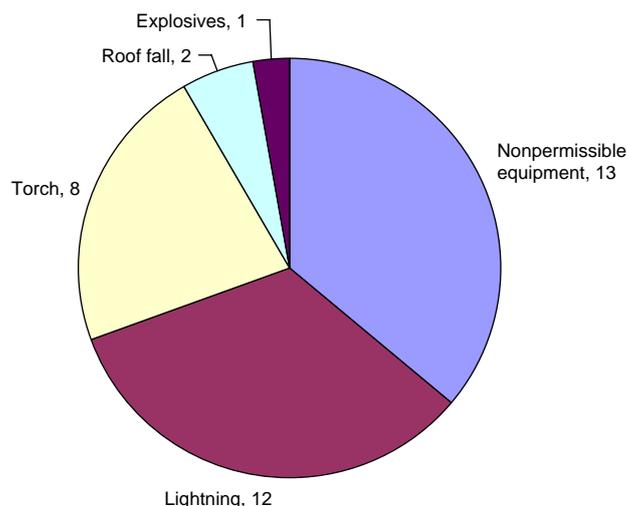
Fig. 5. Most likely ignition sources identified by MSHA for 36 fatalities from methane and methane plus coal dust explosions in underground coal mines from 2000 to 2006.

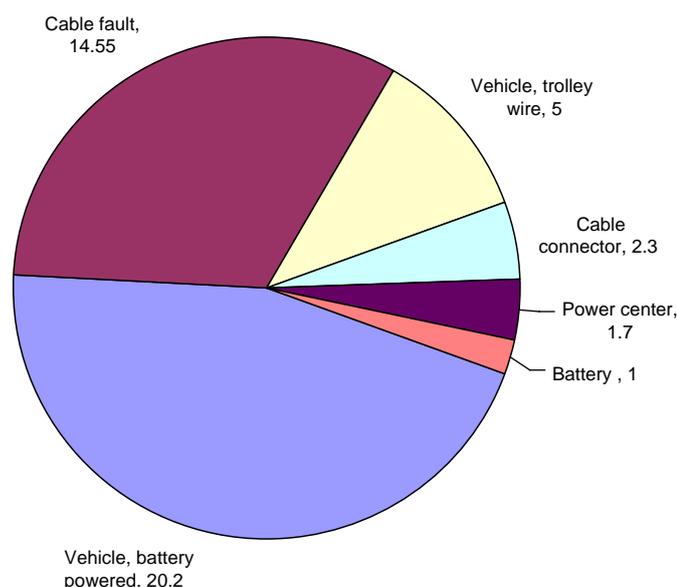
Fig. 4. Methane and methane plus coal dust explosion fatalities linked to non-permissible electrical equipment in intake air courses from 1976 to 2006. Numbers of fatalities per category were weighted by ignition source uncertainties of the 1983 McClure disaster and the 1987 Double R explosion.

Twelve of the cable fault fatalities (Fig. 4) can be linked to the damaged block light cable igniting the second massive Brookwood explosion. The block light system was not required to be designed to prevent methane ignition as it was installed in an intake air entry. The description of the block light circuit (MSHA, 2002) suggests the block light installation may not have met several requirements for flexible cords in Class I Hazardous Locations (2005 NEC 501.140; 505.17)². Potential violations involved: lack of a separate grounding conductor, cord not listed for extra hard usage, cord not protected from damage by location or suitable guard. Compliance with these NEC[®] and OSHA requirements might have prevented the 2nd 2001 Brookwood explosion (Dubaniewicz, 2007).
