## STABILITY OF UNDERGROUND OPENINGS ADJACENT TO THE SINK HOLE AT THE NIOSH LAKE LYNN RESEARCH LABORATORY

D. R. Dolinar, T. E. Marshall, T. M. Barczak, T. P. Mucho  
NIOSH  
Pittsburgh, PA

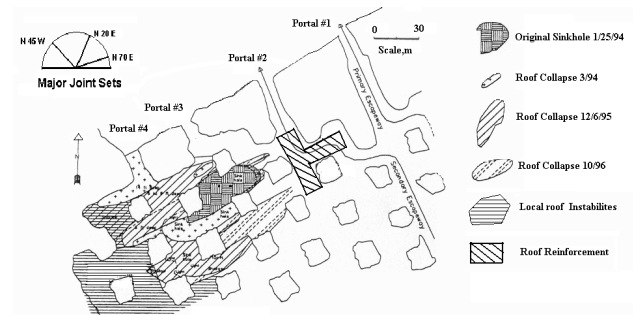
On January 25, 1994 a large roof collapse occurred in the old workings near portals 3 and 4 and in close proximity to the highwall. The roof fall encompassed approximately 2,550 m<sup>2</sup> of entries and crosscuts. Over the collapsed area, the overburden thickness was approximately 30.5 m. Given the relatively shallow depth and the intersection of two significant joint sets observable through most of the roof rock units a sinkhole formed during the initial collapse. With time, the underground failure and sinkhole have expanded. Figure 1 shows the location of the original roof collapse and sinkhole as well the extension of the failure.

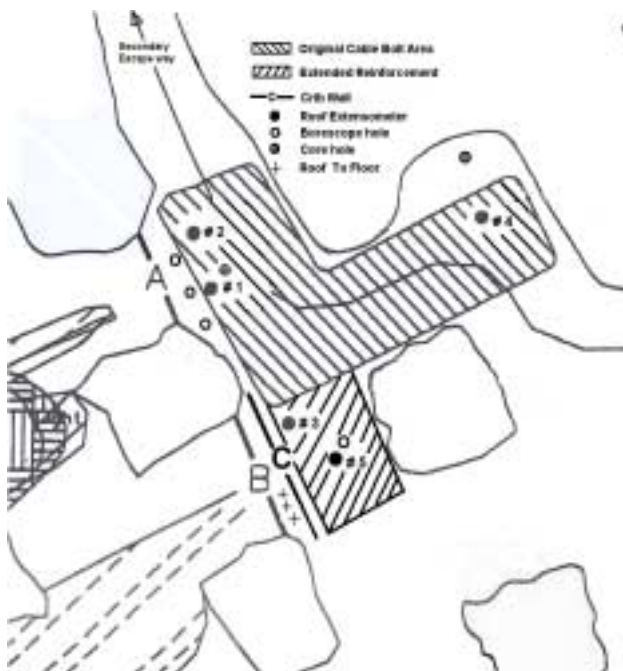
**Figure 2. Location of roof reinforcement and instrumentation in the vicinity of the secondary escape way.**

In October 1996, a roof fall occurred adjacent to the sinkhole near crib wall B that extended along the dominant joint set and encompassed an area from 6.1 to 15.2 m wide and 45.7 m long (figures 1 and 2). Most of the roof fall was only a few feet thick. However, one large block of rock estimated to be 4.3 to 5.6 m thick, 5.6 m wide and 9.1 m long weighing an estimated 4,500 kN fell from the roof and damaged the crib wall. The roof cavity where the large block fell extended to a depth of about 6.1 m possibly through the shale. Upon falling, the large block rotated upon striking the floor and a corner of the rock impacted the lower portion of the crib wall with a blow resulting in the collapse of one half or three crib sections of the wall (figure 5). However, the wall was not designed to take a dynamic side load from a 4,500 kN rock falling nearly 9.1 m. The impact was sufficiently violent to knock concrete crib blocks 15.2 m into the entry. Although the wall did partially fail, it did break the roof failure and prevented any extension of the roof fall into the entry beyond the crib wall.

Two concrete crib walls were built in crosscuts between the sink hole and secondary escape way and across the dominant joint set to act as breaker walls (figure 2). Each wall was about 15.2 m long, 9.1 m high, and 1.8 m wide, and composed of six four-point concrete cribs. The walls consisted of pre cast reinforced concrete sections that were stacked as four point cribs interlocked at specified positions. The walls were topped at the each of the crib corners with 1.83-meter-high timber crib packs. Grout bags were placed on the top of the timber cribs and pressurized to lock the crib walls in place resulting in about 4,270 kN of active force being applied to the roof.

To provide reinforcement along the dominant joint set, fully grouted tensioned cable bolts were also installed in the secondary escape way behind crib wall A (figure 2). The bolts were made from a 1.5 cm diameter, 7-strand cable with a minimum breaking strength of 258 kN. A total of 81 cable bolts were installed on a 3-m offset row spacing. To intersect the dominant near vertical joint set, the cables were installed at a 30-degree angle from vertical with half the cables angled inby and half outby from the portal in an alternating row pattern. A cable length of 9.1 m was used to allow anchorage into the upper limestone and the suspension of the lower limestone and shale layers from the upper limestone. Prior to grouting, the cables were pre-tensioned to 200 kN.

Another component of the plan was the installation of more instrumentation during 2002 to monitor roof behavior and add a further element of safety as work progressed in the entry that was to be supported. A fifth extensometer was placed in the center of the entry between the two joints along which the 1996 rock fall occurred (figure 2). Further, three roof to floor convergence monitors were installed just 1.52 m in by the new crib wall toward the roof fall in the crosscut (figure 2).

A new crib wall (C) was built across the entrance of the cross cut just behind crib wall B (Figure 2). Figure 8 shows the completed crib wall that extends for a length of 21.3 m and covers two major joints, spaced 18.3 m apart. The crib wall was built on a steel reinforced concrete pad that was either 0.3 or 0.6 m thick depending of the floor elevation. A total of 9 interlocking 4-point cribs were erected with the height of the concrete crib portion of the wall being 6.71 to 7.01 m. The crib blocks were made from steel reinforced concrete were 0.61 m by 0.3 m and 1.83 m long.

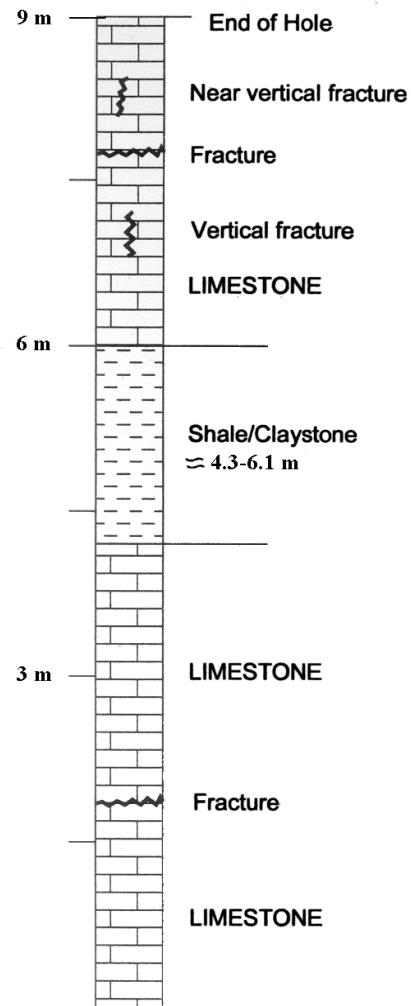
**Figure 3. Roof geology observed in secondary escape way.**

To evaluate the geology and structure, two drill core holes (one core hole was angled 30 degrees from vertical) and several borescope holes have been drilled in and near the secondary escapeway (figure 2). A geologic column of the roof in the secondary escapeway based on the drill core obtained underground is shown in figure 3. The immediate roof consists of a competent gray limestone to a depth of 4.3 m. Above the limestone there are a series of red claystones and gray shales to a depth of 6.1 m. The claystones and shales are then overlain by 2.7 m of fined-grained limestone.

Several fractures and joints were observed in the core from both the lower and upper limestone sections. At a roof depth of between 0.9 and 1.2 m, sections of core were missing. This zone appears to correspond to a major separation along the bedding that was also noted in several observations holes in the secondary escapeway. In these holes the bedding separations and even open breaks in boreholes were observed at depths of 1.52 to 1.68 m in the mine roof (Molinda et al., 1996). In an adjacent area, the open fractures were noted at depths of 1.83 and 2.44 m in the roof.

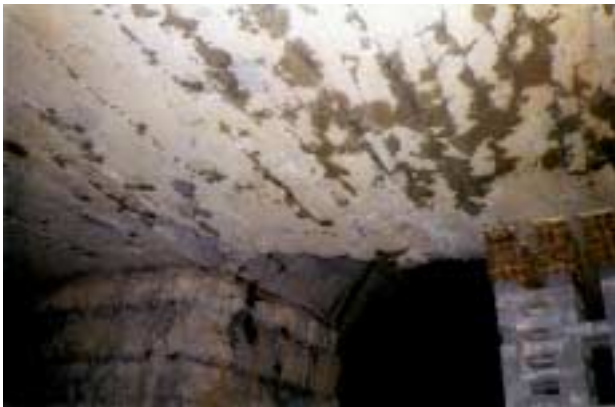
The roof in the area of the secondary escapeway is heavily jointed with near vertical joints spaced between 0.3 to 1.83 m apart and orientated mainly N 70° E. These joints are nearly perpendicular to the orientation of the entries and parallel to the crosscuts and the highwall. However, some of the joints are inclined from vertical and intersect the adjacent near vertical joints, forming small wedges that are no more than 0.3 to 0.61 m wide that can fall out from the roof. Figure 4 shows these dominant roof joints crossing an entry adjacent to the secondary escapeway. In general, the joint density increases towards the portals and highwall. The vertical extent of most of these joints is not known but there appears to be several large joints or zones with several closely spaced joints with spacing between 6.1 to 9.1 m that may have a much greater vertical depth, possibly up through the shale. These large fractures and joints appear to be the main avenues for water seeping through the roof. The dominant joint and fracture system as well as the shale zone in the roof were taken into account in the design of the original reinforcement system installed in the escapeway.

**Figure 4. Dominant joint set (N 70° E) that is nearly perpendicular to the entry and parallel to the high wall.**

Because of the potential for the failure to extend along the dominant joint set orientated at N 70° E, the secondary escape way was reinforced in July of 1994 (figure 1). The design of the reinforcement systems developed to protect the secondary escape way focused on three elements: (1) isolating the secondary escape way from the collapse, (2) reinforcing the secondary escape way roof structure and (3) reducing the inflow of water through the roof. Three support remedies were then used that included crib walls, cable bolts and polyurethane grout (Zelanko et al., 1996).

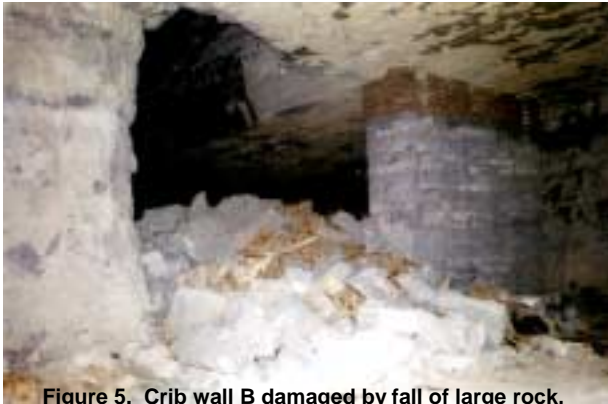
Examination of the fall revealed that the block fell out between two near vertical joints orientated N 70° E that extended up through lower limestone to the shale. Further, the area was partially surrounded or isolated by collapsed roof. This partial isolation further reduced any confining forces along the joints that failed. Water was also present along the joints and roof in the area further weakening the shale above the immediate limestone roof and reducing the joint cohesion over time.

**Figure 5. Crib wall B damaged by fall of large rock, October 1996.**

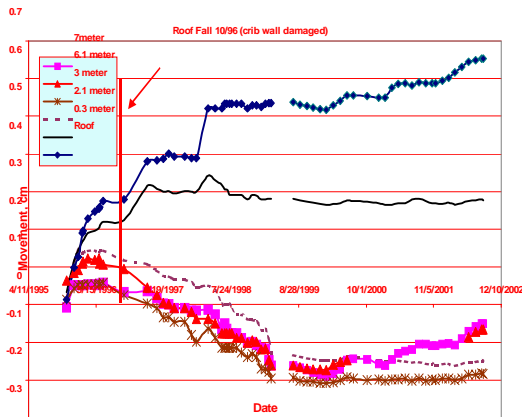
**Figure 6. Roof movement measured at extensometer 3 between October 1995 and August 2002. Note: the gap in the data from March to July 1999 resulted from damage to the extensometer.**

Figure 6 shows the roof movement at the various anchor horizons for extensometer 3. On the figure, the roof movement is for an anchor at a given roof depth with respect to the 8.1 m reference anchor. Between November 1995 and August 2002 over 0.63 cm of total movement of the roofline was detected with about 0.25 cm movement between 0.3 and 2.1 m movement and 0.25 cm between the roofline and 0.3 m. Through 1999, accelerated movements were initiated in November 1995,

between late October 1996 and March 1997 and mid March 1998. There appears to be a seasonal pattern to the movement with the accelerated movement initiating in the fall or winter. Through March 2000, a fairly large amount of movement occurred but the movement was relatively shallow in the roof with most of the movement below 2.1 m. Since March 2000, there has been less than 0.13 cm of roof movement. However, most of this movement has been between 3.0 and 6.1 m into the roof, clearly much deeper than the previous movement.

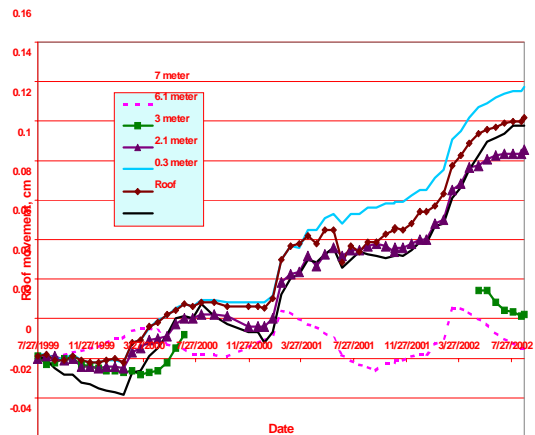
Beginning in March and April of 2000 a pattern of roof movement was observed at extensometer 3 that would lead to the decision to reinforce the entry adjacent to the damaged crib wall. Figure 7 shows the roof movement from July of 1999 to August of 2002. Again, the roof movement is for an anchor at a given roof depth with respect to the 8.1 m reference anchor. Although nearly an order of magnitude smaller, these roof movements were occurring at much greater depths than previously detected (figure 6). During this time period, only about 0.12 cm of movement was measured. However, most of this movement occurred between 3.0 and 6.1 m into the roof, the depth of the October 1996 roof collapse that partially destroyed the crib wall.

**Figure 7. Roof movement measured at extensometer three between July 1999 and August 2002.**

For three consecutive years, the roof movements were initiated in late January to mid-February. After each period of accelerated movement, there was a period with little or no movement. This movement pattern suggests that overall roof conditions are still stable. However, continued seasonal movement could result in a destabilization of the roof and eventually a large roof fall (Zavodini, 2000). Therefore, because of this pattern of deeper seasonal movement, a decision was made to develop and initiate a roof reinforcement plan to support the section of entry adjacent to the damaged crib wall.
