Personal Protective Equipment Conformity Assessment Studies and Evaluations

Evaluation of a Self-Contained Breathing Apparatus Involved in a Fatality While Operating at a Structure Fire

Howard County Department of Fire and Rescue Services Request for a MSA Model G1

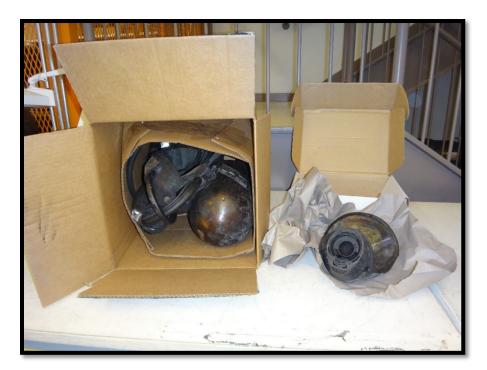
- SCBA unit was hand delivered to Lab H1513 by NIOSH DSR investigators
- Cylinder was received with 2250 psi and closed
- Bypass was closed
- Mask-mounted regulator (MMR) was securely connected to the low pressure line
- Facepiece was included

Figure 1: SCBA as received

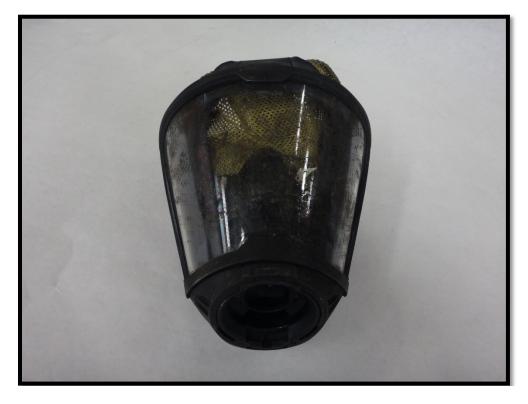
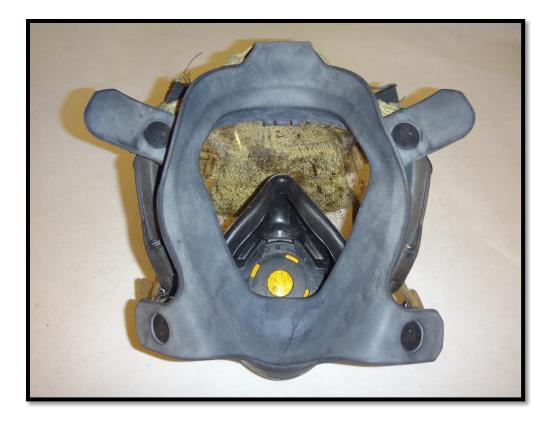
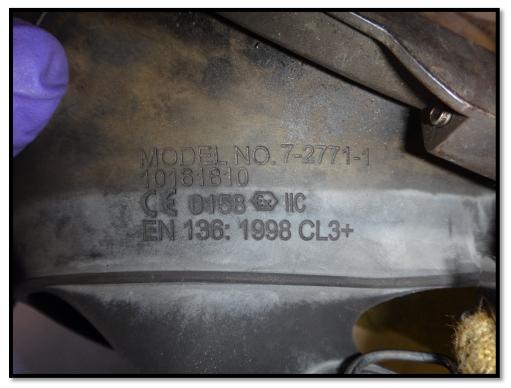
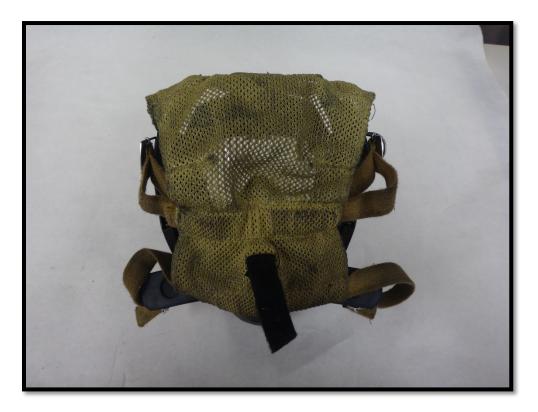
Facepiece (Figures 2-5)

- Facepiece seal P/N: 10161810; M/N: 7-2771-1: CE 0168 EXLLC; EN 136 1998 CL3+
- Nosecup MFG date: 8/14
- Overall condition: fair, dirty with scratches
- Lens was crazed and dirty
- Upper lens ring had molten debris on it
- Lens retaining ring was intact
- MMR housing was clean and in good condition
- HUD was present and intact
- Hairnet was in good condition with dirt present
- All straps and buckles functioned properly

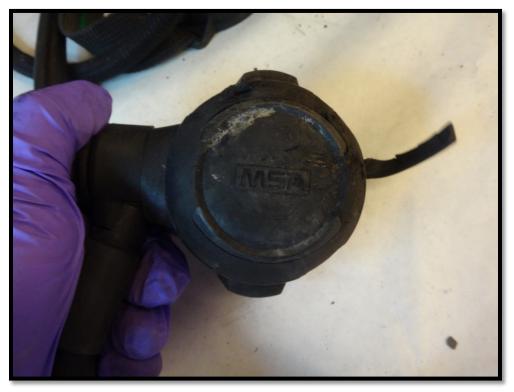
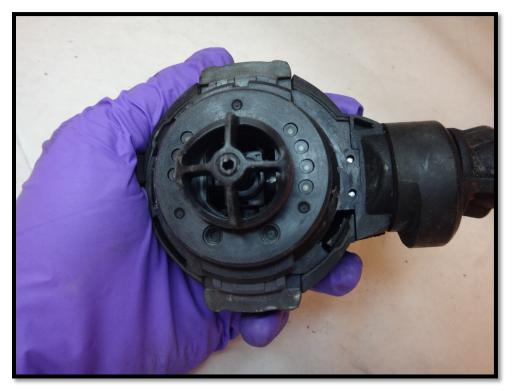
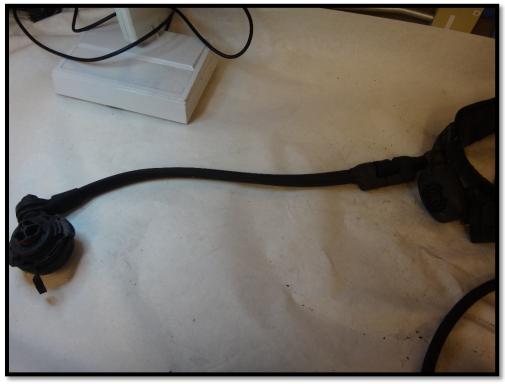
Mask Mounted Regulator (MMR) (Figure 6-8)

- MMR label on front: MSA; M/N: 7-2779-1
- Overall condition was dirty with signs of heat damage
- MMR was secured to low pressure line
- Bypass closed
- Inside flange had normal wear and in good condition
- Sealing area was fair and slightly dirty
- Regulator could be attached and removed
- Outer rubber casing had physical heat damage
- Low Pressure Regulator Hose (Figures 8-9)
 - Secured at all attachment points
 - Line was in good condition
 - Line passed through the shoulder strap to the reducer

Figure 6: Mask mounted regulator with signs of heat damage

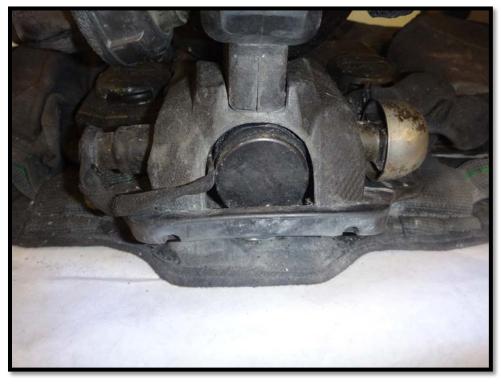
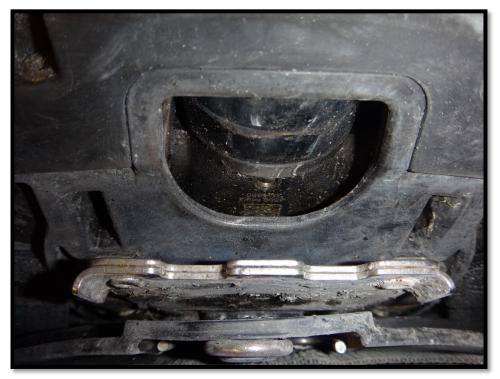
Pressure Reducer Assembly (Figure 10-11)

- Overall condition was good
- All airline connections were secure
- All lines going to the pressure reducer were in good condition
- 4500 Psi; 2115380

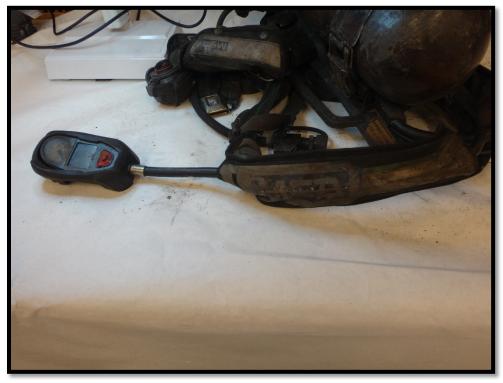
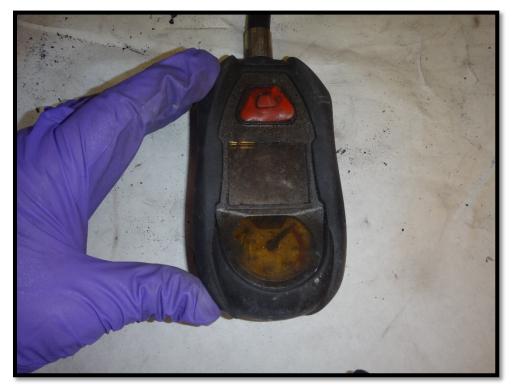
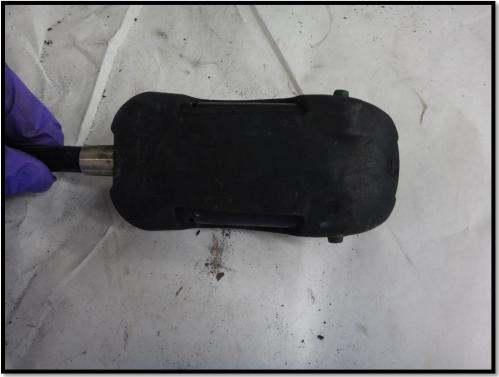
PASS Control Module (Figures 12-14)

- Lines to control module looked good
- Gauge lens was readable
- Protective casing was good and in place
- M/N 2816-1

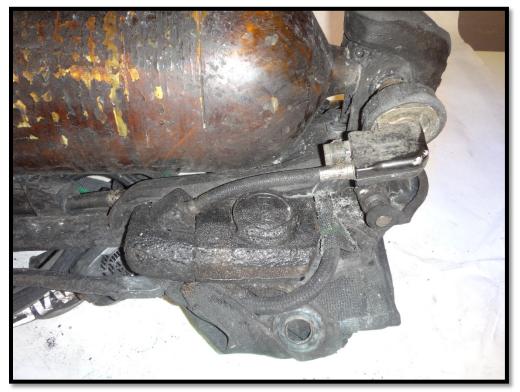
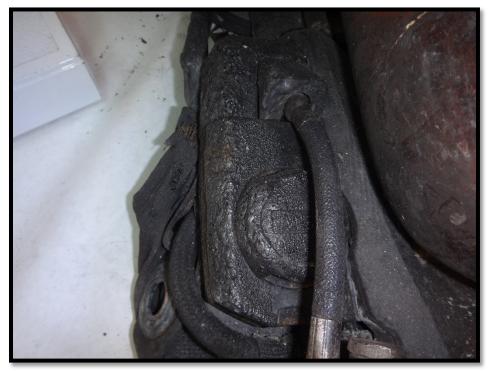
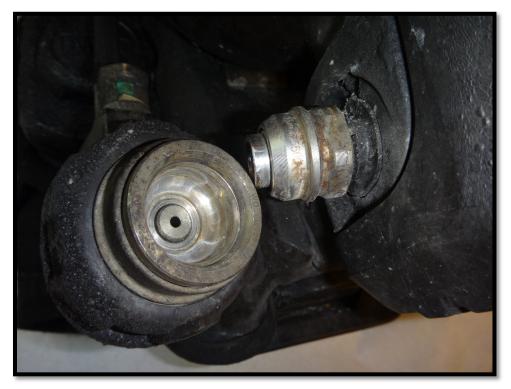
High Pressure Hose and Cylinder Attachment (Figures 15-17)

- High pressure S/N: 7-2844-1 DP
- High pressure line had heat damage, dirty
- Cylinder quick connect attachments were dirty; rubber wheel was burnt

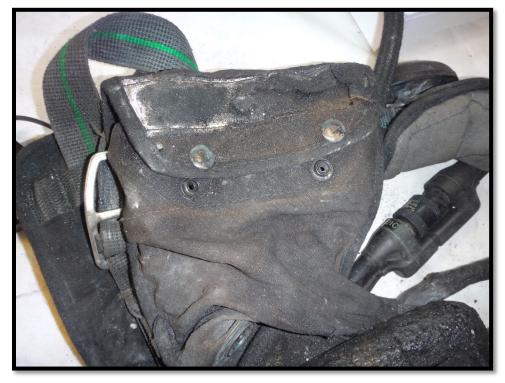
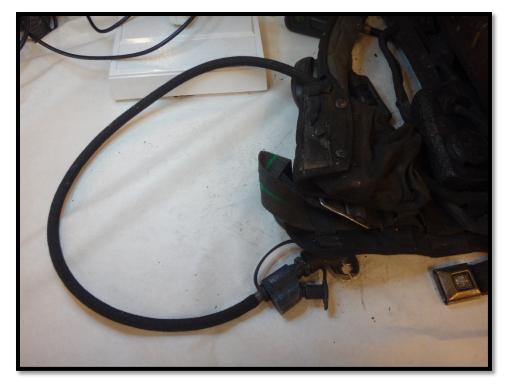
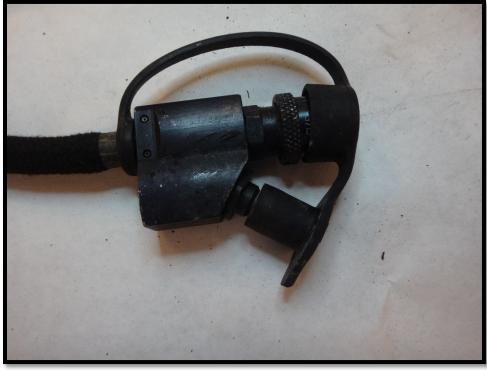
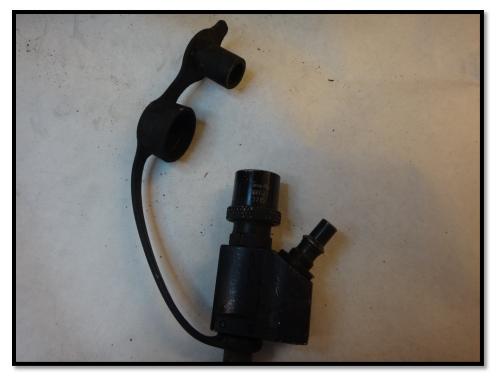
ExtendAire II EBSS (Emergency Breathing Support System (18-21)

- Quick Connect snap tite 9847-22; 3715
- Fair condition; covered with soot

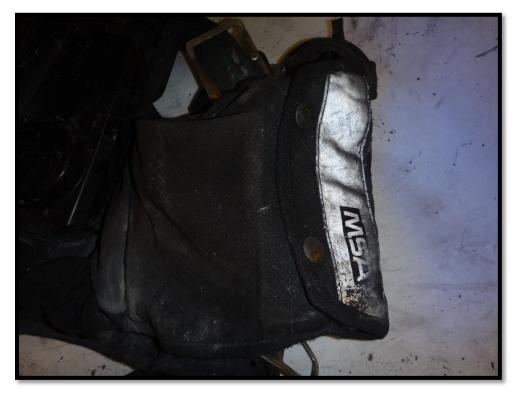
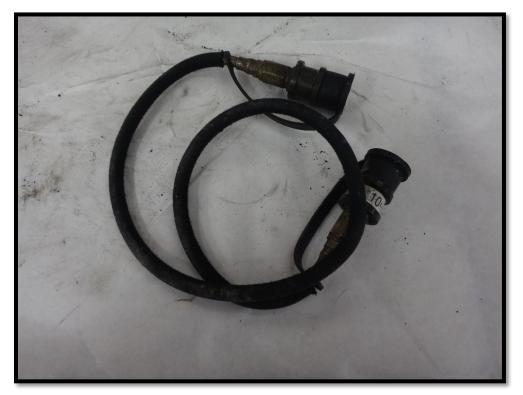
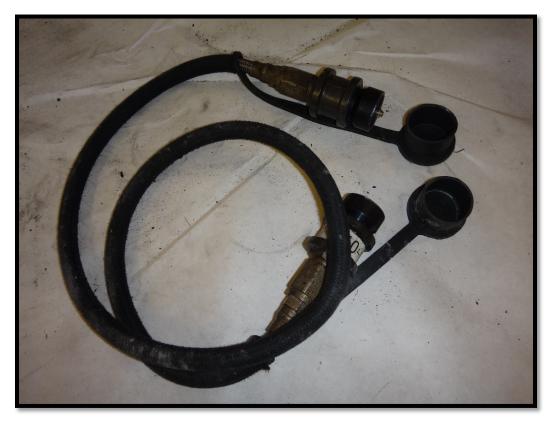
Quick-Fill line (22-24)

- FD 17 series
- HCFD; sticker 10-14
- Sleeve is frayed

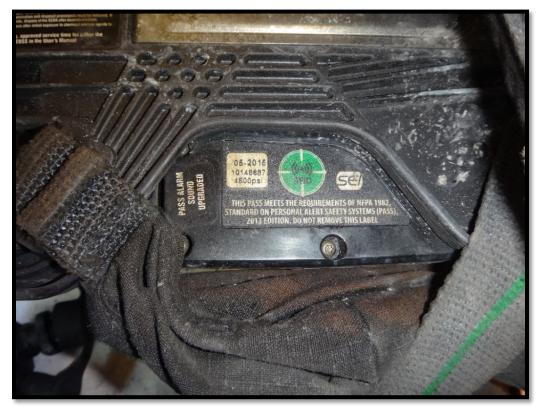
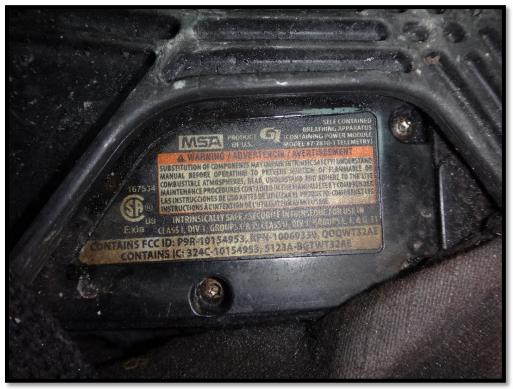
PASS Power Module (Figures 25-26)

- SEI label:05-2015; 10148687 4500 psi; RFID
- PASS met requirements of NFPA 1982: Standard on Personal Alert Safety Systems (PASS) 2013 edition
- FCC ID P9R 10154953, RPN 10069330
- SCBA containing power module M/N 7-2810-1
- Overall condition was good, but very dirty with debris and melted in spots
- Held securely to backframe
- Power module battery was unattached, looked good with dirt

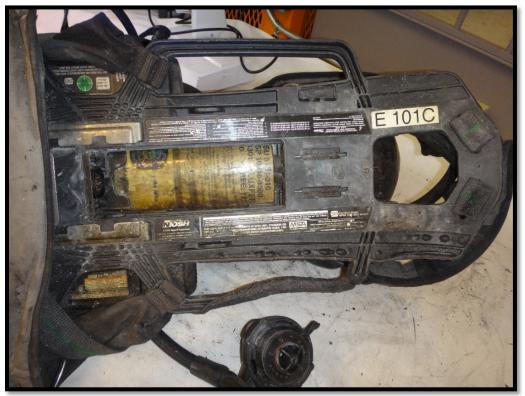
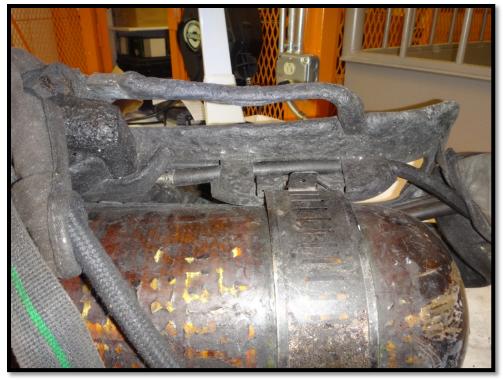
Backframe Assembly (Figures 27-28)

- S/N: 7-N/A
- SEI label 1981-2013 edition
- NIOSH Approval Number label: TC-13F-0798CBRN
- FD label with E 101C
- Overall condition was fair
- Extensive heat damage to left railing and right top
- Soot and debris were found everywhere
- Shoulder straps were attached to the frame

Figure 28: Cylinder strap and heat damage to side rail

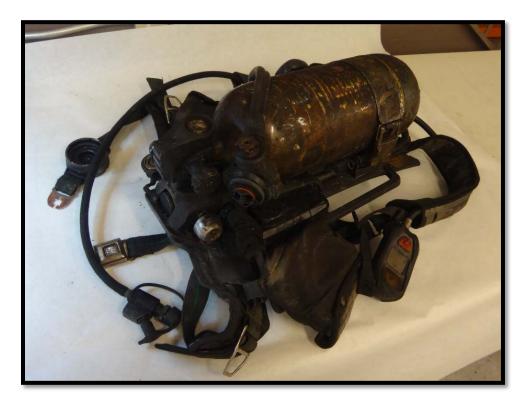
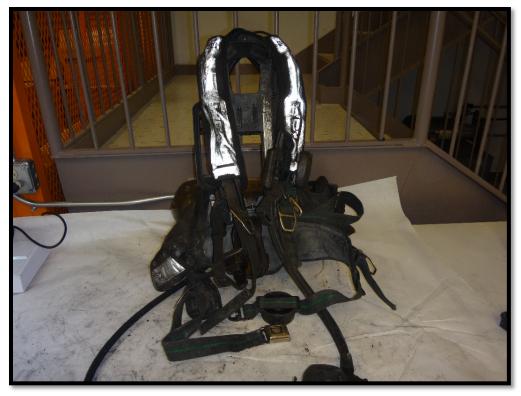
Straps and Buckles (Figures 29-30)

- Overall condition of straps was good, but dirty
- Hose lines passed through shoulder straps
- All adjustable buckles moved and held in place
- Waist area buckle latched

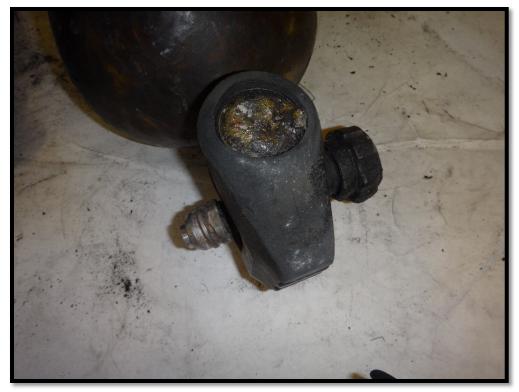
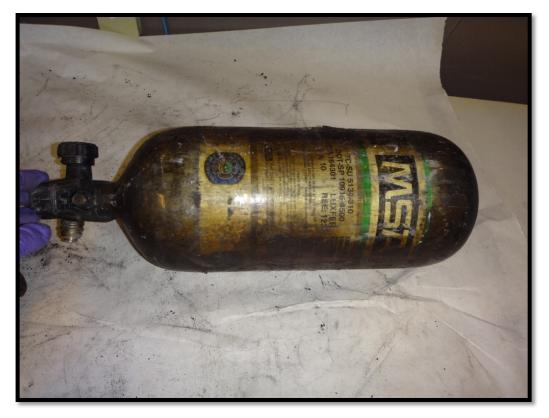
Compressed Air Cylinder and Cylinder Valve Assembly (Figures 31-32)

- DOT-SP 10915-4500; TC-SU-5134-310; OM 164301
- Luxfer P/N L65M-122; REE 123
- MSA M/N 7-1348-1
- Hydrostatic date: ?/2015; 45 minute, 4500 PSI
- Received with 2250 psi
- Overall condition was poor with heat damage
- Gauge was not readable
- Threads were good; attached to the threads was the male quick connect
- O-ring was present and in good condition
- Rubber bumper at base of cylinder valve was in good condition

*A replacement cylinder was used for testing due to damaged cylinder gauge on corresponding cylinder and a replacement facepiece was used for Run #2 on the Positive Pressure and Rated Service Time Test.
