AFFIDAVIT
DESCRIBING UNMONITORED AIRBORN EXPOSURES OF URANIUM
AT
NUCLEAR METALS, INC., WEST CONCORD, MASSACHUSETTS

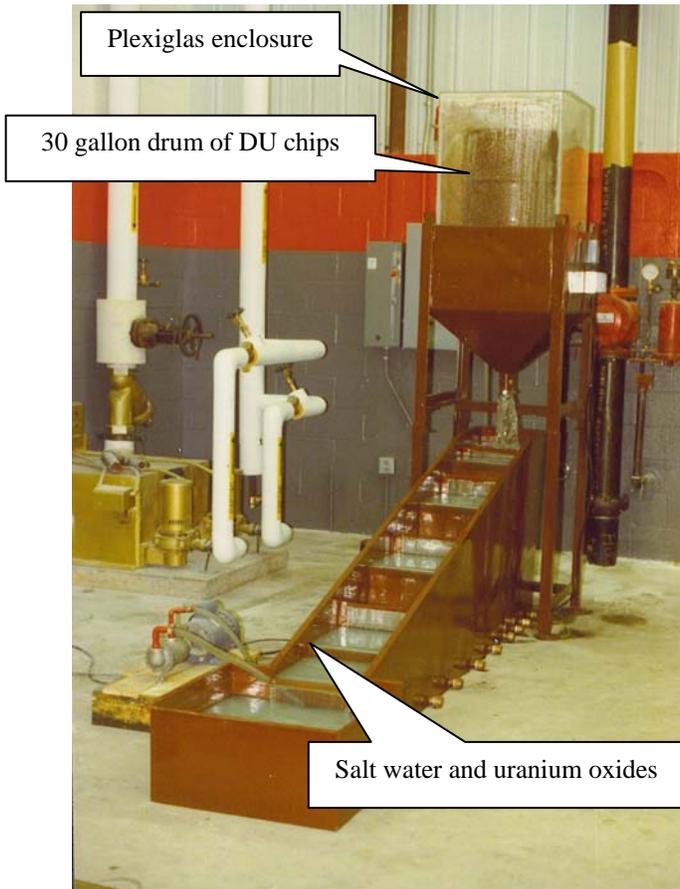
The first time the rig was used filled a 30-gallon steel drum with machine turnings to which a salt-water spray was placed above the drum in the Plexiglas enclosure shown in the photo. As the water drained from the drum it was filtered and recycled.

The process appeared to be working as planned when headed home for the day. That evening was recalled to the plant in response to a Concord Fire Department call when the fire alarm was triggered. The plant was filled with smoke and had managed to completely contaminate the new plant. The test rig was in shambles, the Plexiglas cover had melted and was blown aside by the explosion.

pieced together what had happened. The water was dissociated by the uranium and released hydrogen and oxygen. These gases collected in the Plexiglas dome. At the same time uranium chip size was shrinking as the surface oxides were formed and washed off the chips. This created an exponentially increasing surface to volume ratio in the chip that accelerated chemical oxidation and water dissociation. The process released increasing amounts of heat that further accelerated chemical reactions. When the chips auto-ignited the fire touched off the hydrogen and

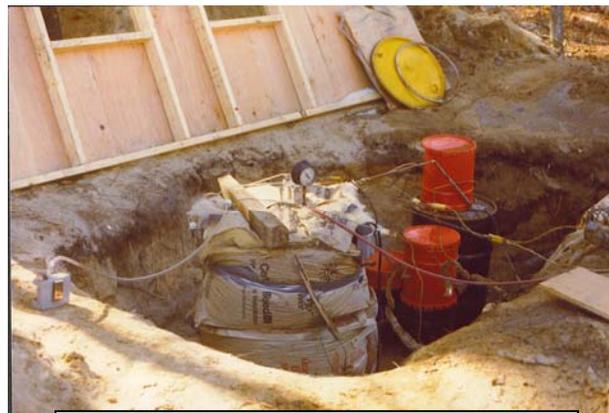
passed this standard. However, there were several occasions after power was turned off when the internal temperature of the package continued to rise. At a time of approximately 16-24 hours into the test the package would auto ignite or explode. Explosions were attributed to accumulated hydrogen from water dissociation.

These fires would cause the Type K thermocouples to melt even though they had an upper temperature limit of 1900 °F. In addition, prodigious amounts of smoke were generated. You can see from the photo that there was no provision for ventilation of the test area. The control area where we used recorders to track package temperature was located about 10 feet from the test pit.

Crude outdoor drum heating test stand. 55 gallon drum inside 85 gallon drum filled with anti-freeze. Insulated to reduce heat loss.

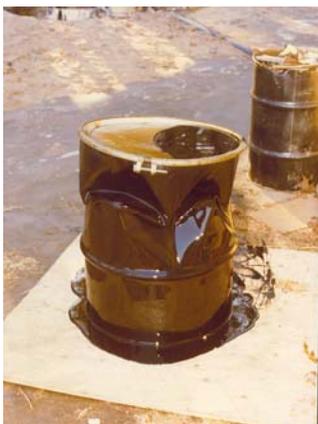
Prior to switching to anti-freeze, heated quench oil was used to heat the test drums. This test drum was removed after testing and is coated in oil. The drum collapsed from a vacuum produced by oxidizing uranium chips that scavenged available oxygen inside the drum.

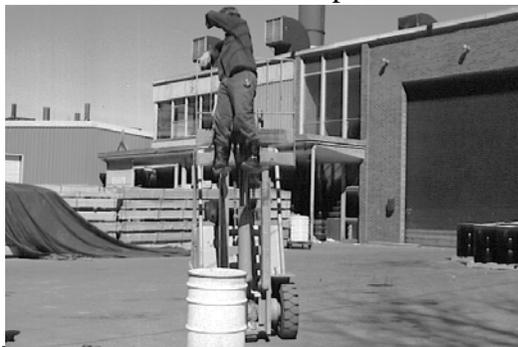
Employee performing crude DoT impact penetration test behind Building C to test for foam barrel puncture resistance.

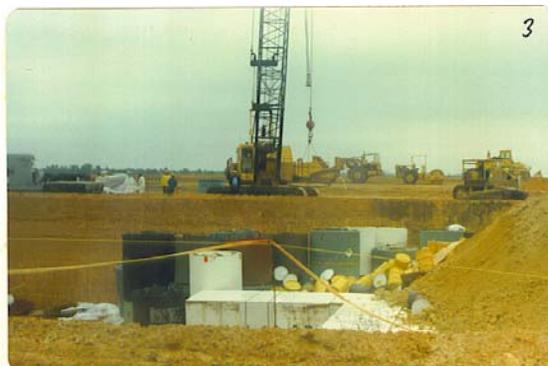
foam-uranium drums to Barnwell, SC, or Hanford, Washington disposal sites. The site photo shows NMI drums being dropped into a disposal pit. They had a long way to drop. When one of the drums was dropped a spark was generated which caused the drum to explode. assumed this explosion was caused by accumulated hydrogen that pressurized the drum as hydrogen was released by the dissociation of water by the uranium.

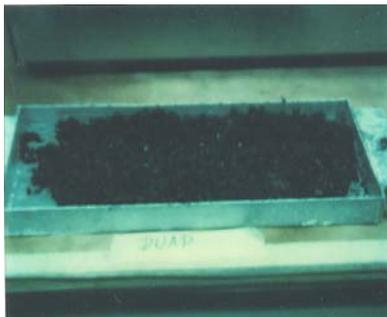
DUAP machine chips in chemical treatment tray

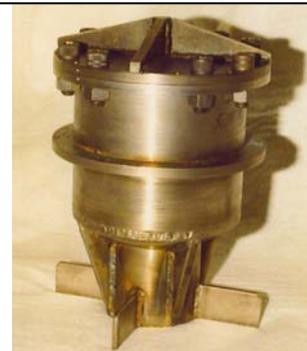
Graphite Lined mini-bomb reduction vessels (approx 12" tall)

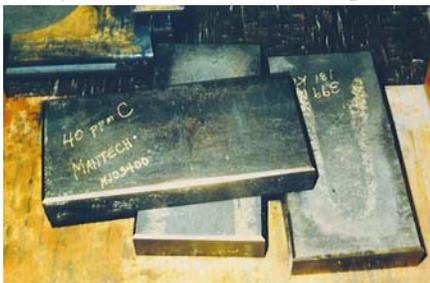
USAF Mantech castings – unalloyed DU for sheet rolling to reproduce Oak Ridge Y-12 material produced for LANL.

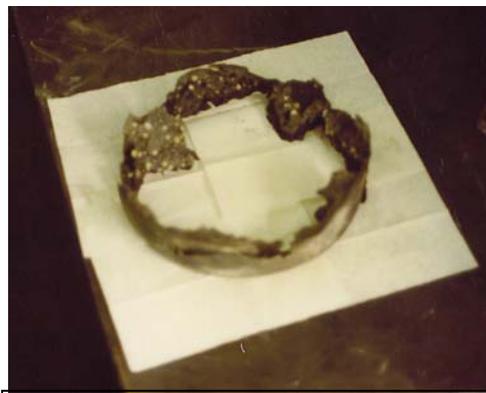
removed foundry crucible residue of unmelted Niobium pellets and uranium. Higher temperatures were required, necessitating the development of better mold wash coatings. Alternative VIM process to Rocky Flats eb melting trials.

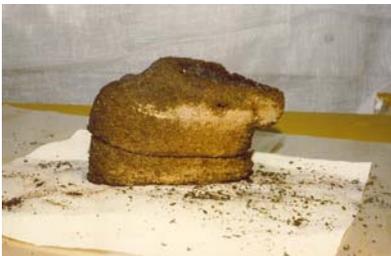
Briquetted DU machine turnings removed from foundry crucible. DU metal trapped in oxide layers could not be reclaimed. Note DU oxide powder everywhere in work area.

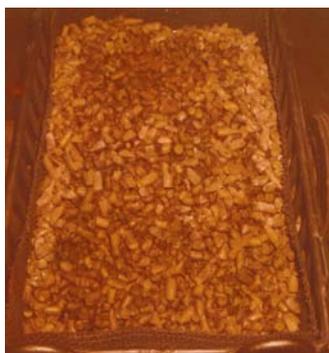
Post water rinse for first cleaning

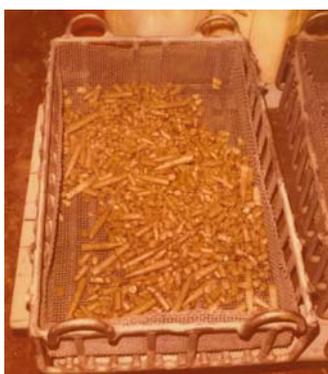
Post nitric acid etch.

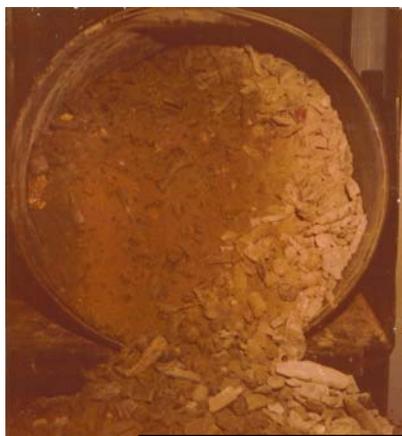
Initial inspection of 55 gallon drum scrap. Waste composed of sand, uranium bullet fragments and aluminum sabots.

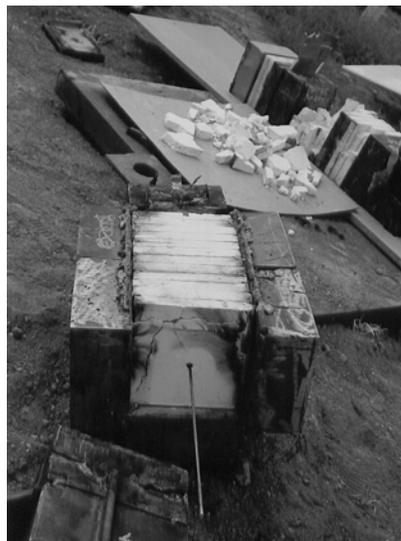
Uranium impact target photo inspection. One of many in my collection.
