INCIDENT HIGHLIGHTS

DATE:
September 11, 2018

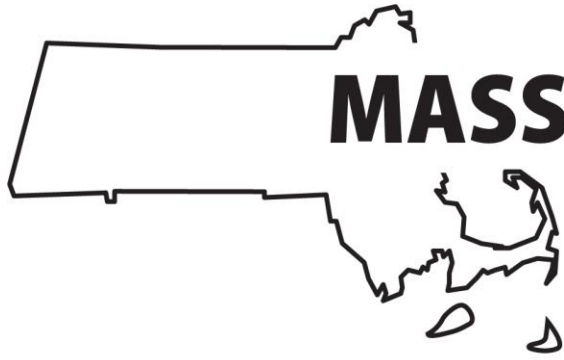
- Work towards creating a positive safety culture and safety climate in the workplace.
- Ensure that all workers assigned to tasks where they will spend time along roadways wear high visibility, reflective clothing. [LEARN MORE](#) > (p.6)

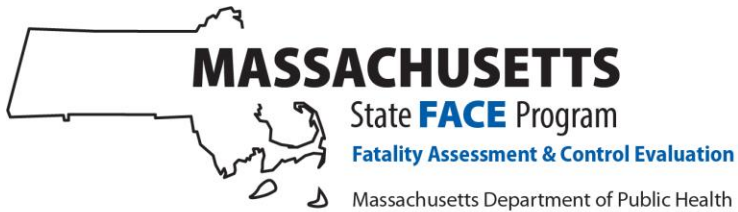
The Massachusetts Department of Industrial Accidents (DIA) has grants available for providing workplace health and safety training to employers and employees. Any company covered by the Massachusetts Workers' Compensation Insurance Law is eligible to apply for these grants. More information about these DIA grants can be found on their website at www.mass.gov/dia/safety.

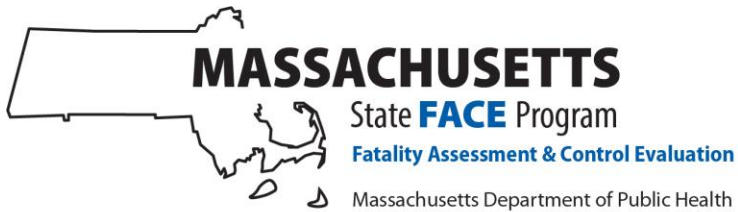
3. OSHA. Recommended Practices for Safety and Health Programs. OSHA 3885. 2016. www.osha.gov/shpguidelines/. Date accessed: April 10, 2018.
4. Laborers' Health and Safety Fund of North America. Lifelines. Assessing and Improving Safety Climate on Your Jobsite. January, 2017; Vol 13, Num 8. www.lhsfna.org/index.cfm/lifelines/january-2017/assessing-and-improving-safety-climate-on-your-jobsite/
