A summary of a NIOSH fire fighter fatality investigation

October 04, 2016

# Career Fire Captain Drowns After Stepping Into Flooded Storm Drain During Floodwater Rescue – Oklahoma

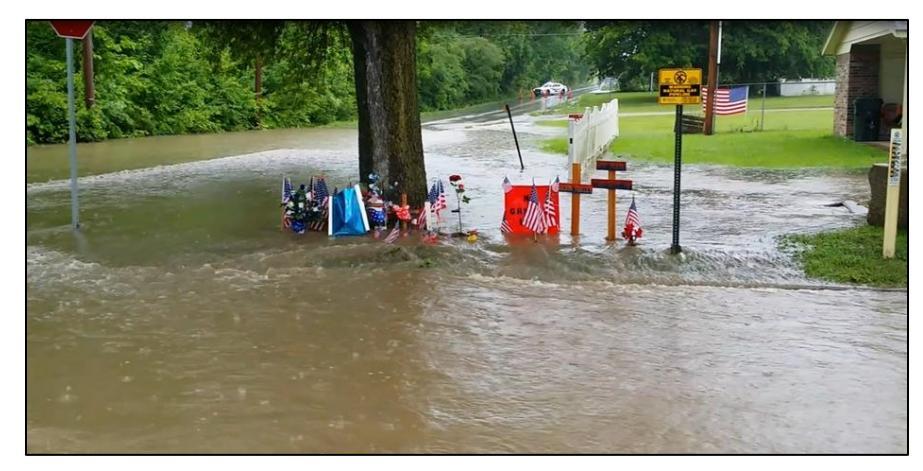
Photo taken on June 10, 2015 during similar flood conditions at the site of drowning incident. Both fire and police departments had responded numerous times to this flood prone location. (Photo courtesy of Police Department.)

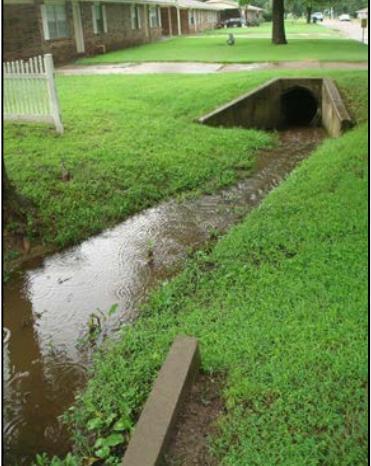
Catch basin and unguarded entrance to underground storm drain where 46-year-old fire captain drowned.

Consider enacting and enforcing requirements for identifying, marking and guarding underground storm drains.

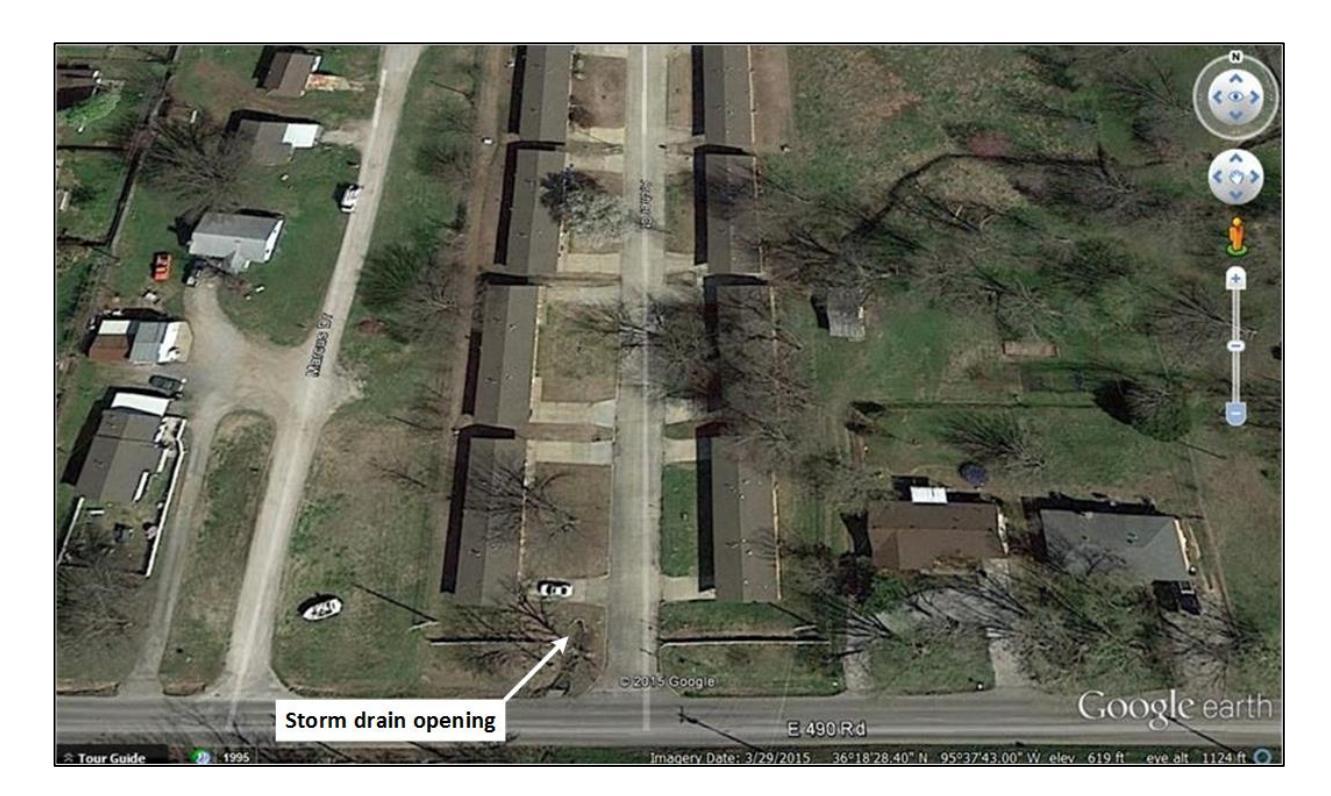
Photo 1. Overhead view of the incident site. (Adapted from Google Earth, image date 3/24/2015.)

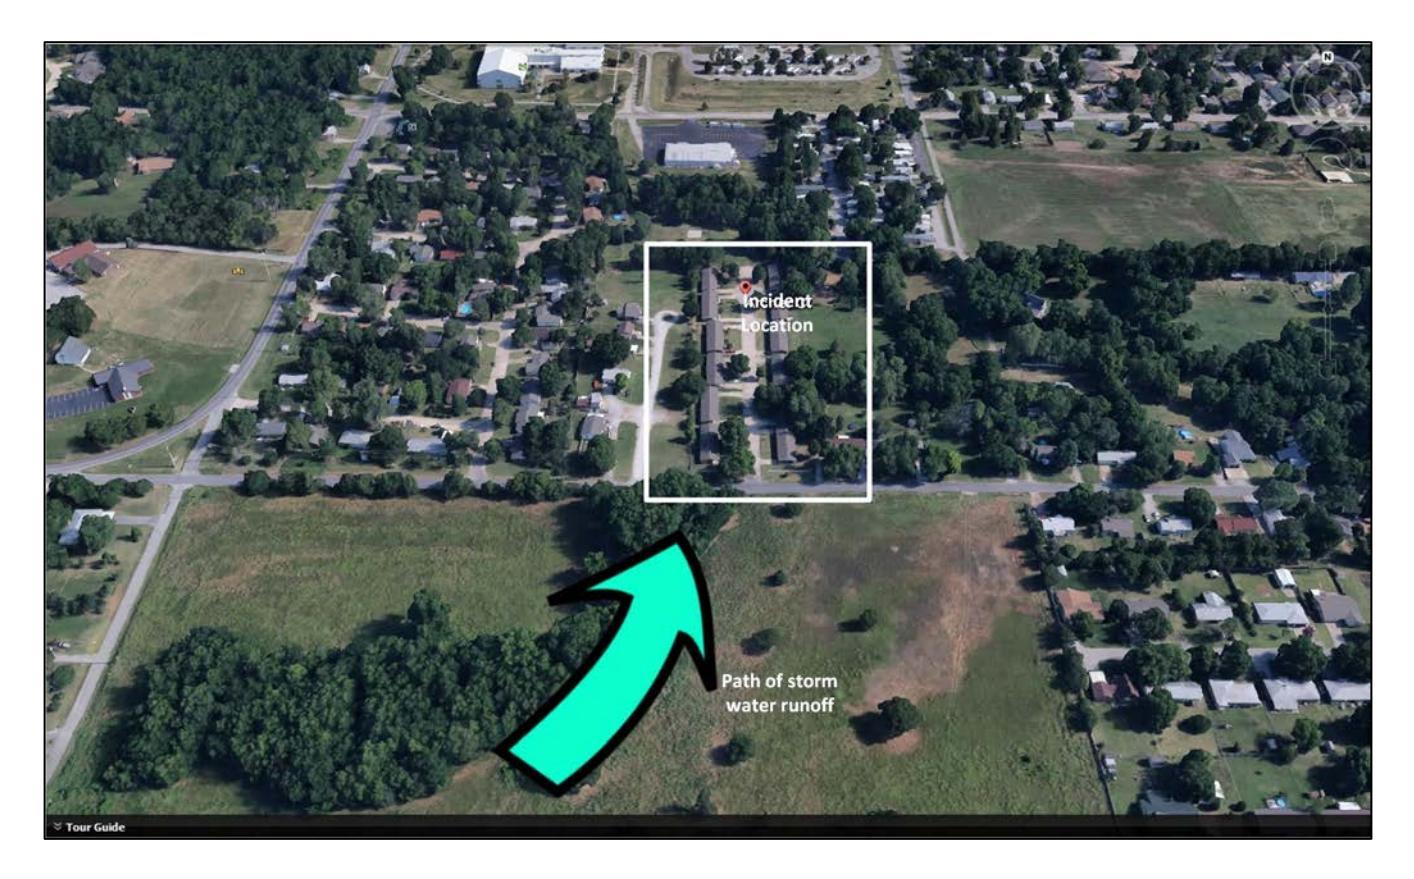
According to city records, the development was permitted in the late 1970s. The area was not considered to be a flood plain. City ordinances at the time covered drainage. The catch basin and underground storm drain were included in the development plans. The development contractor installed the drainage system within the housing development while drainage along the city stream was the responsibility of the Oklahoma Department of Transportation. The city's master drainage plan designated the development as a problem area due to storm water runoff and local street flooding. In 2008, the city had attempted to purchase the first two duplex units on the east side of the street for demolition using Federal Emergency Management Agency (FEMA) funds. However the effort was not successful at that time. Photograph 2 and Diagrams 1 through 3 illustrate the incident location.

Diagram 1. Overhead view showing location of incident scene west of center of town. The green arrow depicts the general path of natural drainage for storm water runoff following heavy rainfall. NIOSH diagram adapted from Google Earth.

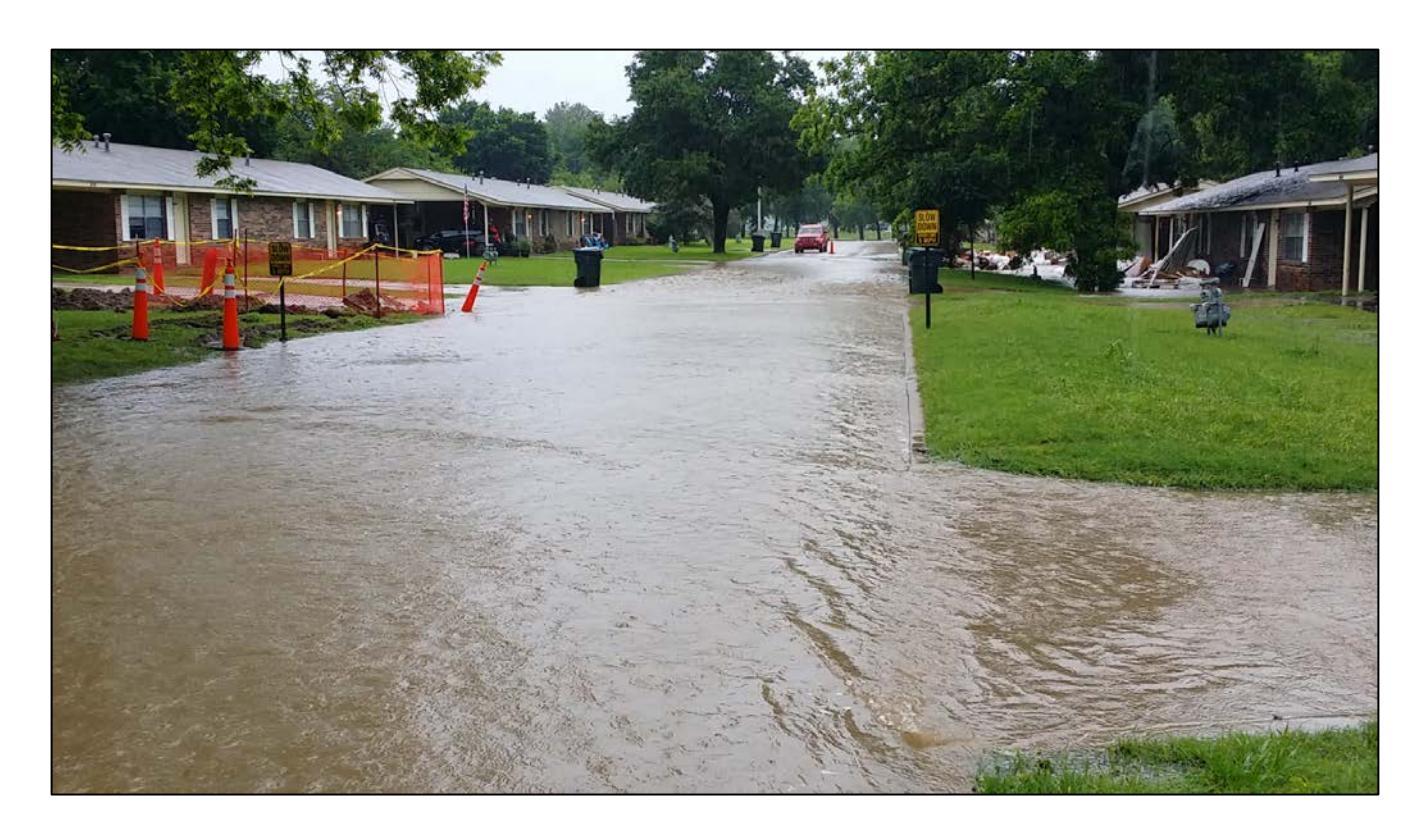
Photo 2. View of incident scene taken on June 10, 2015 during similar flood conditions. Note how duplex units on east side of street (right portion of photo) sit at a lower elevation than units on the west side of street (left side of photo). During the May 23, 2015, incident, the floodwater was reported to be up to the bottom window ledges on the duplex units on the east side of the street (right side of photo). Area surrounded by orange fence and caution tape is the location where the underground storm drain was opened to extricate the victim. *Photo adapted from scene video provided by police department.*

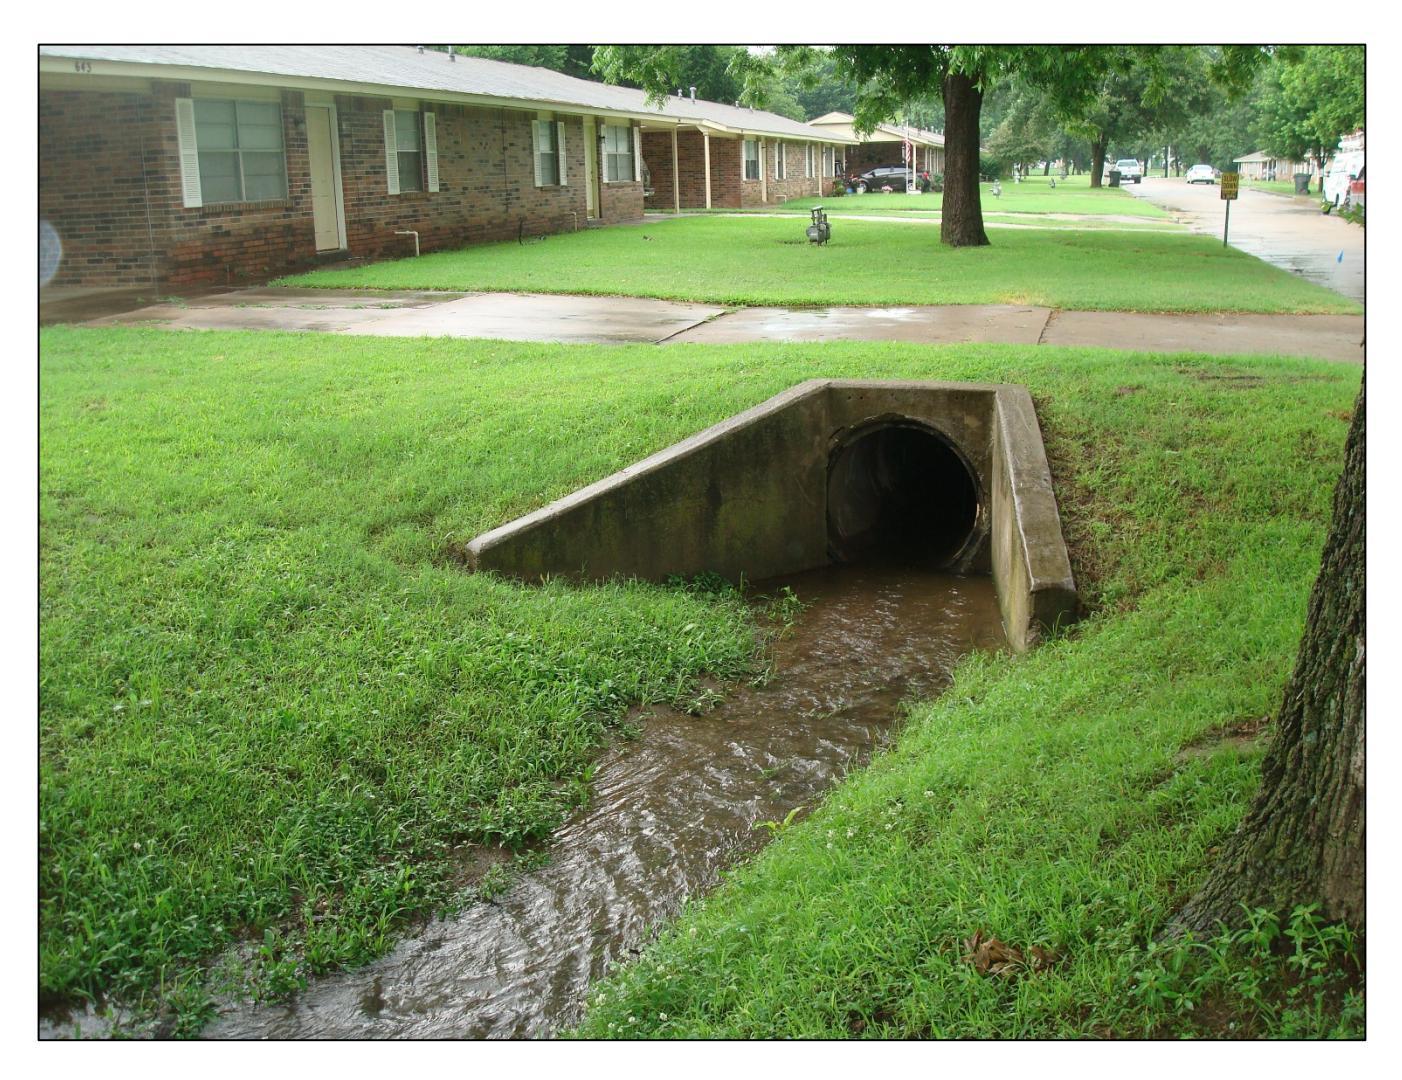
The vertical opening to the underground storm drain was a 36-inch diameter opening set in the middle of a concrete wall, 42 inches high, with angled walls on both sides (see Photo 3). During this incident, the Engine 2 captain was unable to travel past an 8-inch sewer drain pipe that bisected the underground storm drain approximately 95 feet from the drain entrance and became stuck inside the drain at this location. Following the incident, the city contracted to have a robotic camera travel through the underground drain to document the interior condition with video photography. The entire underground drain was documented (see Photo 4).

Photo 3. View of opening to underground storm drain looking north. Carport where fire fighters placed turnout gear is at the upper left corner of photo. NIOSH Photo.

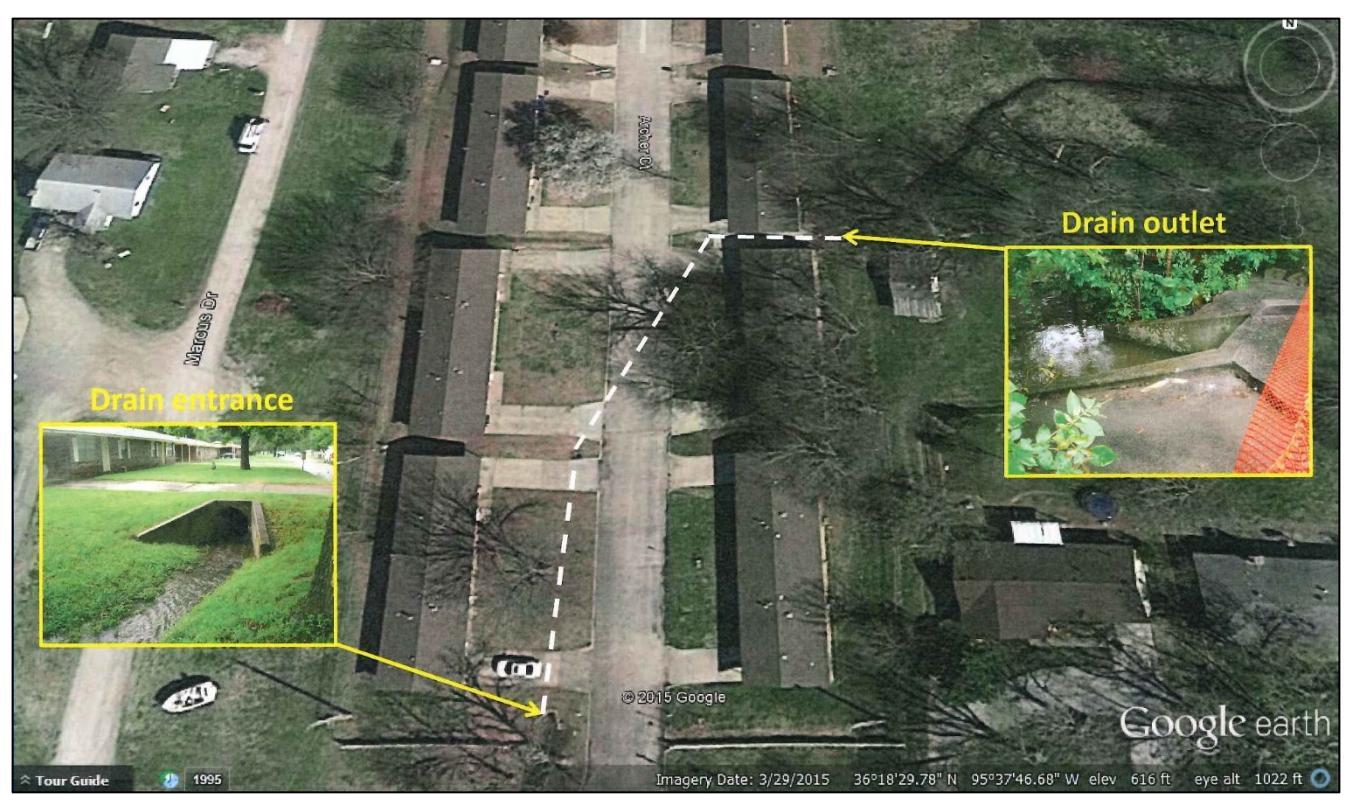
Diagram 2. Overhead view showing location of underground storm drain. NIOSH diagram adapted from Google Earth.

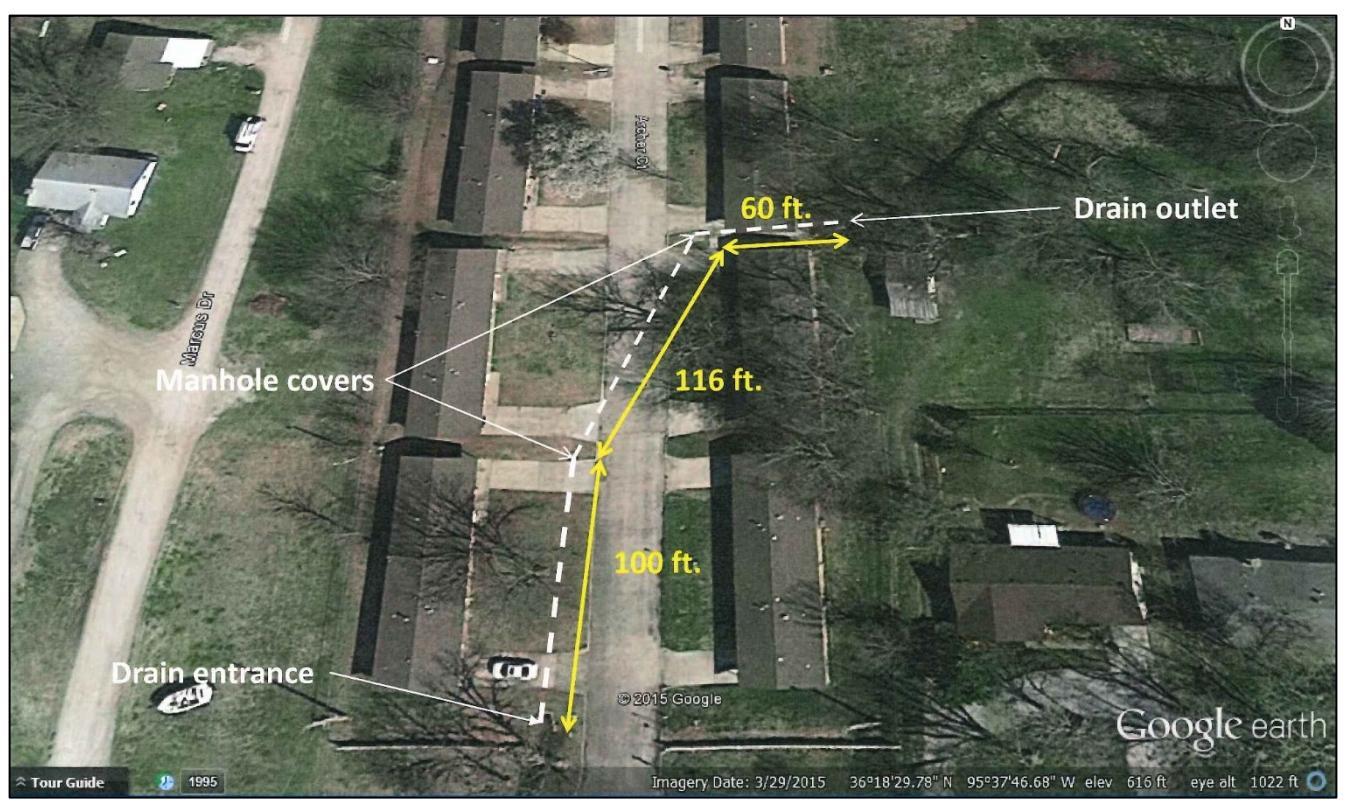
Diagram 3. Overhead view showing approximate dimensions of 276-foot-long underground storm drain. NIOSH diagram adapted from Google Earth.

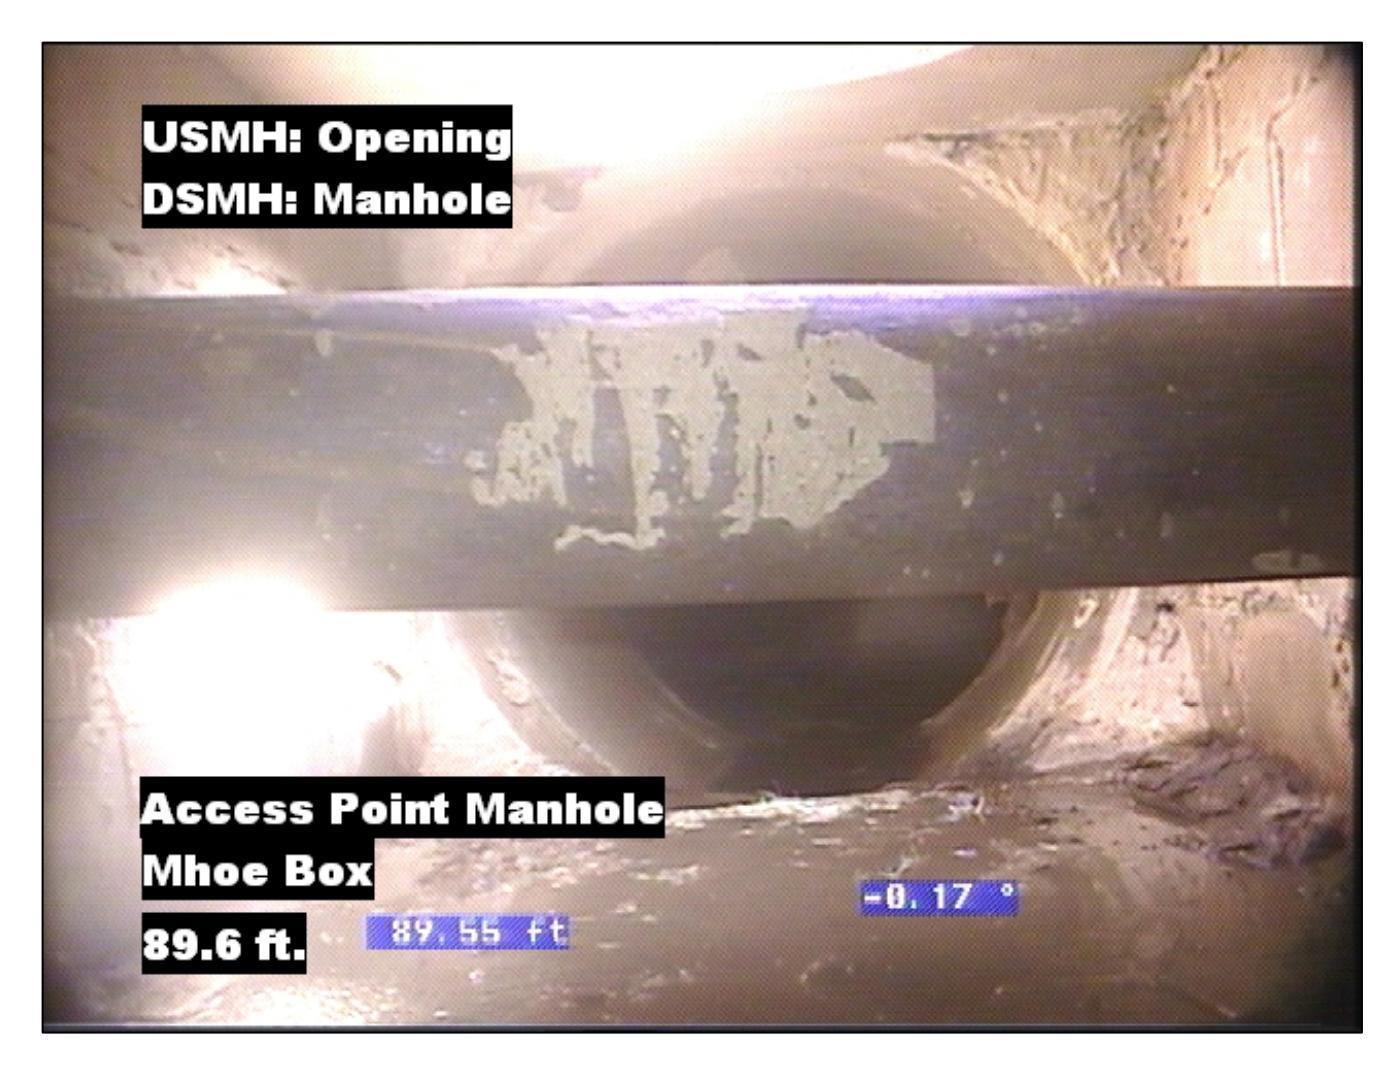
Photo 4. View of inside of underground storm drain taken by robotic camera after incident. View shows location where Engine 2 captain was recovered. Photo courtesy of the fire department.

The city water department was called to begin opening manholes to inspect the inside of the stillflooded storm drain. A manhole cover approximately 100 feet from the storm drain entrance was opened and the Engine 2 captain was found inside the drain a few feet south of the manhole, entangled on an 8-inch sewer drain pipe set perpendicular to the storm drain. The search operation was called off at 0109 hours on May 24. Heavy equipment was brought in to cut through the top of the concrete storm drain to gain access to the Engine 2 captain's body. The captain was recovered at approximately 0325 hours.

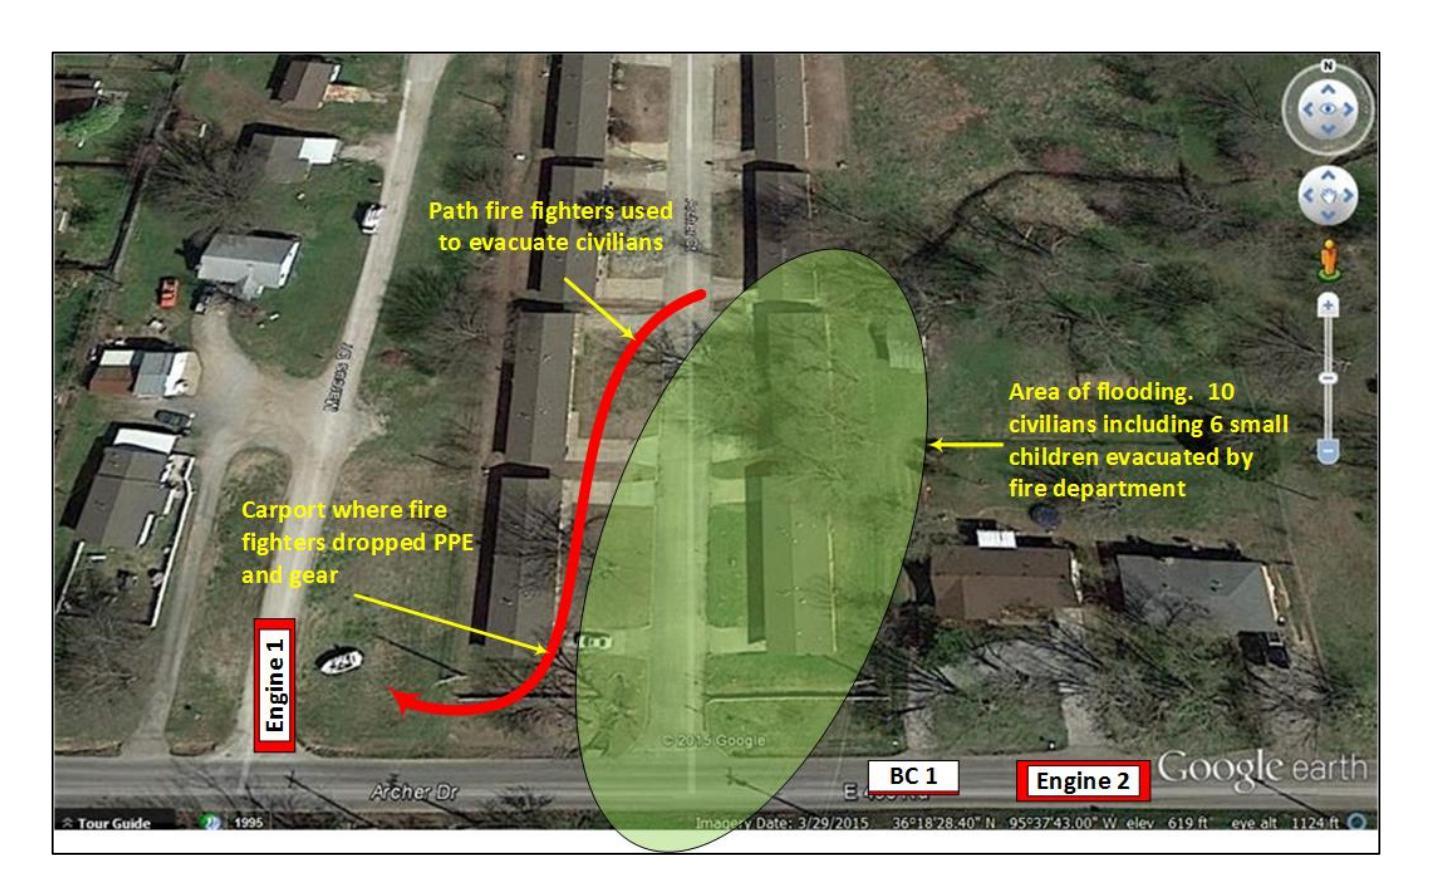
The duplex units on the east side of the development were at a slightly lower elevation than the units on the west side. The Engine 2 crew found the street leading into the development flooded with water over top of the curb on both sides of the street. As much as 3 feet of floodwater was running through the yards in front of the first three duplex units east of the street. The Engine 2 captain instructed his crew to walk in a single file behind him as they proceeded to each residence. The Engine 2 crew began knocking on doors on the east side of the development to determine the status of the occupants in each duplex. When the Engine 1 crew cleared the motor vehicle incident, the battalion chief immediately radioed for Engine 1 to come to the development for assistance. Engine 1 approached from the west and staged in an empty lot behind the duplex units on the west side of the street (see Diagram 4).

#### Diagram 4. Overhead view showing approximate area of most extensive flooding and travel path used by fire fighters to evacuate civilian residents. Floodwater was reported to be 3 to 4 feet deep in front of the duplex units in the area highlighted in green. (NIOSH diagram adapted from Google Earth.)

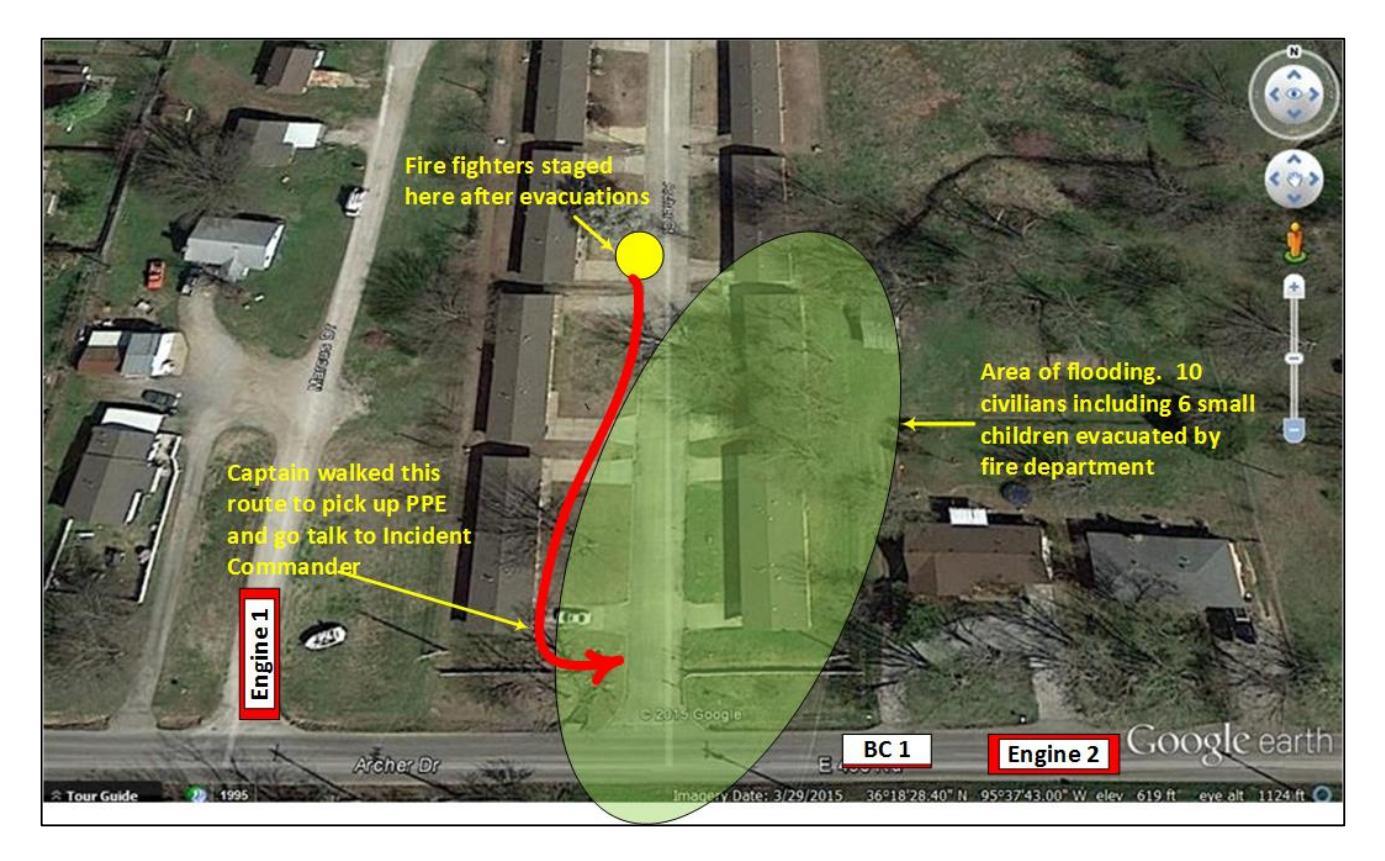
Diagram 5. Overhead view showing approximate area of most extensive flooding and travel path taken by Engine 2 captain to meet with the acting battalion chief (incident commander). The Engine 2 captain retrieved his turnout coat and helmet from the carport at the first duplex on the west side of the street, then walked through the floodwater to meet with the incident

commander. (NIOSH diagram adapted from Google Earth.)

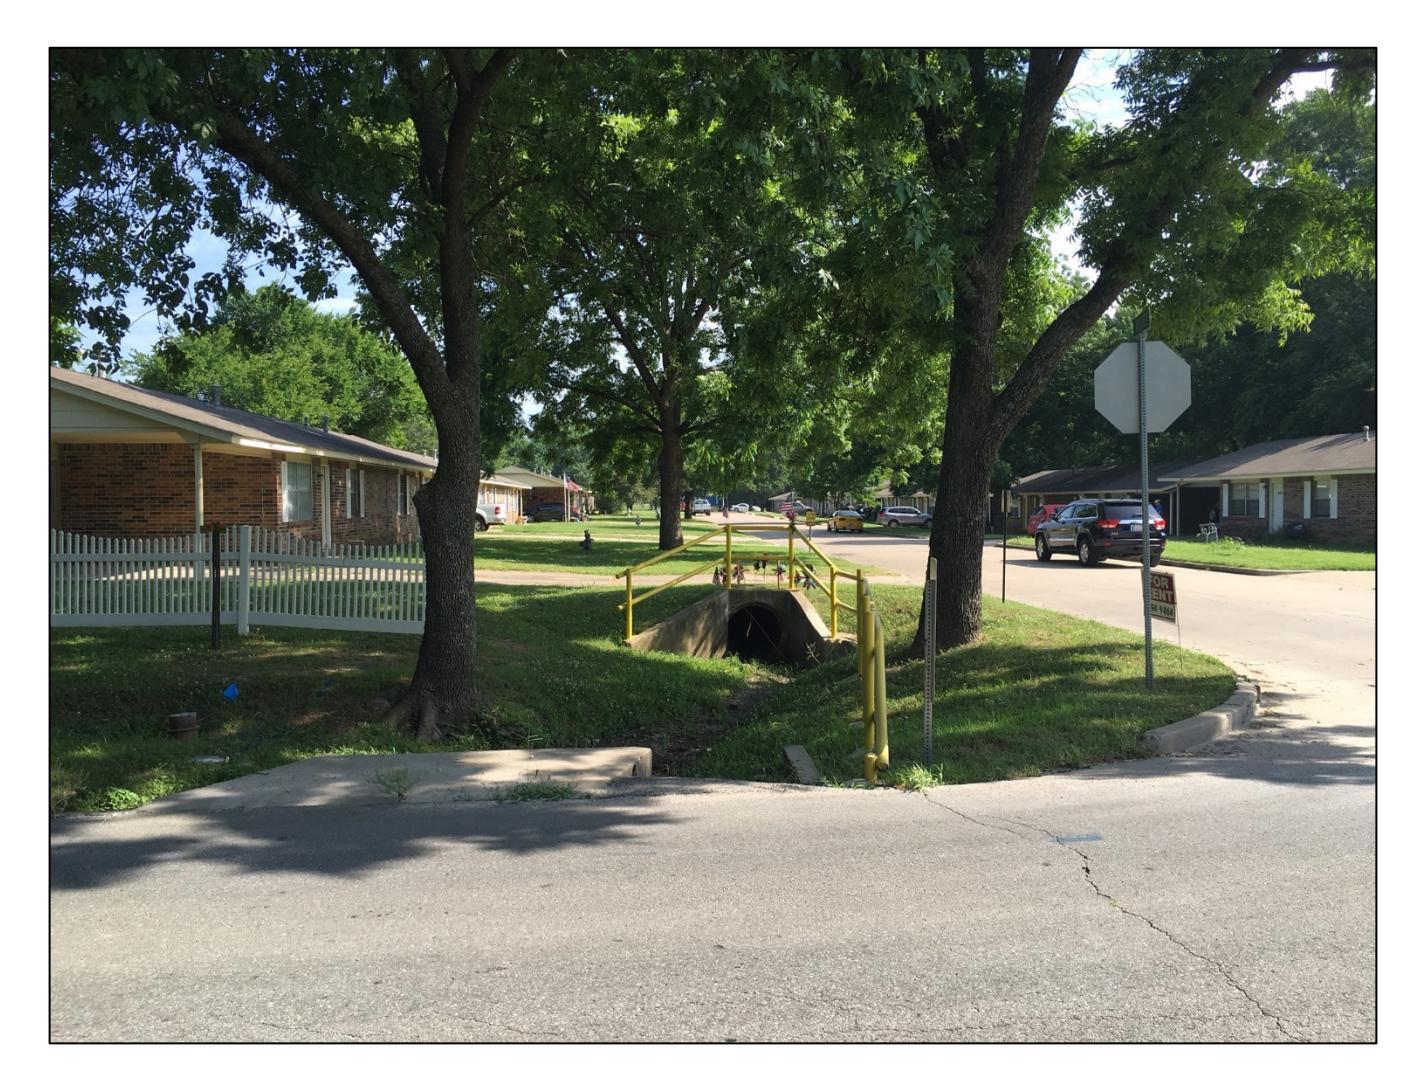
Photo 5. Note guard rail installed by city around entrance to storm drain inlet. (Photo courtesy of the fire department.)

In this instance, a site survey or pre-plan that identified the location of the storm drain could have aided the fire department in avoiding the flooded catch basin and also by identifying the drain's discharge location. Whenever possible, this information should be input into computer-aided dispatch systems so that the information is readily available to first responders and the incident commander. Such information is useful when developing the incident action plan. Shortly after this incident, the city installed a fence around the catch basin where this incident occurred (see Photo 5).
