Deck Engineer on Barge Dies When Struck by Crane Counterweight in Washington State

Investigation: # 10WA040
Release Date: June 8, 2012
SHARP Report: # 52-24-2012

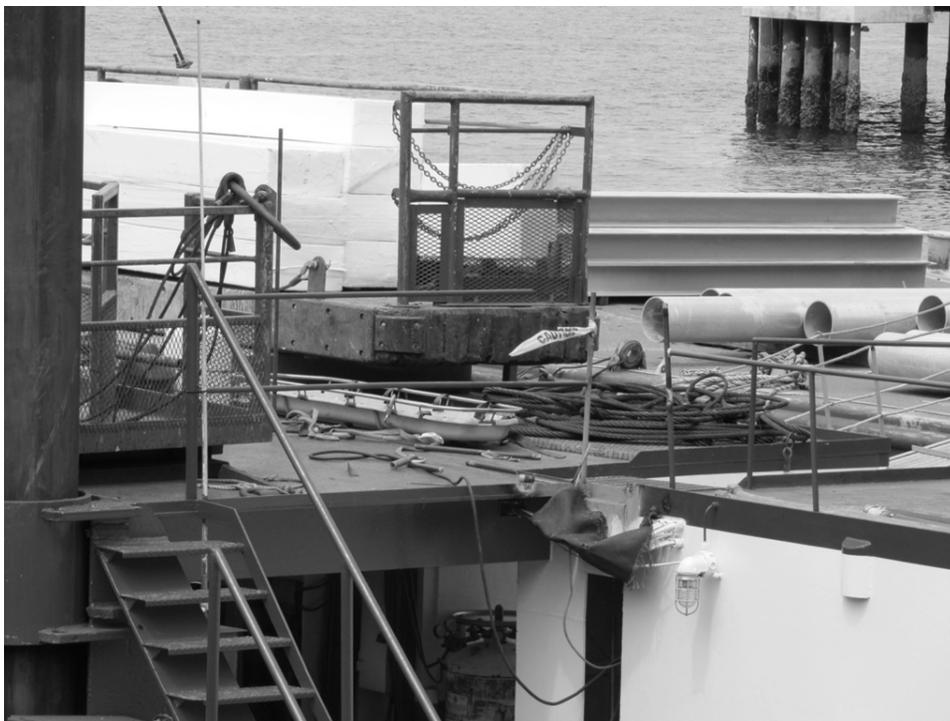
Photo 4: Upper deck of barge where victim was welding a broken railing (photo taken shortly after incident).

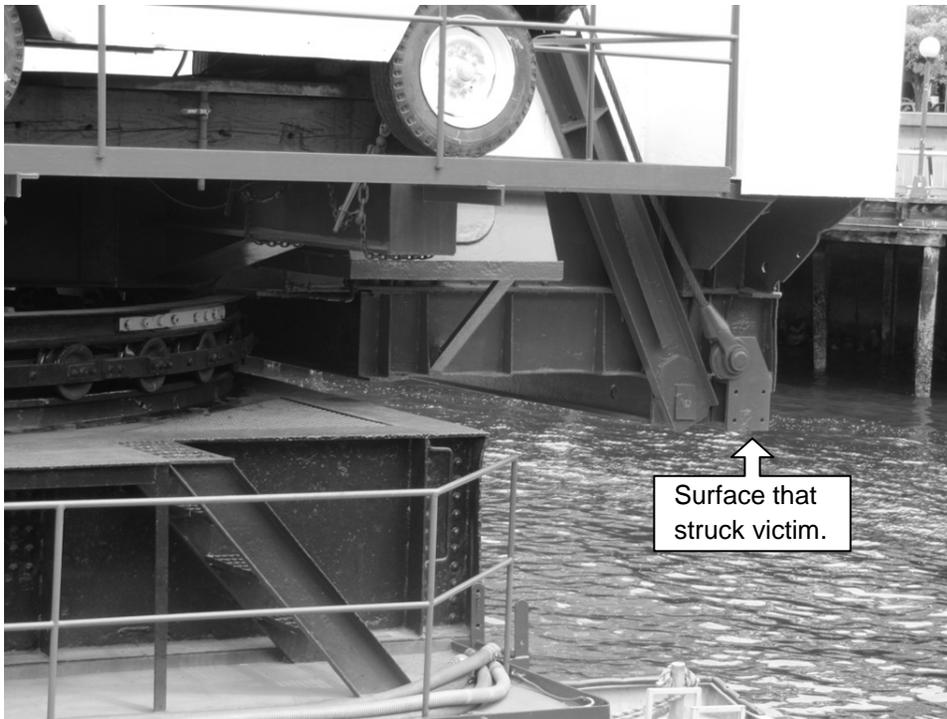
Photo 5: Crane counterweight which struck victim (photo taken shortly after incident).

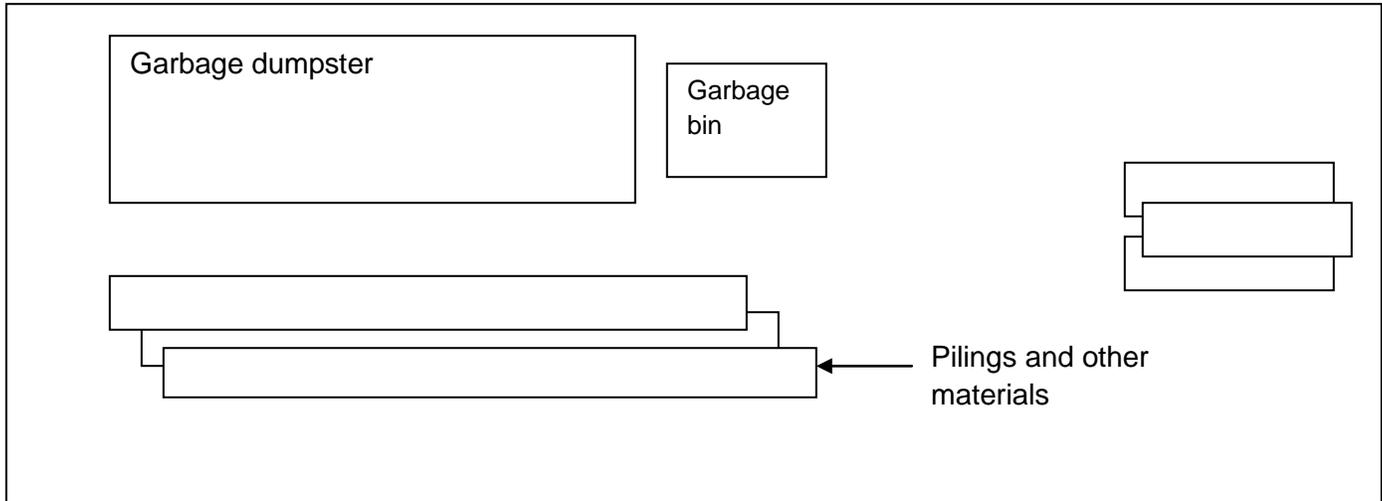
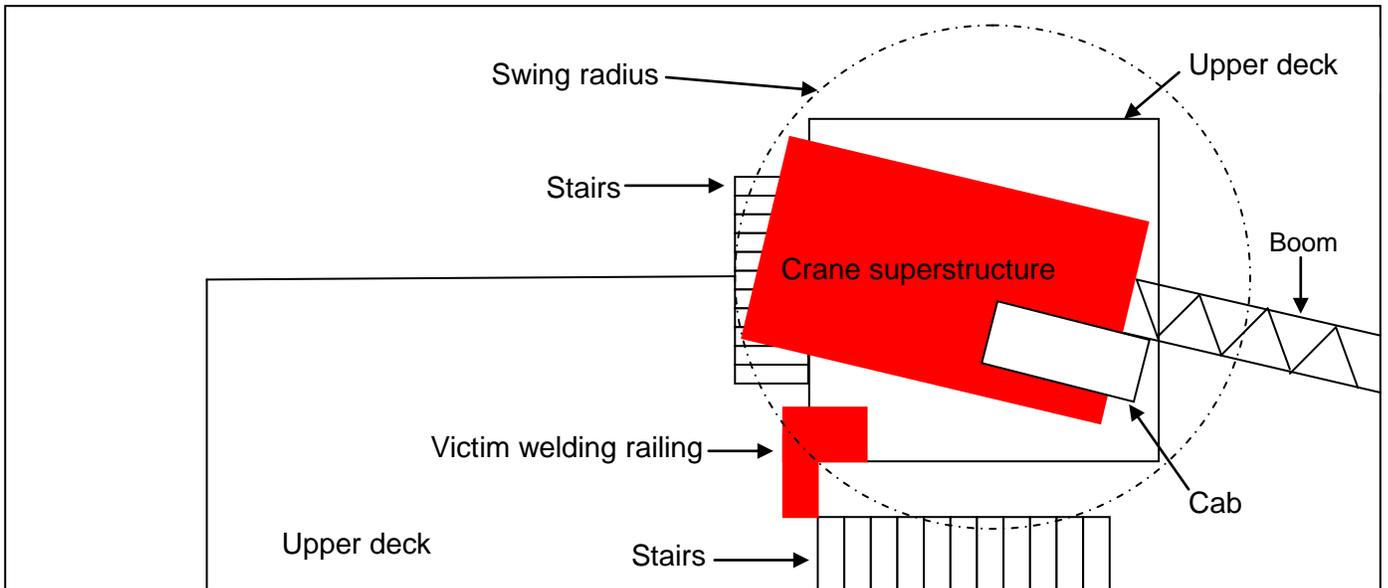
Figure 1. Approximate position and layout of barges prior to the incident. As the crane made the pick from the water to deposit the waste pilings in the garbage bin on the adjacent barge, the crane superstructure rotated counterclockwise, striking the victim while she was making welding repairs to the railing on the barge's upper deck.
