**FATALITY ASSESSMENT AND CONTROL EVALUATION****Restaurant Co-owner Fatally Crushed  
by a Dumbwaiter Car  
Case Report 12NY033****CASE SUMMARY**

**CONTRIBUTING FACTORS**

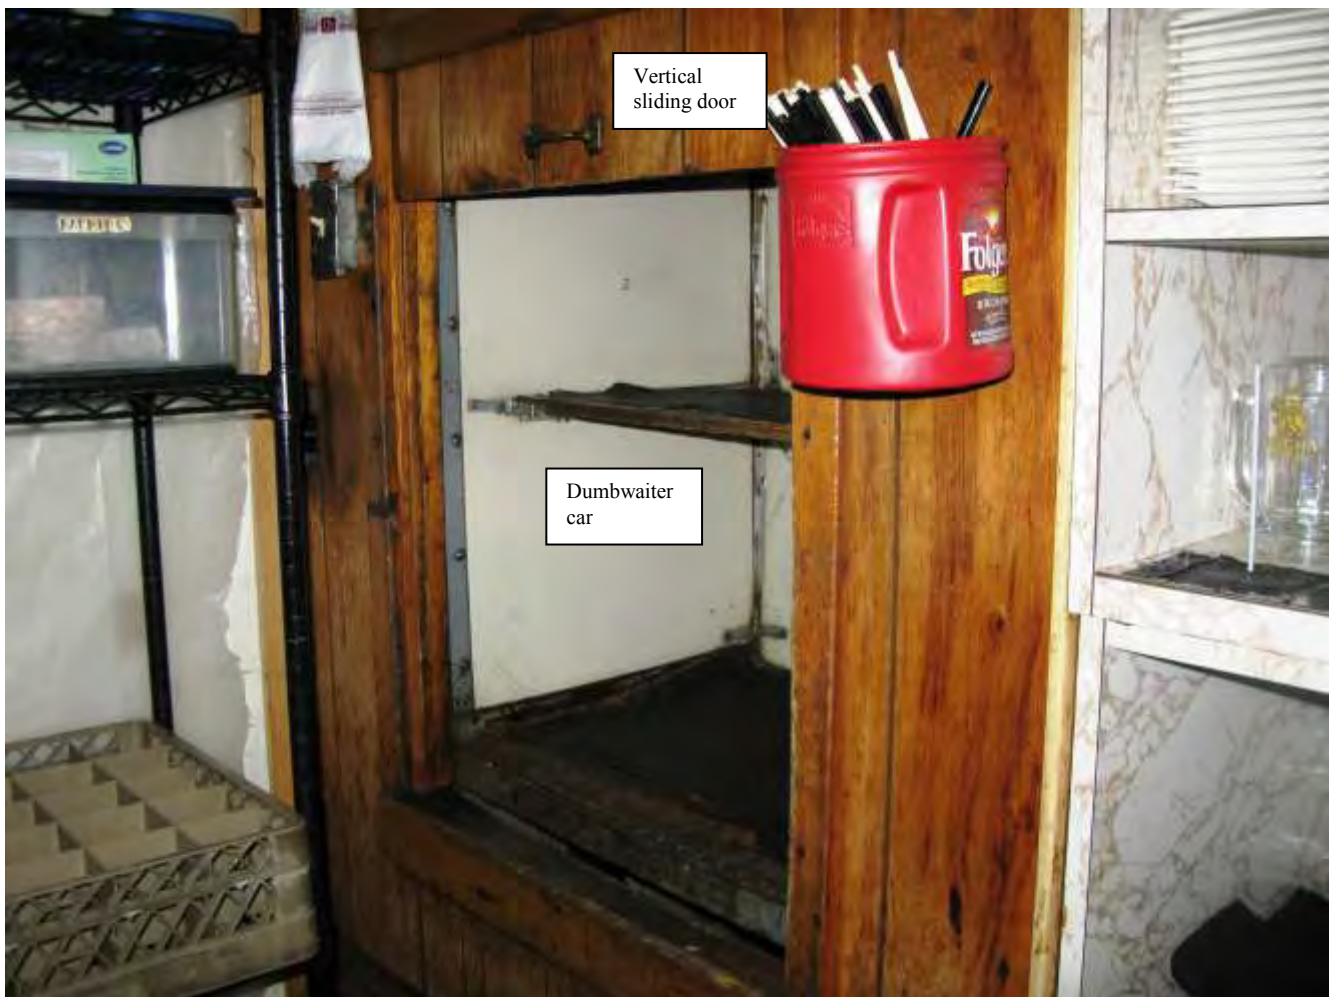
*Photo 1. The hoistway door opening in the upstairs food preparation area with the dumbwaiter car in the landing zone. The sliding door was nailed to stay in the up and open position.*
