Forklift Operator Dies When Crushed between Forklift Overhead Guard and Mast

Investigation: # 12WA015 Release Date: January 22, 2018 SHARP Report: # 52-42-2018

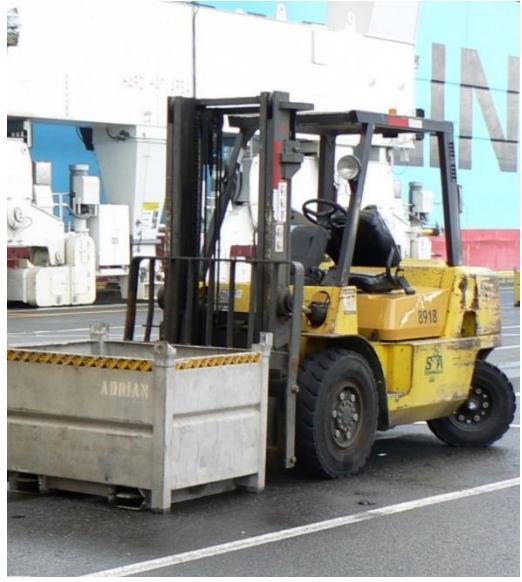
**Photo 1:** Employer forklift similar to the incident forklift with a cone bin on the incident dock.

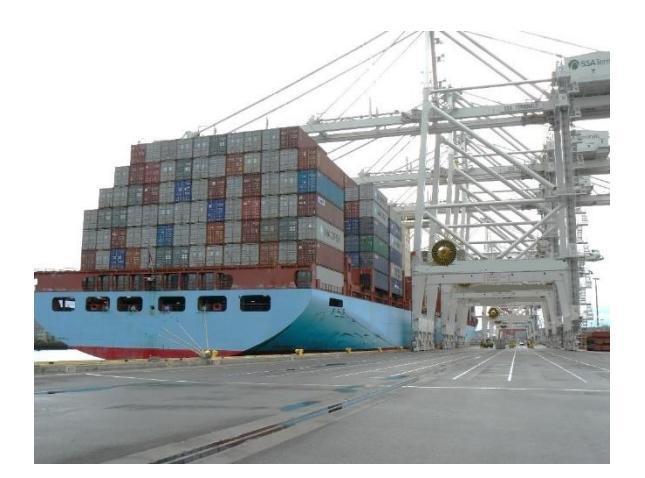
**Photo 2:** Port terminal dock with ship loaded with shipping containers.

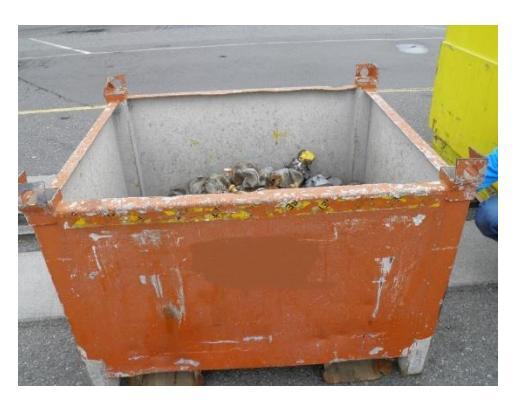
Photo 3: Cone bin.

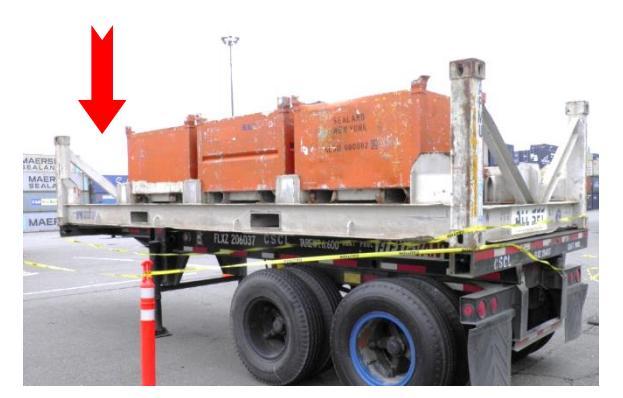
**Photo 4:** Cone bins set on flat racks loaded on to an intermodal chassis trailer. The arrow indicates the location of the bin that the victim had lifted and elevated on the forks of the forklift.

At 6:24 p.m., while operating the forklift, the victim approached a trailer loaded with four cone bins. He then used the forklift to elevate a cone bin approximately 2 feet above the flat rack mounted on the trailer. The forks were elevated to be about parallel with the top of the forklift's overhead guard. Leaving the forklift's engine running, he then left the operator's seat, climbed over the control console, and stood on the dash of the forklift between the mast and the overhead guard, presumably to look into the elevated bin and perhaps other bins on the trailer. His right foot moved backward and contacted the mast tilt control lever on the console. (The mast tilt lever controls the angle of the forks relative to the ground.) This caused the mast to tilt back, pinning his torso between the mast cross member and the overhead guard (photos 5–9).

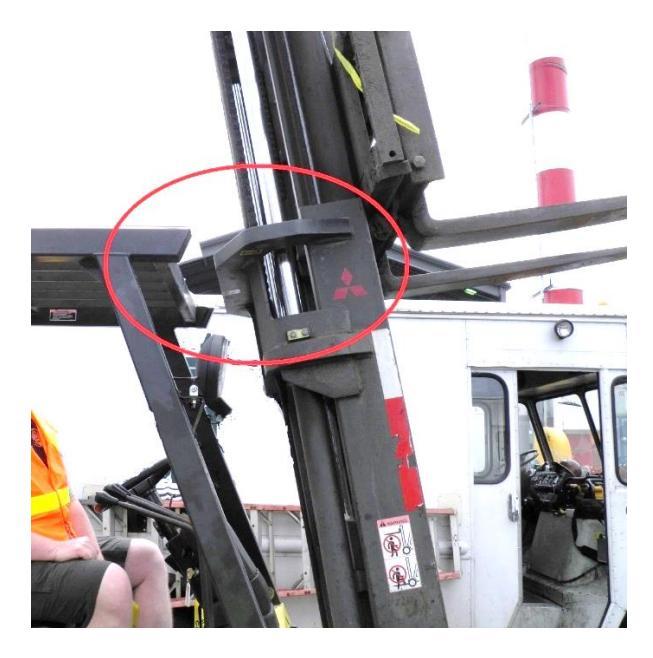
- It took 2 to 3 seconds for the mast to tilt to the full rearward position from a starting backward tilt position of 5 degrees.
- In the full rearward position the mast was approximately 1 inch from the plastic overhead guard cover and 4 inches from metal frame of the overhead guard.

- The mast cross member when in the full rearward position was 42 inches above the forklift dash. The overhead guard was also 42 inches above the dash.

- Fractures on the plastic cover of the overhead guard indicated that the victim was located near or just to the right of the forklift's center line when his torso was crushed between the mast cross member and the overhead guard.

**Photo 5:** Forklift mast in the full tilted back position. The red circle indicates the area where the victim's torso was crushed between the cross member of the overhead guard and the mast.

# <u>Recommendation 1:</u> Ensure that forklift operators never position themselves between the forklift operator's cab overhead guard and mast while the forklift is running.

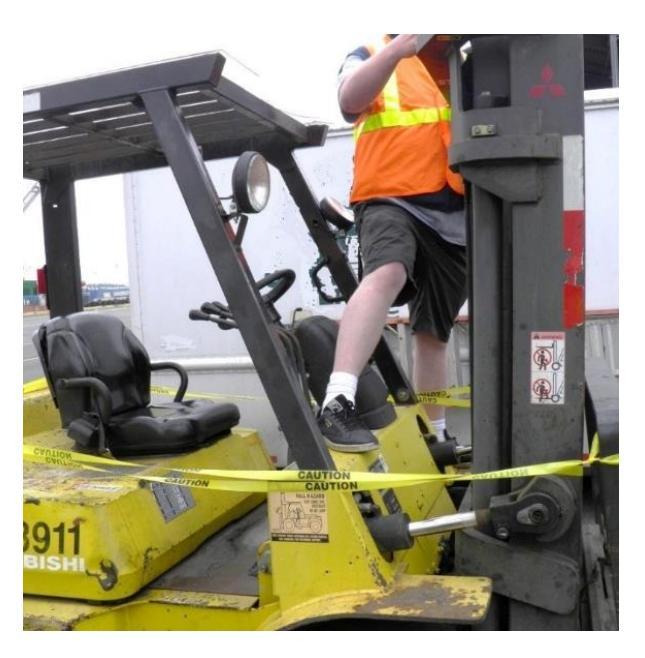
**Photo 6:** A longshore worker demonstrates how the victim might have accessed the forklift's dash to look into the bin elevated on the forklift's forks. The victim was standing with both feet on the dash when his right foot inadvertently activated the forklift control on the dash that caused the mast to tilt backwards, crushing him against the operator's cab overhead guard.

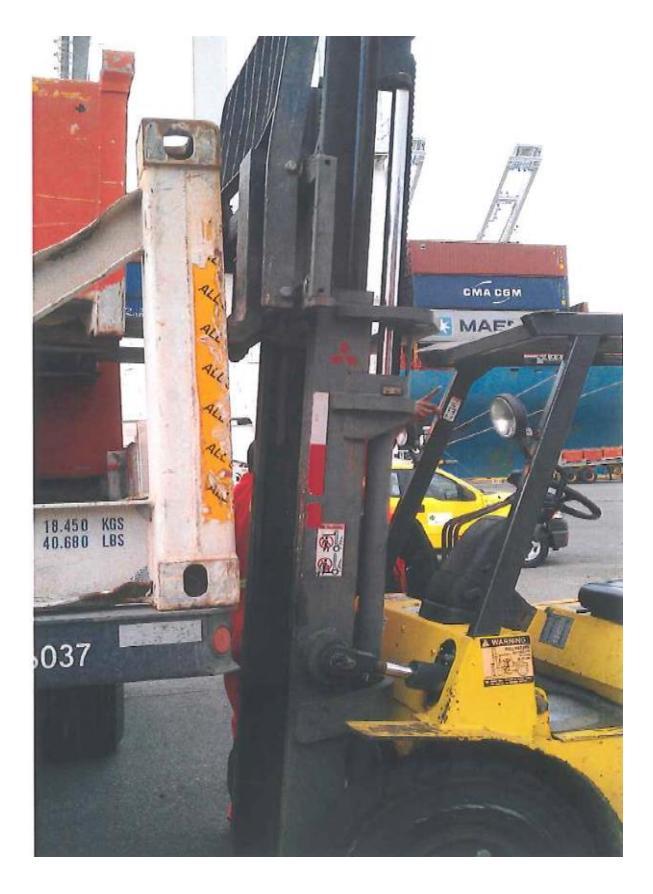
**Photo 7:** Recreation of the position of the forklift just before the incident. The forklift is next to the intermodal chassis trailer with a bin elevated on its forks. The victim climbed on to the forklift's dashboard between the mast and overhead guard to look into the bins on the trailer.

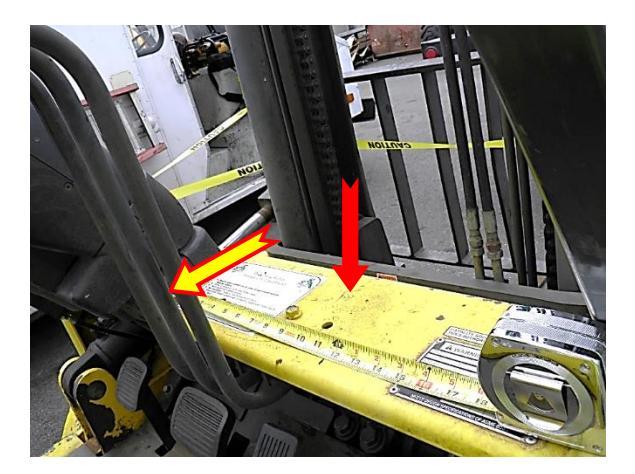
- The mast tilt control lever is about 1 ¼ to 1 ½ inches behind the top of the dash.
- Only a half-inch of movement of the mast tilt control lever was necessary to initiate and continue the rearward tilting of the forklift mast.

**Photo 8:** Forklift dash (red arrow) upon which the victim was standing when his foot inadvertently pushed against the mast tilt lever (yellow arrow). View is from inside the operator's cab.

<u>Recommendation 4:</u> Consider purchasing or equipping forklifts with an operator safety interlock device such as an Operator Presence Sensing System (OPSS) that prevents powered movement of the forklift, and its mast and forks when the operator is not seated properly at the controls.

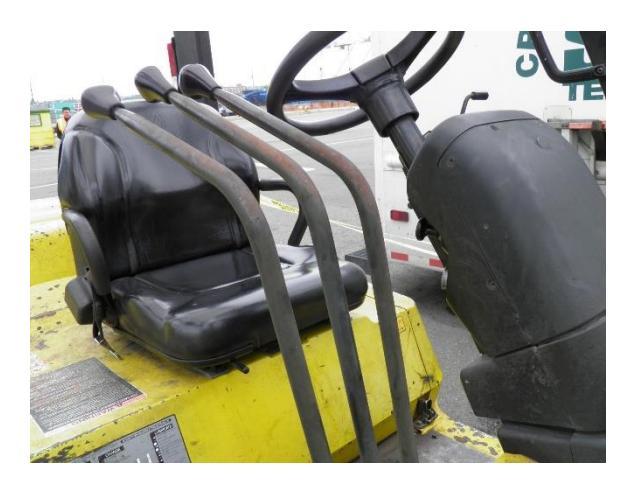
**Photo 9:** Forklift control levers used to adjust the forks and mast. The middle lever is the mast tilt lever.

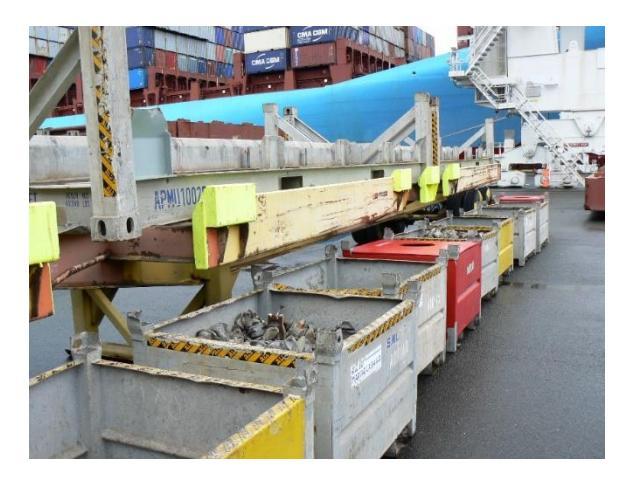
**Photo 10:** Cone bins on dock after corrective action by the employer was taken.

Following this incident, through an agreement between the longshore workers union and the employer, all bins are now routinely removed from the trailer mounted flat racks and placed on the dock. This

allows forklift operators to see into the bins while remaining seated in the forklift (photo 10).
