# MIFACE INVESTIGATION REPORT #13MI043

## SUBJECT: Truck Driver Crushed By Roll Off Scrap Metal Box During Unloading From Truck

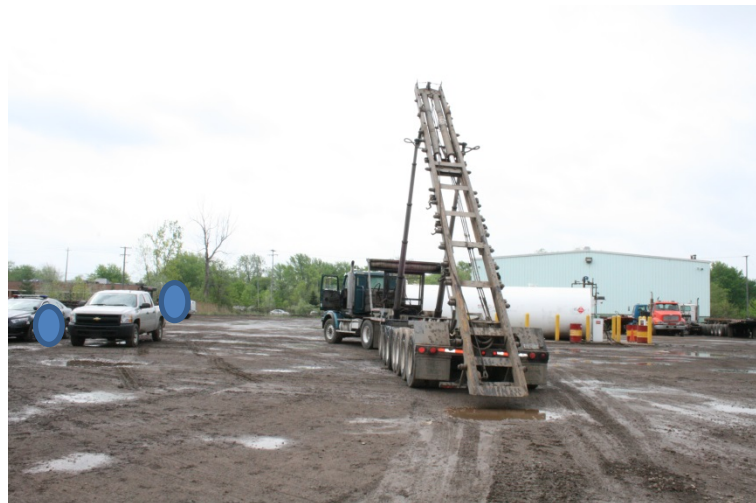
Figure 3. View of truck/trailer from near container and decedent’s location. Note that stinger is not fully on the ground.
