Maintenance Technician is Struck by Crane, Falls 10 feet to Conveyor and Dies

CASE SUMMARY

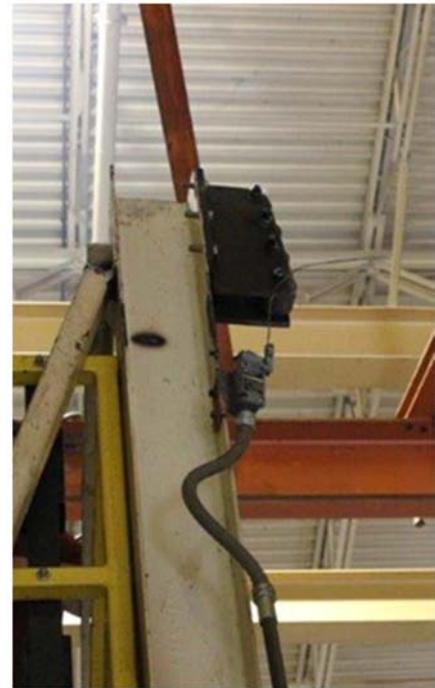
Figure 1. Micro switch the victim was repairing at the time of the incident.

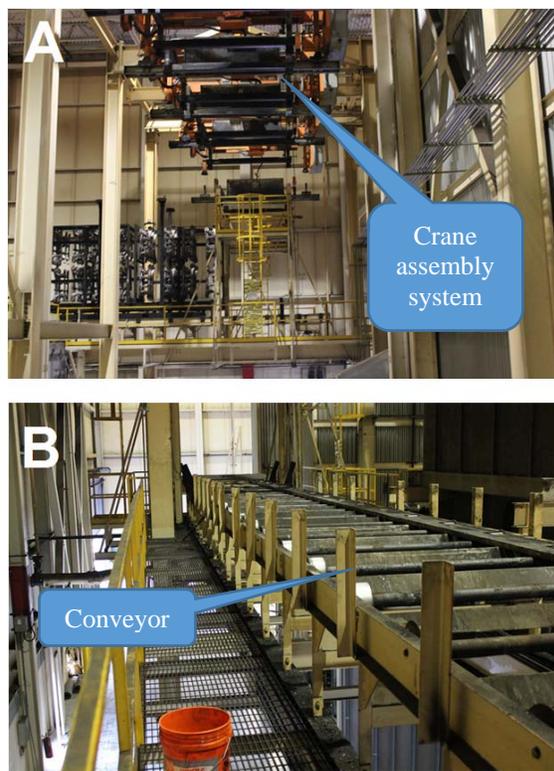
Figure 3. A) Overhead crane assembly system. B) Conveyor that was beneath the crow's nest.

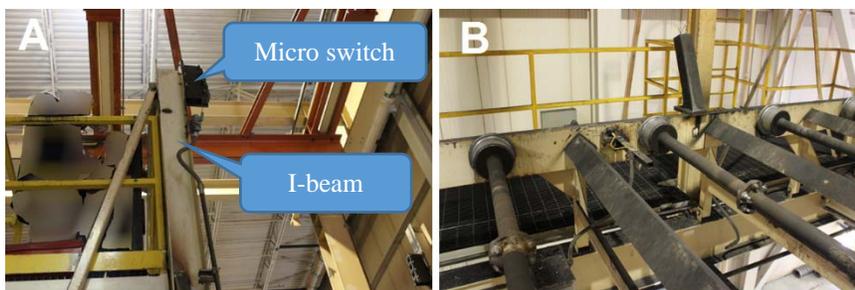
Figure 4. A) Micro switch being repaired and I-beam victim was holding on to. B) Area of conveyor belt where victim fell.
