Occupational Fatality Report

Kentucky FACE Program

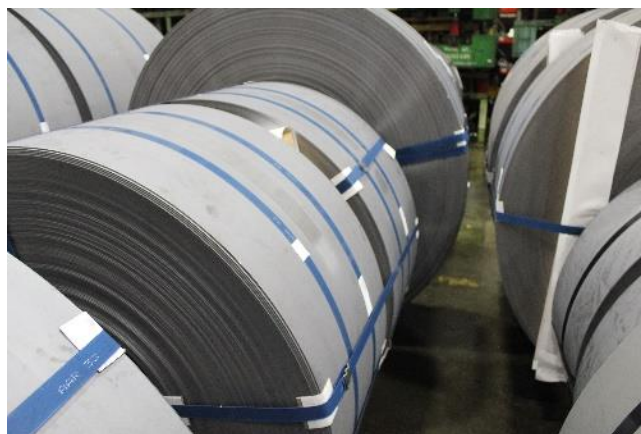
Figure 1. Photo of steel coils at the jobsite.

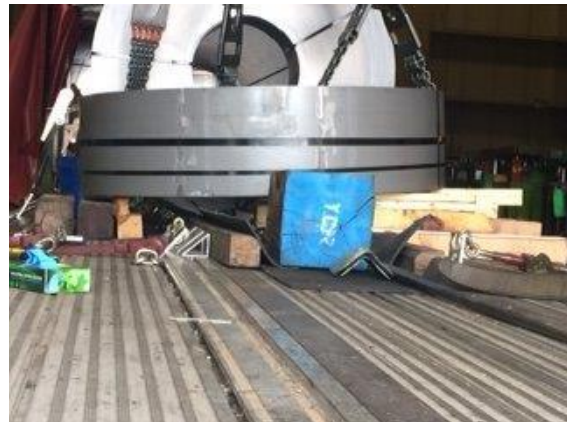
Figure 8. Steel coil that fell on and crushed truck driver, on flatbed trailer.

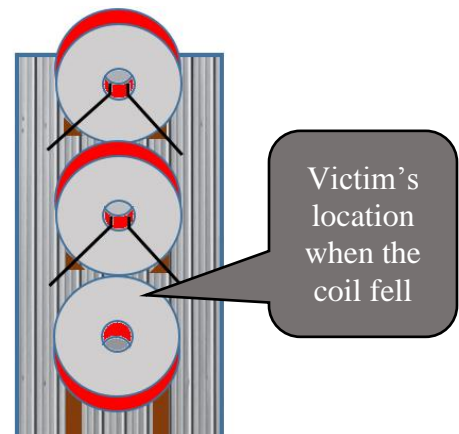
Figure 9. Depiction of steel coil that fell on and crushed truck driver, on flatbed trailer.
