Machine operator fatally struck by safety block ejected from mechanical power press (Case # 16NY064)

NAICS: 335991/Carbon and Graphite Product Manufacturing

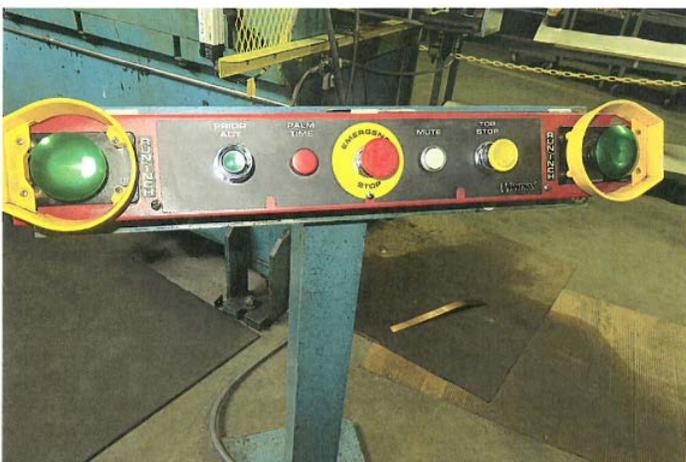
Photo 2: Pedestal-mounted two-button controller for press actuation. (Photo courtesy of OSHA)

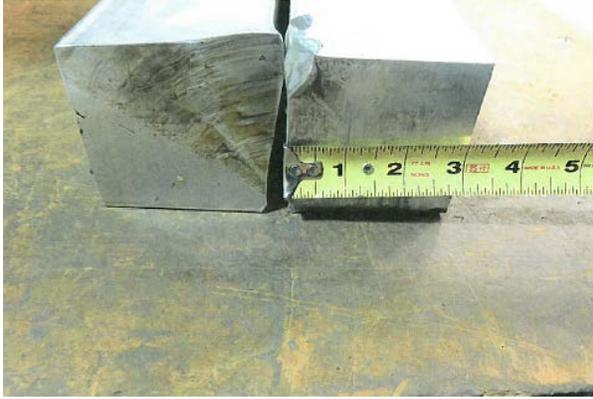
Photo 4: In-house fabricated aluminum safety blocks with deformed corners and scraped metal face (Photo courtesy of OSHA)

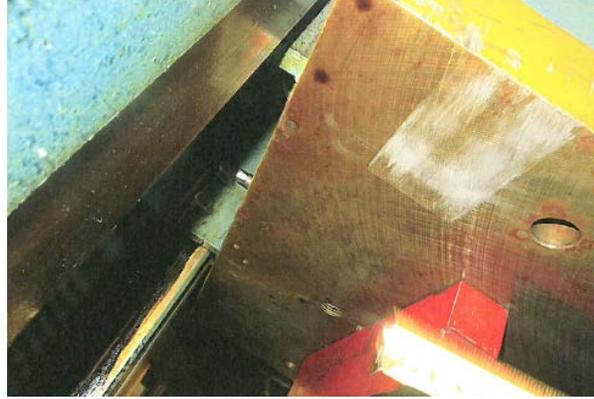
Photo 5: Picture of mechanical press ram indicating where safety block had been placed. (Photo courtesy of OSHA)

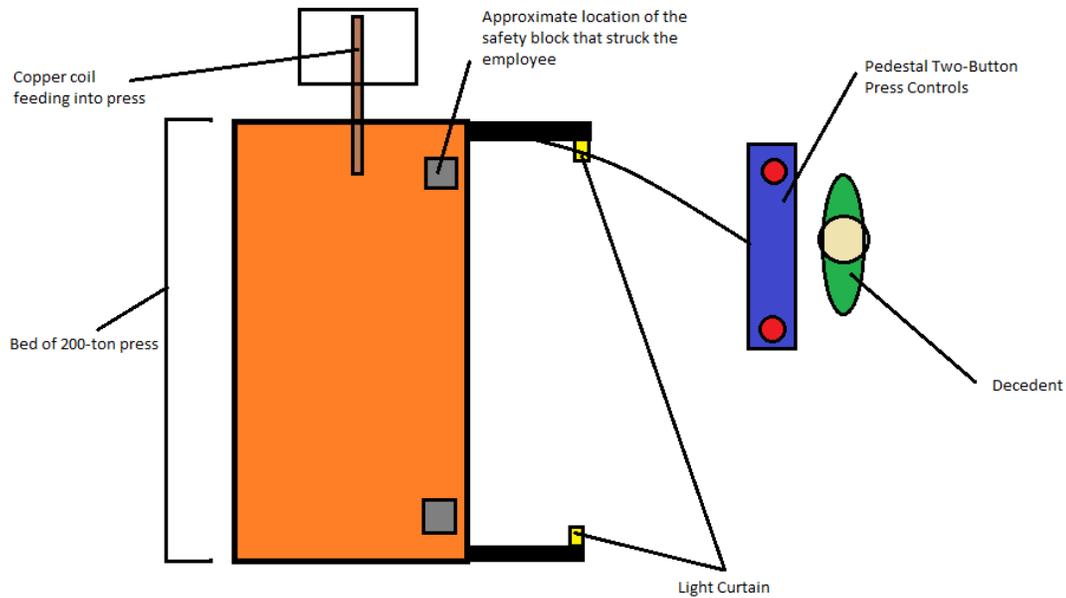
Overhead View of Incident Scene

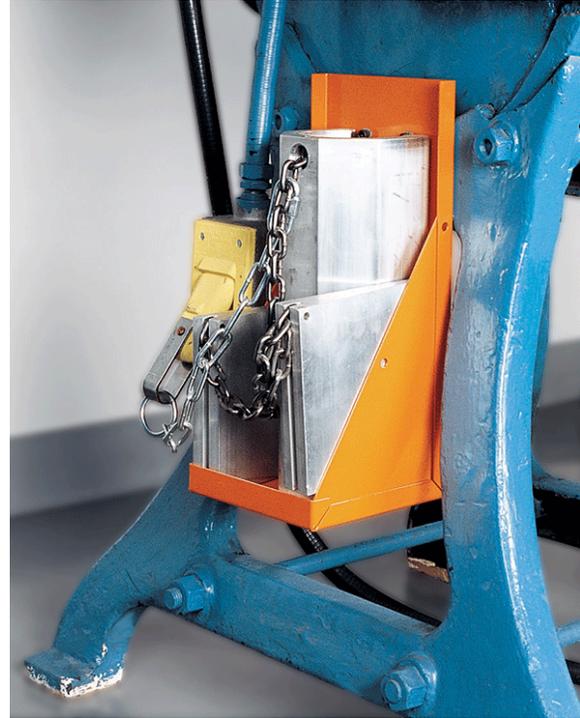
*Photo 1: Example of safety blocks with interlock devices
(Photo from EHSToday.com)*
