## INCIDENT HIGHLIGHTS

**DATE:**  
September 26, 2018

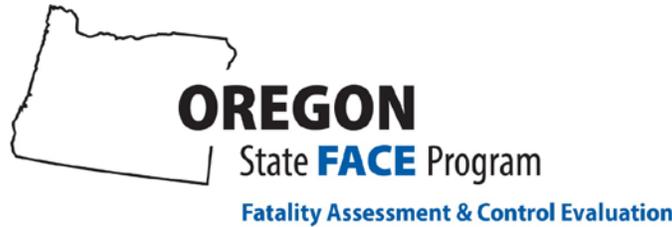
Oregon Institute of Occupational Health Sciences • Oregon Health & Science University  
3181 SW Sam Jackson Park Rd. L606 • Portland, OR 97239 • 503-494-3940

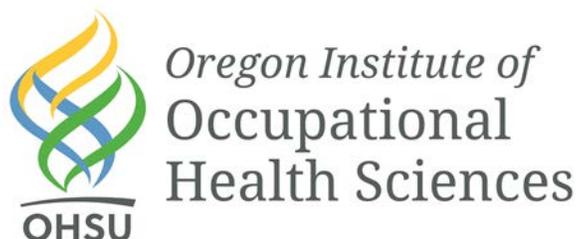
**OR-FACE supports the prioritization of safety interventions using a hierarchy of safety controls, where top priorities are hazard elimination or substitution, followed by engineering controls, administrative controls (including training and work practices), and personal protective equipment.**

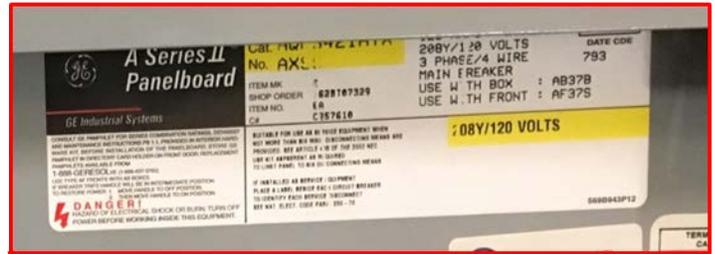
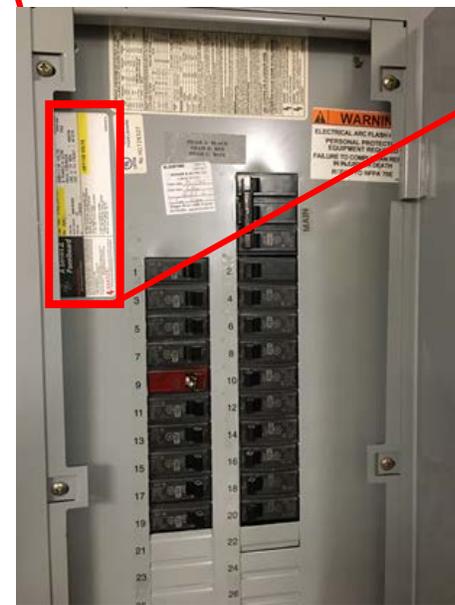
Image 3. 208/120V electrical panel controlling accent lighting and store outlets, with close-up of information sticker on inside of the breaker panel box. Note this is a 3-phase panel.

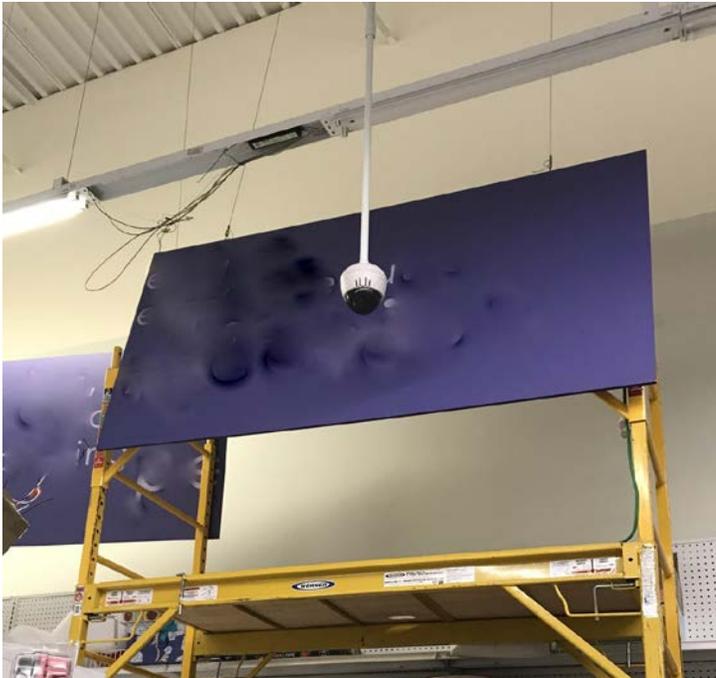
**Image 6. Light fixtures and signage suspended from the roof by metal braided wire. Scaffold location recreates where decedent was working at the time of the incident. Writing on signs obscured for report.**

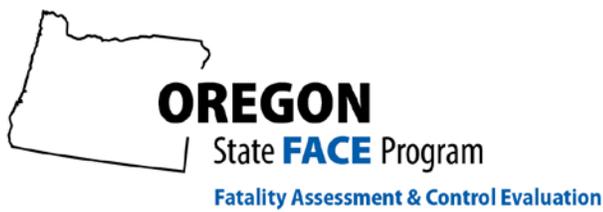
Oregon Institute of Occupational Health Sciences • Oregon Health & Science University  
3181 SW Sam Jackson Park Rd. L606 • Portland, OR 97239 • 503-494-3940
