**REPORT#:** 18MA035

**REPORT DATE:** 8/13/2021

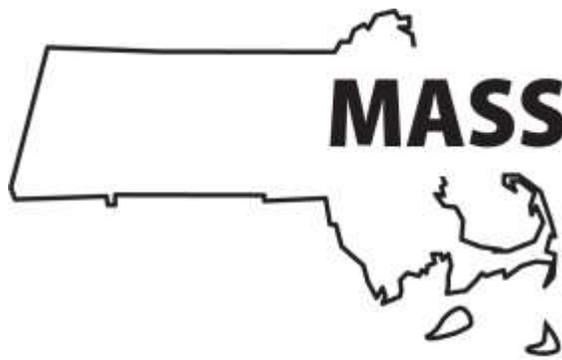
- Adopt and implement the concept of Prevention through Design (PtD) to identify potential hazards associated with equipment and then eliminate these hazards through design changes. [LEARN MORE](#) > (p.8)

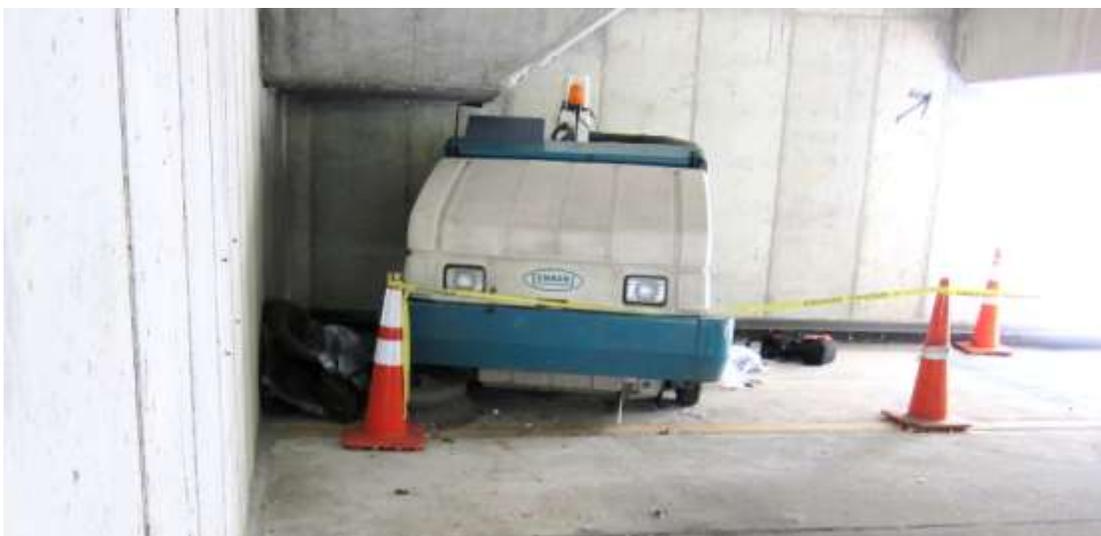
Figure 7 – Sweeper position after the victim was removed.

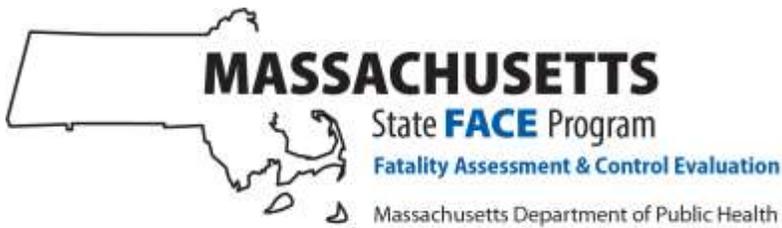
employee's preferred language. This means the training must be provided in the language(s) and at the literacy level(s) of the employees.
