Death in the line of duty...

A Summary of a NIOSH fire fighter fatality investigation

October 20, 2003

Parapet Wall Collapse at Auto Body Shop Claims Life of Career Captain and Injures Career Lieutenant and Emergency Medical Technician - Indiana

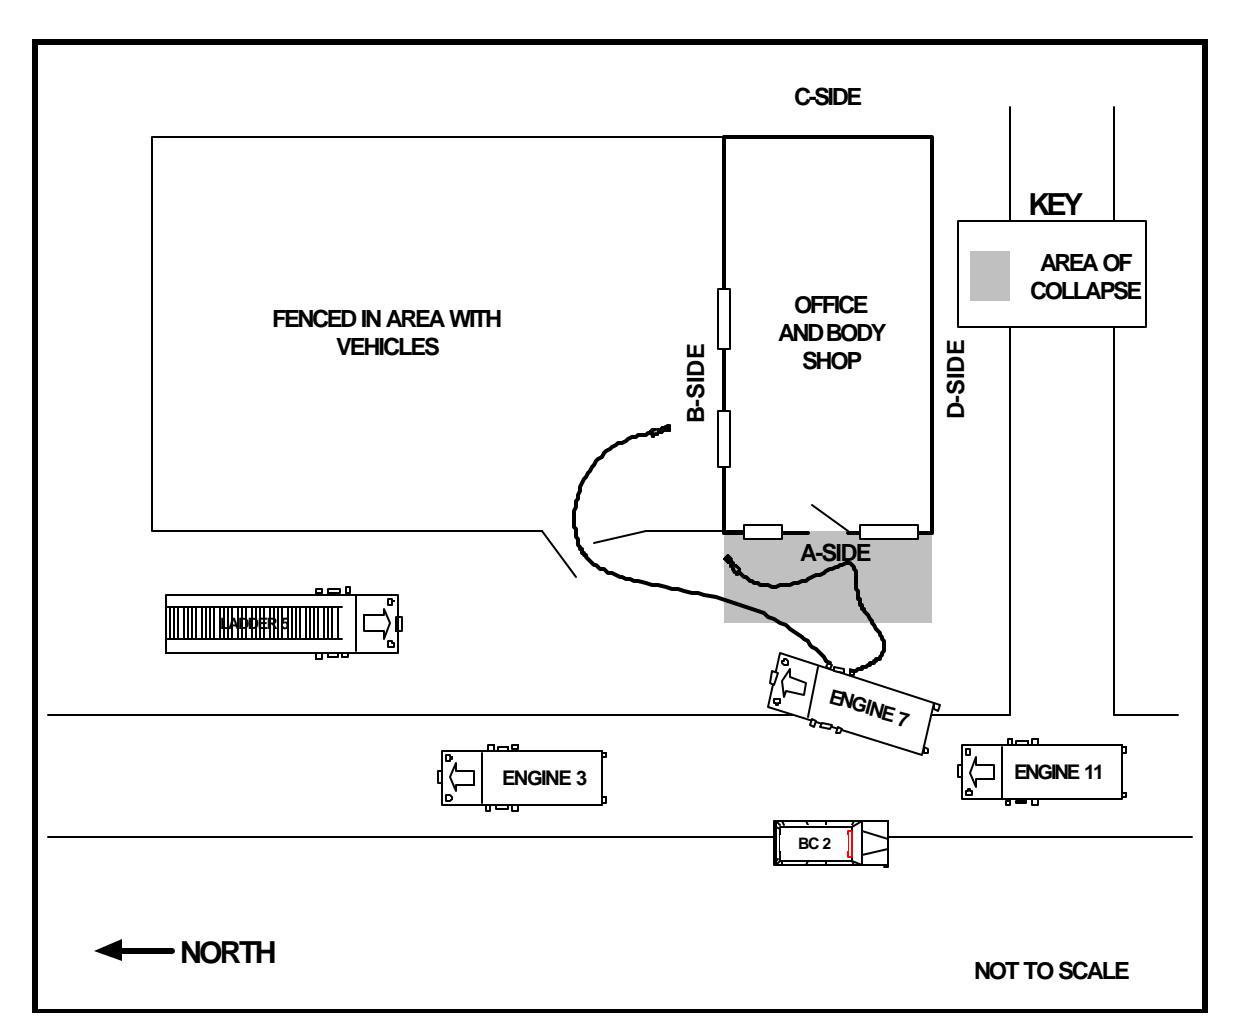
Diagram. Aerial view of Incident Scene

line was advanced to allow the crews to attack the fire from the B-side of the building. collapsed. The parapet wall and overhanging facade fell forward, landing on top of the victim (Diagram

At 0211 hours, Engine 3, Ladder 5, and Air Truck 1 arrived on the scene. Engine 3 proceeded past the scene and connected to the hydrant. The Captain from Engine 7 ordered the victim and another fire fighter to pull another preconnect from Engine 7 and begin an attack on the A-side of the building (Diagram).

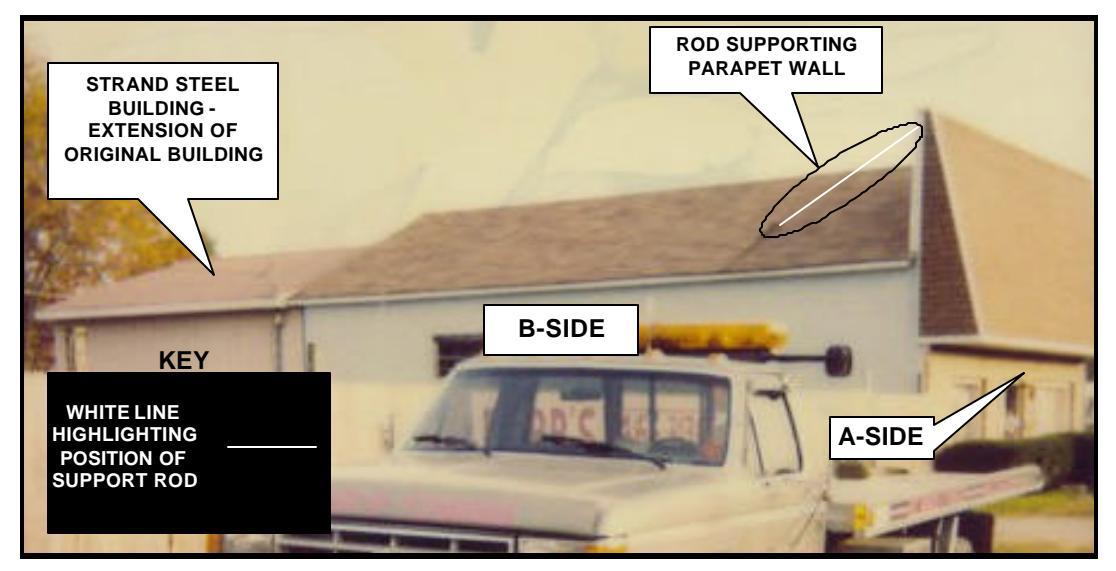
This was a structure of Type III ordinary construction with approximately 1800 square feet of floor space. The original building had exterior walls constructed of masonry concrete blocks with an extension of a steel building to the C-side (Photo 1). A steeply pitched overhanging facade above the door and windows, constructed of 2 x 4s and plywood, and covered with asphalt shingles, was later added to the parapet wall on the A-side of the building. The weight of this overhanging facade caused cracks in the exterior masonry wall. Reinforcing rods were fashioned into support rods that connected the parapet wall to the roof in an attempt to prevent further damage to the exterior walls (Photos 1 and 2). This building was grandfathered under current city building codes and therefore no code violations were issued by the office of the City Building Commissioner.

Photo 1. View of the A- and B-Sides of the building prior to the incident

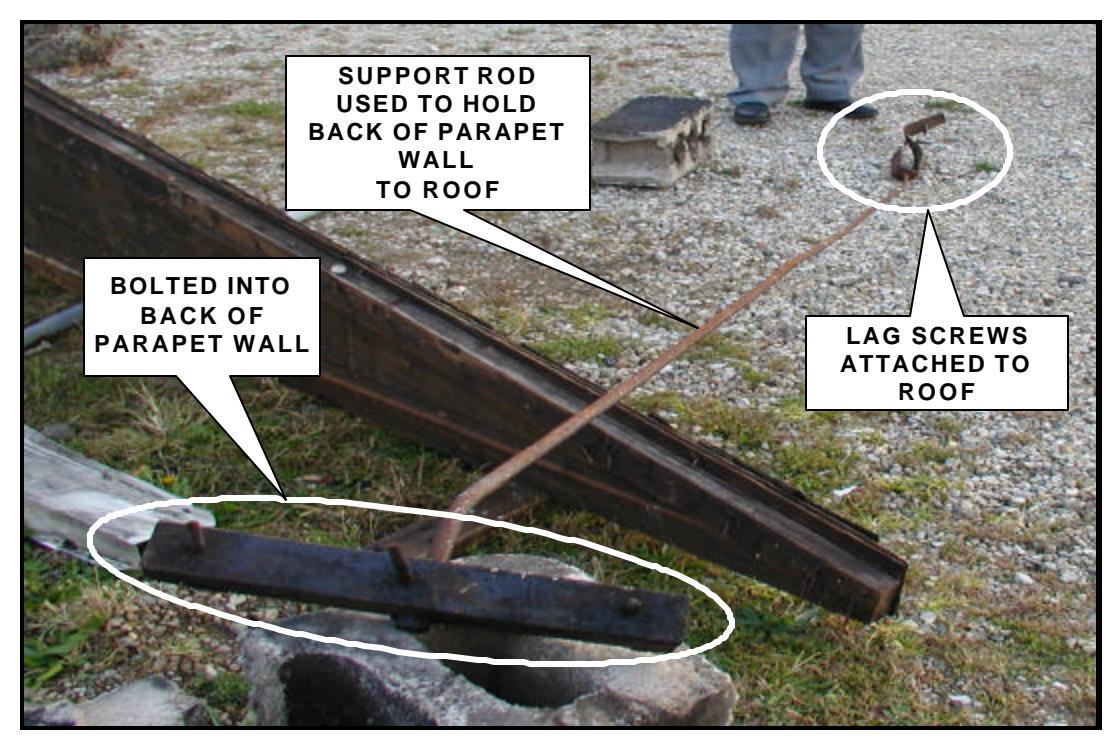
Photo 2. Support rod for parapet wall

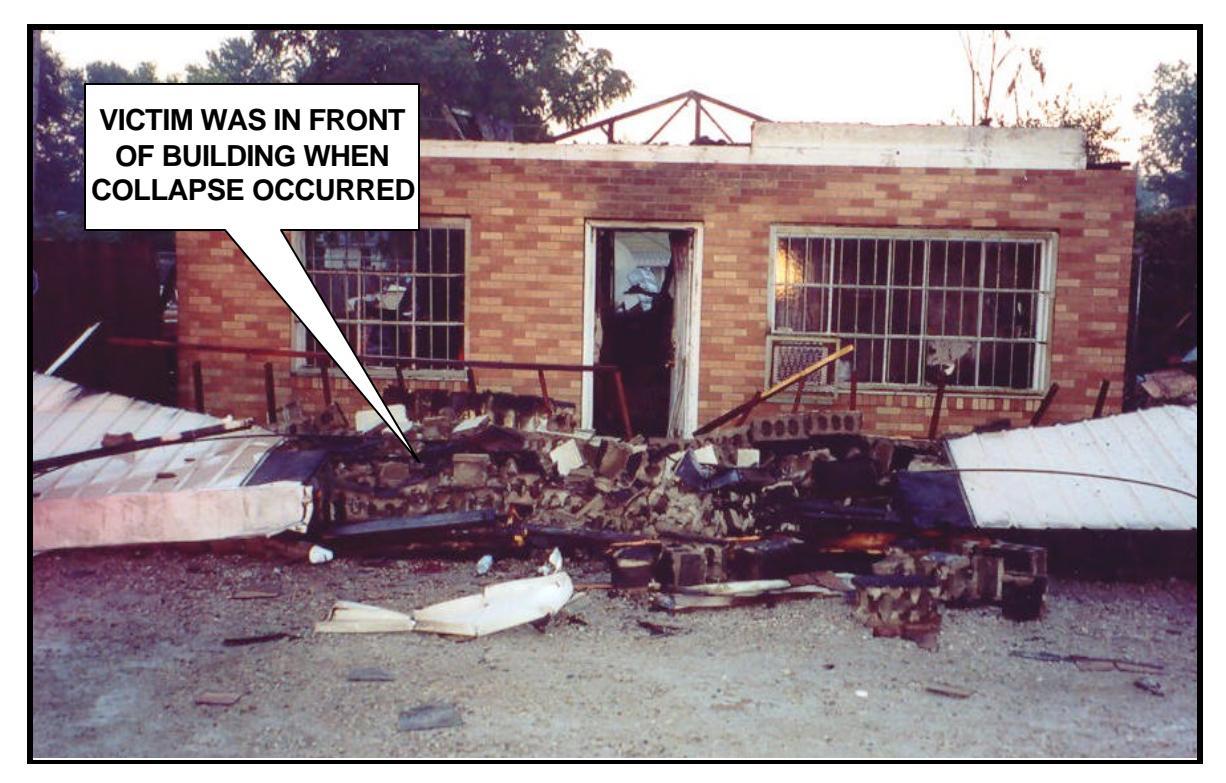
Discussion: If structural integrity is questionable, a collapse zone needs to be established. Fire fighters and officers must recognize and know the dangers of operating underneath or near a parapet wall. As a free-standing masonry wall, a parapet has little if any lateral stability and presents an extreme collapse hazard. Collapse may be caused by the failure of the roof structure pulling the wall in or pushing it out. Also, an external load such as a sign or electric service reacting on a wall weakened by fire conditions may cause the collapse of a parapet. The collapse zone should be equal to the height of the building plus an additional allowance for debris scatter and at a minimum should be equal to 11/2-times the height of the building. For example, if the wall were 20 feet high, the collapse zone would be established at least 30 feet away from the wall.

Photo 3. A-side of building after collapse

Recommendation #3: Fire departments should ensure that a collapse zone is established and clearly identified at structure fires involving buildings susceptible to collapse. ^{4, 5, 7}
