Death in the line of duty...

A summary of a NIOSH fire fighter fatality investigation

August 17, 2009

Two Career Fire Fighters Die and Captain is Burned When Trapped during Fire Suppression Operations at a Millwork Facility – North Carolina

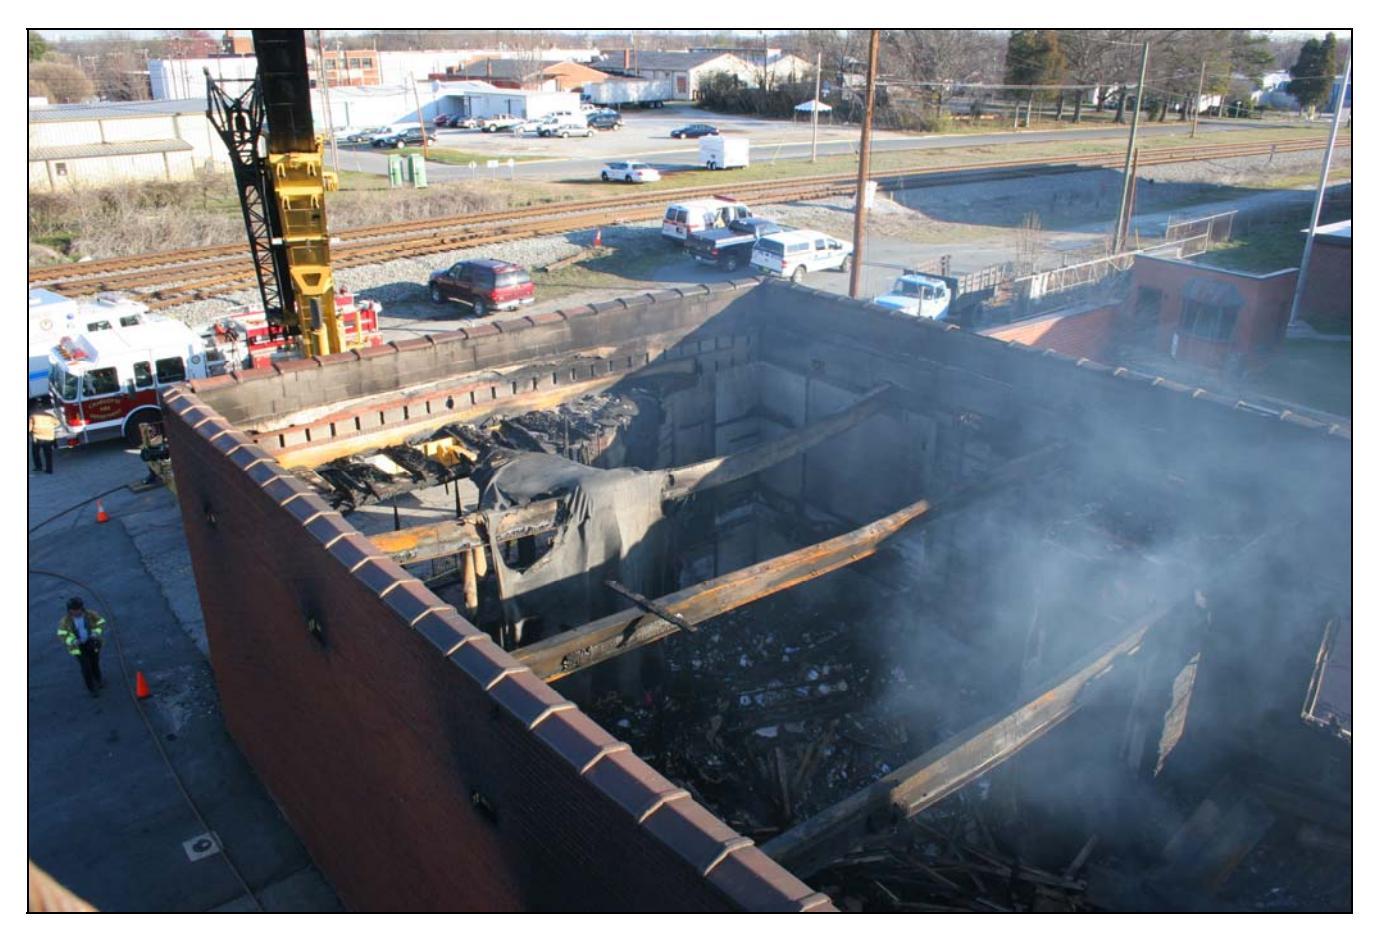
Photo 1. Overhead view of office area. Front entrance (A-side) is at the upper left. Note steel Ibeams that supported roof along with recessed pockets in masonry walls for joists. Photo from ATF – provided by fire department

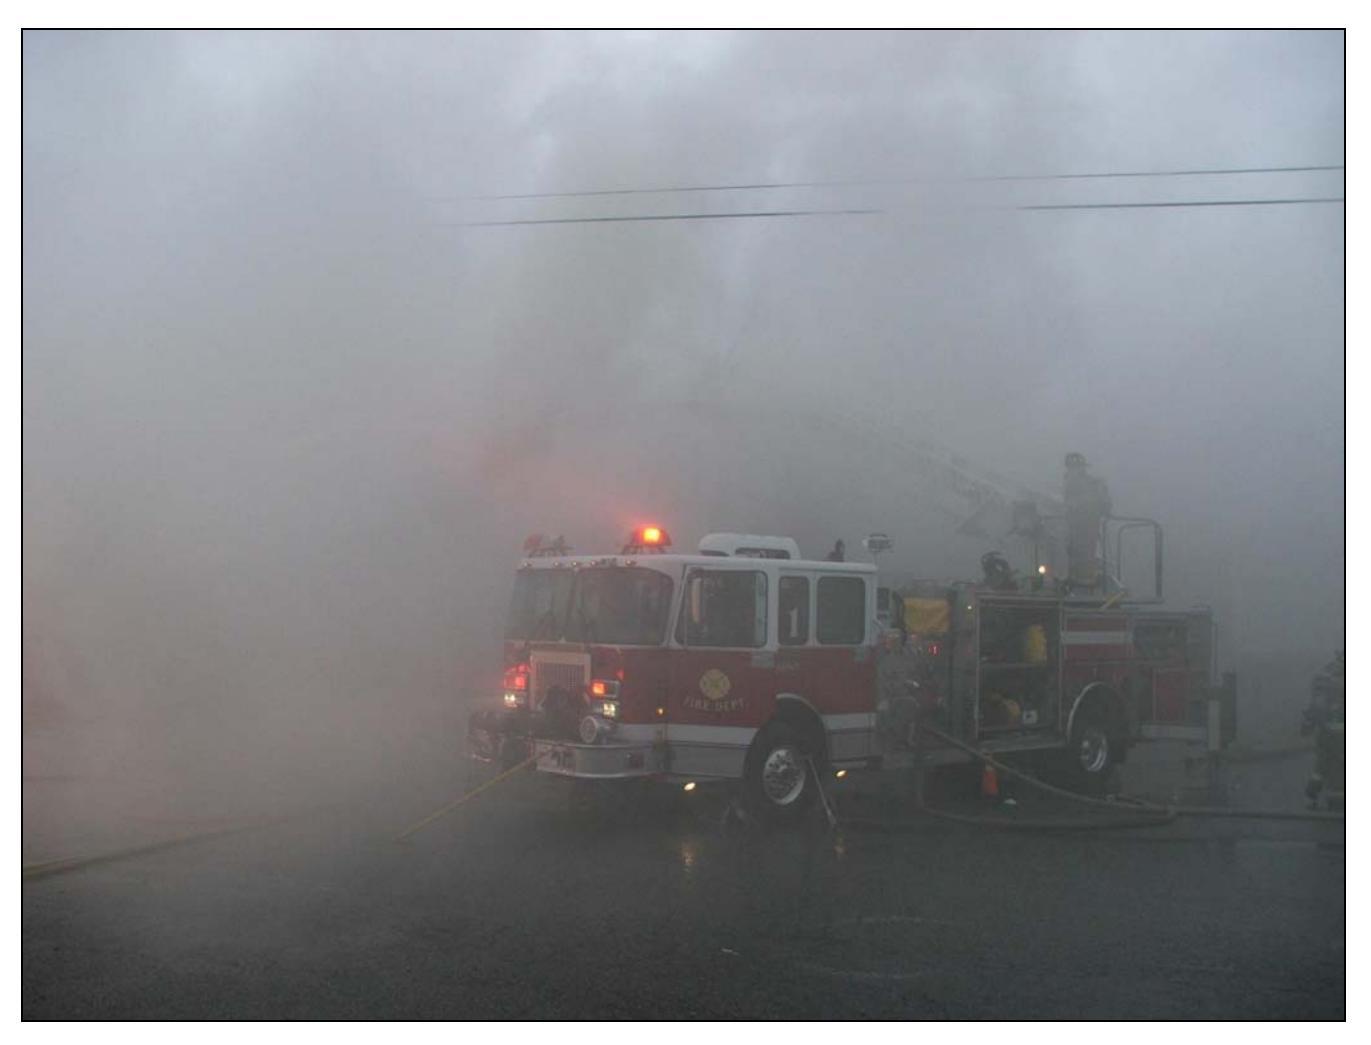
the structure (see Photo 2). Company vehicles and a semi trailer at the loading dock and a large tree also interfered with a clear view of the incident scene (see Diagrams 1-5).

Photo 2. Photo shows an example of the limited visibility in front of the fire structure. Photo shows Quint 1 positioned near the A-D corner of the office area. Photo provided by fire department.

Recommendation #5: Fire departments should ensure that the incident commander establishes the incident command post in an area that provides a good visual view of the fire building and enhances overall fireground communication.
