A summary of a NIOSH fire fighter fatality investigation

October 08, 2009

Career Fire Fighter Dies While Diving for a Civilian Drowning Victim -Rhode Island

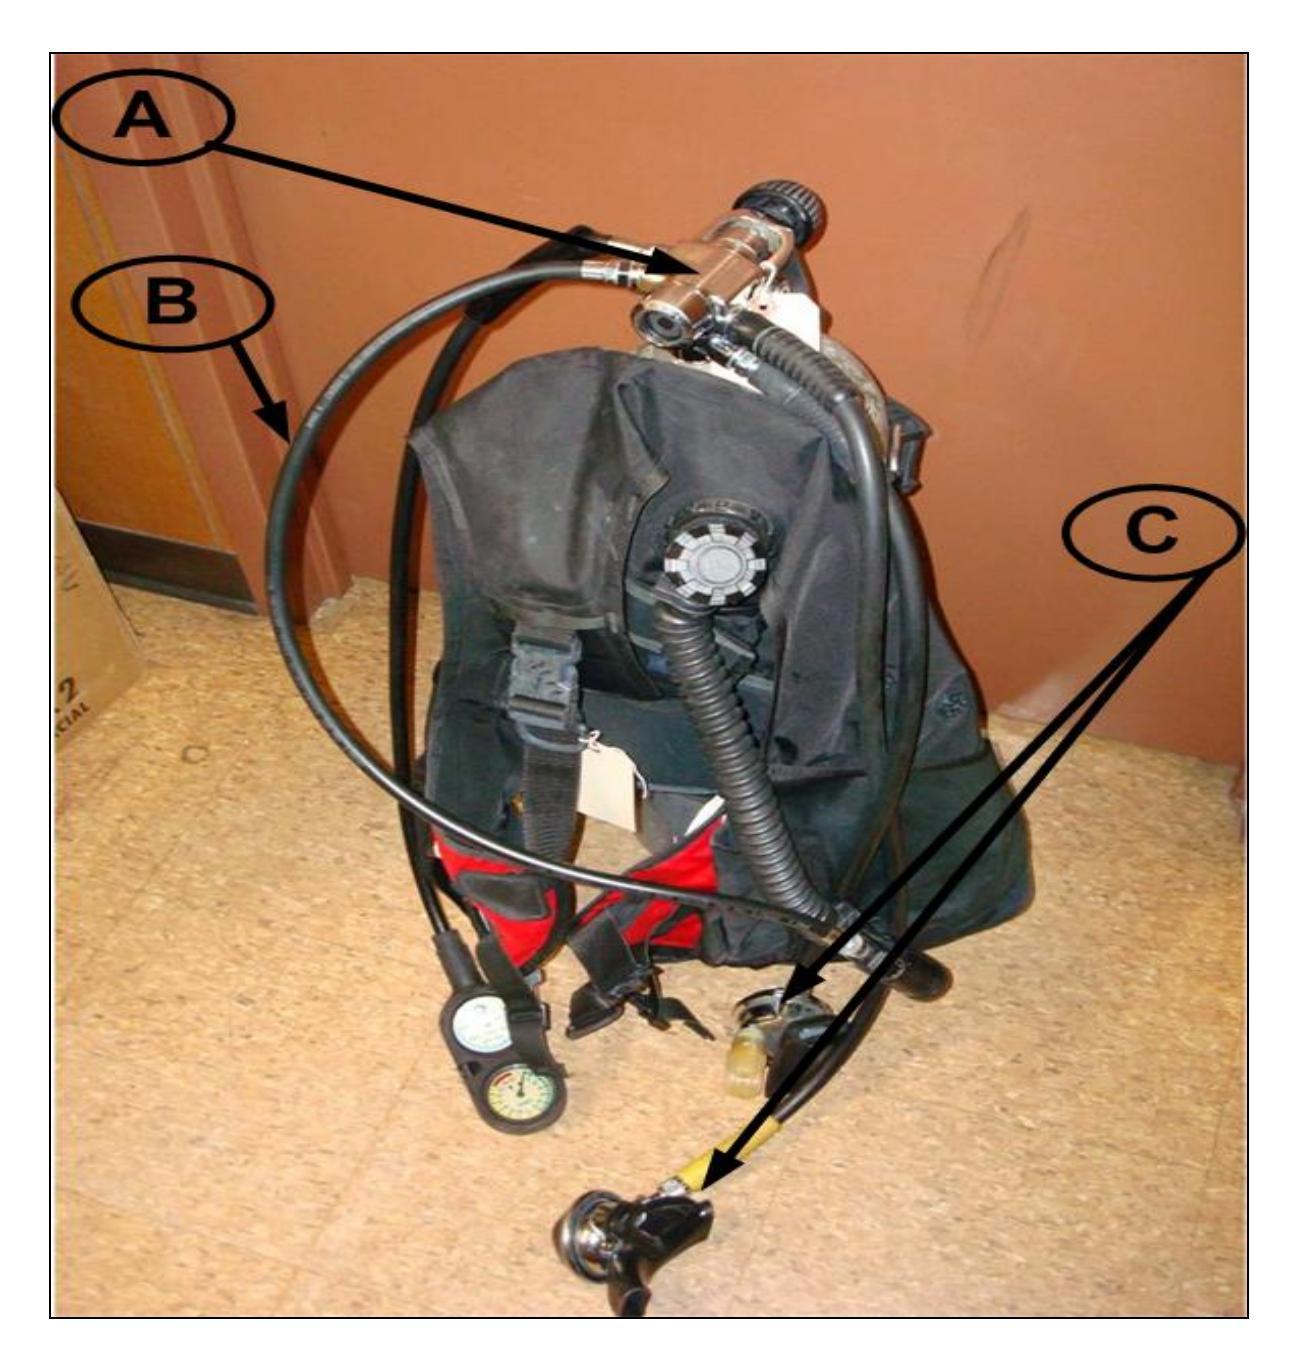
• 1 open-circuit SCUBA demand regulator,^b having a single intermediate pressure hose with first-stage pressure reduction at the yoke^c (cylinder attachment) and second-stage regulator at the mouthpiece. The first-stage regulator and yoke were found mounted on the tank valve upside down (see Photo 1) resulting in the primary second-stage and octopus regulators presenting over the left side of the victim instead of the normal profile of having the regulators on the right side of the diver.

- The configuration of the air delivery system was rotated 180° from normal, resulting in the attached hoses presenting in an unconventional and possibly confusing manner.

Photo 1.Victim's SCUBA gear. First-stage regulator (A) attached to tank valve upside down, resulting in the intermediate-pressure auto-fill hose (B) profiling across the victim's chest instead of over the left shoulder. Primary second-stage and octopus regulator (C) incorrectly profiling off the left side of the victim resulting in the incorrect mouthpiece orientation (upsidedown exhaust valve), possibly creating a breathing air complication underwater. *(Photo by NIOSH.)*

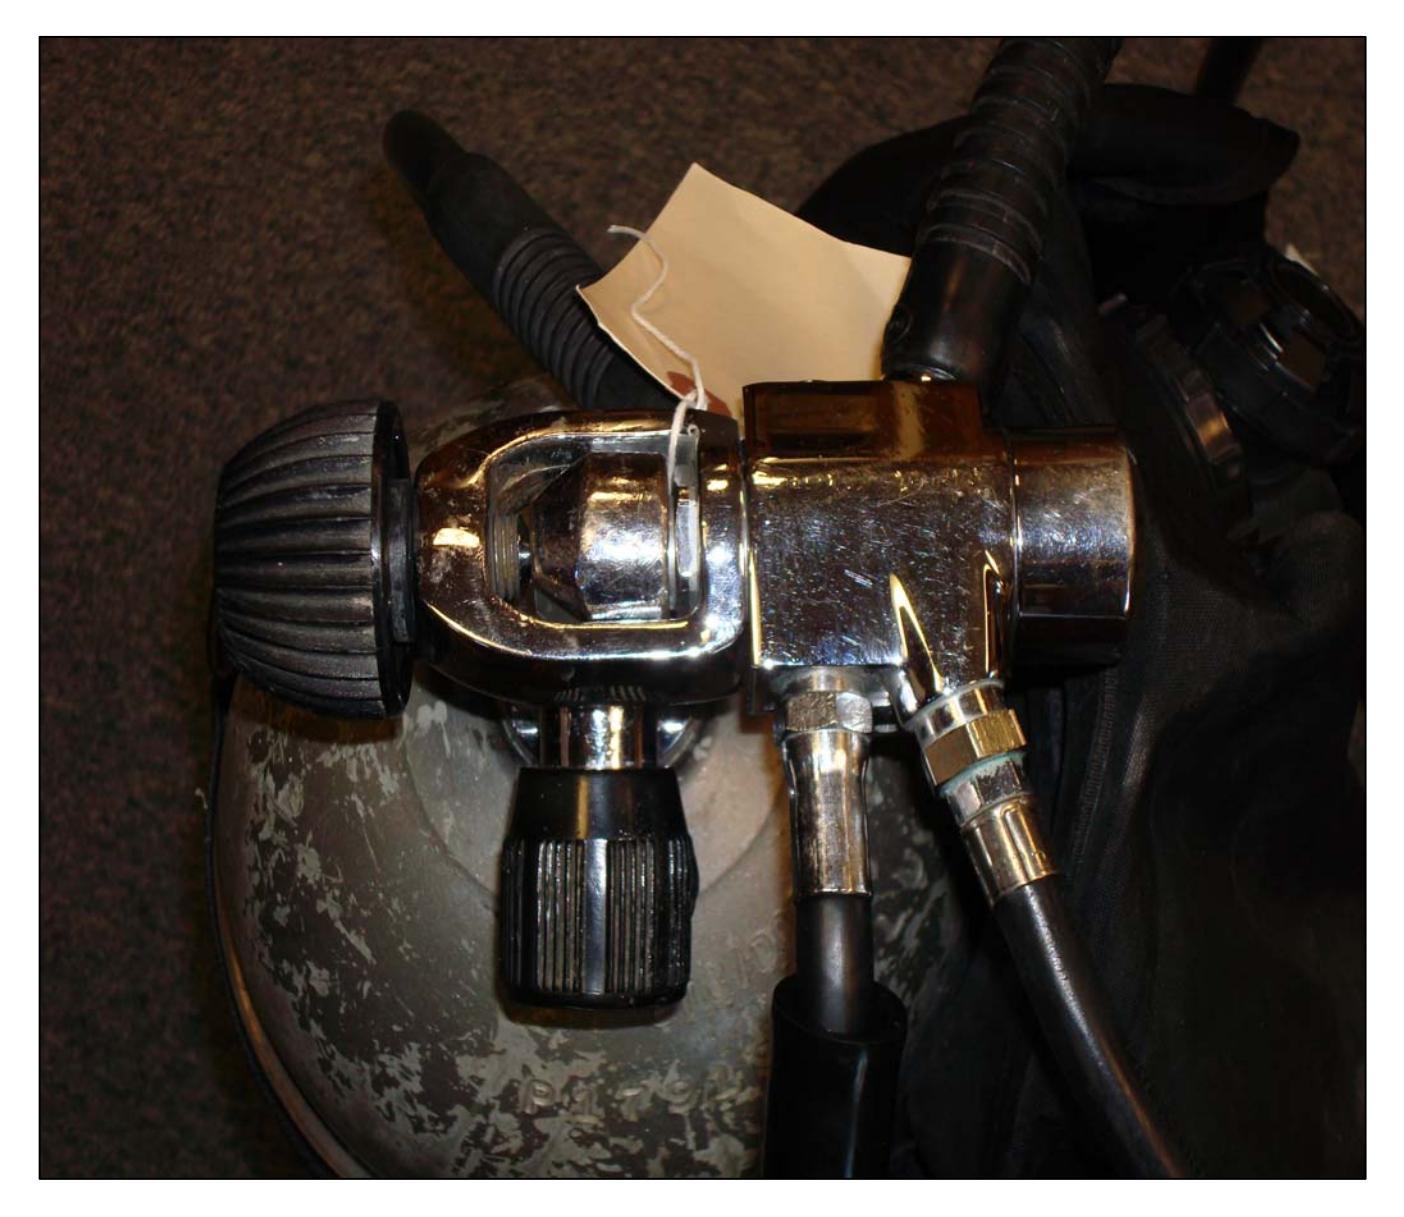
Photo 2. First-stage regulator attached at the cylinder valve incorrectly. The regulator block to the right of the valve should have been rotated 180 degrees so the second-stage hoses appearing at the top of this picture would have profiled at the bottom or the diver's right side. *(Photo by NIOSH.)*

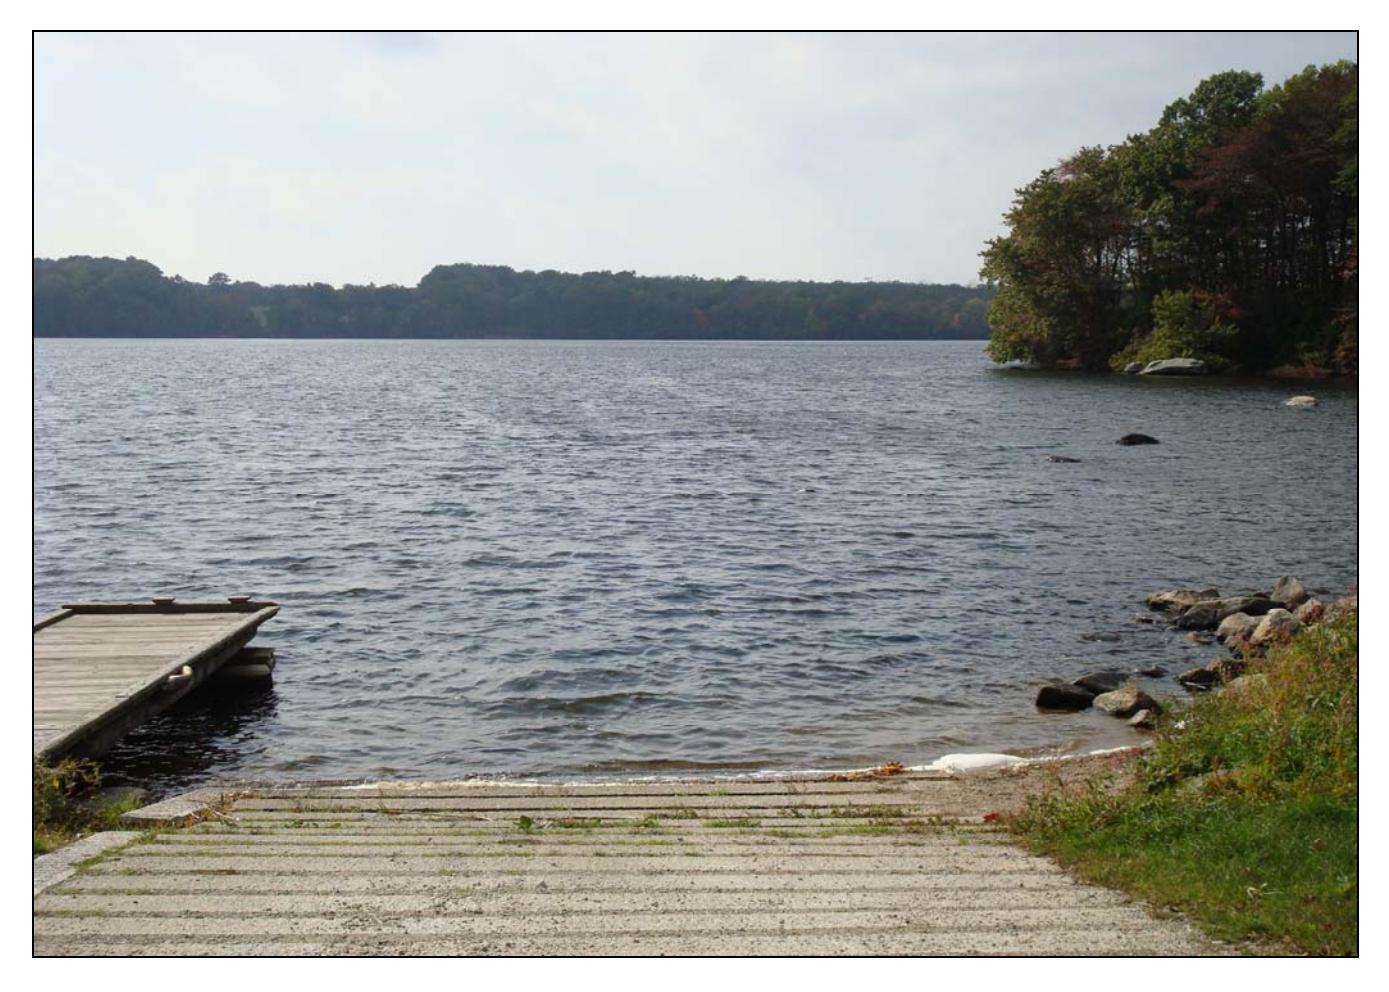
Fire fighters from Squad 1 launched Marine 2 at a local ramp (see Photo 3), and then three fire fighters boarded Marine 2 and began trying to locate the victims on the lake. Marine 2 spotted a small aluminum boat with no one on board and a life jacket hanging on a fishing pole in the rear of the boat. The three fire fighters then saw a female in the water frantically waving. The crew rescued the female civilian and learned from her that there was another civilian, a male, who fell or jumped from the boat and was under the water. Marine 2 then transferred the female to another civilian boat and instructed them to take her to shore. One of the three fire fighters from Marine 2 was placed on another civilian boat to assist with search patterns, while Marine 2 obtained a small fender (air-filled bumper used for mooring protection between a boat's hull and other boats or a dock) from the civilian boat and tied it to Marine 2's anchor to mark the spot where they had picked up the female civilian.

Photo 3. Boat ramp where rescue boats were launched and the location of the command post. The dive site is not visible due to distance and the land mass on the right side of the picture. (Photo by NIOSH.)
