Death in the line of duty...

A summary of a NIOSH fire fighter fatality investigation

October 29, 2009

Volunteer Fire Fighter Dies after Suffering a Head Injury While Operating a Platform Aerial Ladder—Rhode Island

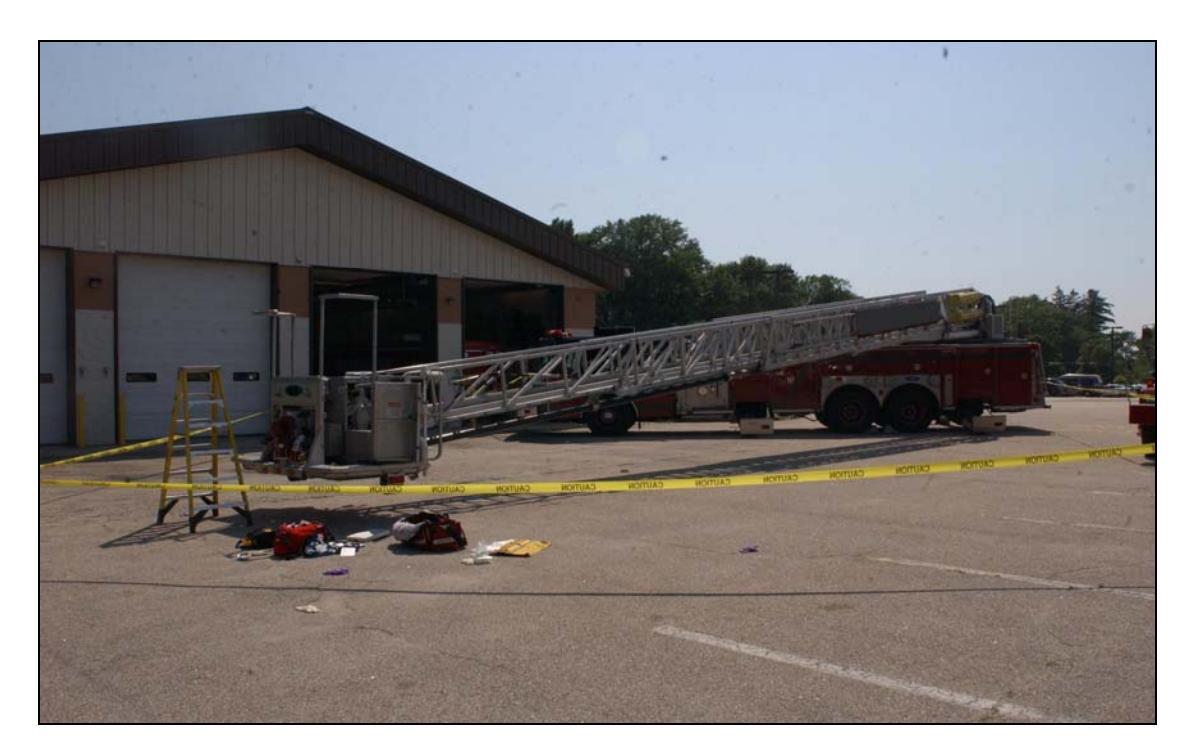
Incident scene after victim was removed. (Photo courtesy of police department.)

When he reached the platform, he called the victim's name again and received no response. He noticed that all the safety and access gates were in the closed position. He discovered the victim positioned in the right corner of the platform, to the fire fighter's right side, with his back facing him. The fire fighter also noticed that the victim's head was pinned between the bay door header and top guardrail on the platform.

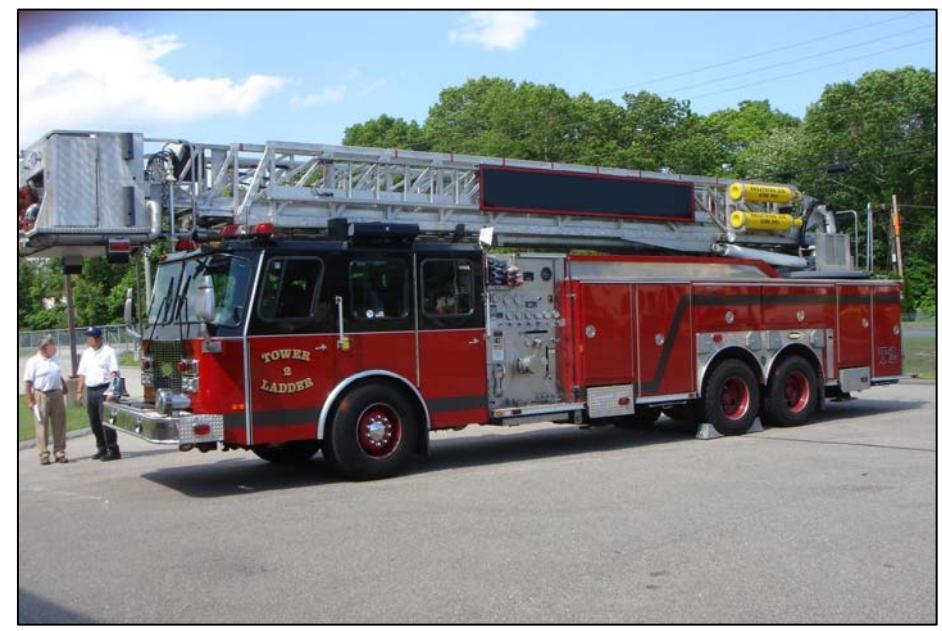
Photo 1. Platform aerial apparatus. (NIOSH photo.)

The apparatus involved in this incident was a 2000. 95-ft rear-mounted platform aerial ladder (see Photo 1). The fire department took possession in 2001 of this demo model from a local vendor. The gross vehicle weight rating of the apparatus was 73,000 lbs. The apparatus had an automatic transmission, diesel engine, an air brake system, and three axles with ten wheels (two in the front and eight in the rear).

The apparatus measured approximately 46 ft (length) x 8 ft (width) x 12 ft (height). The digital display on the dashboard of the apparatus read 51,431 odometer miles and 4,745 engine hours when documented at the scene of the incident.

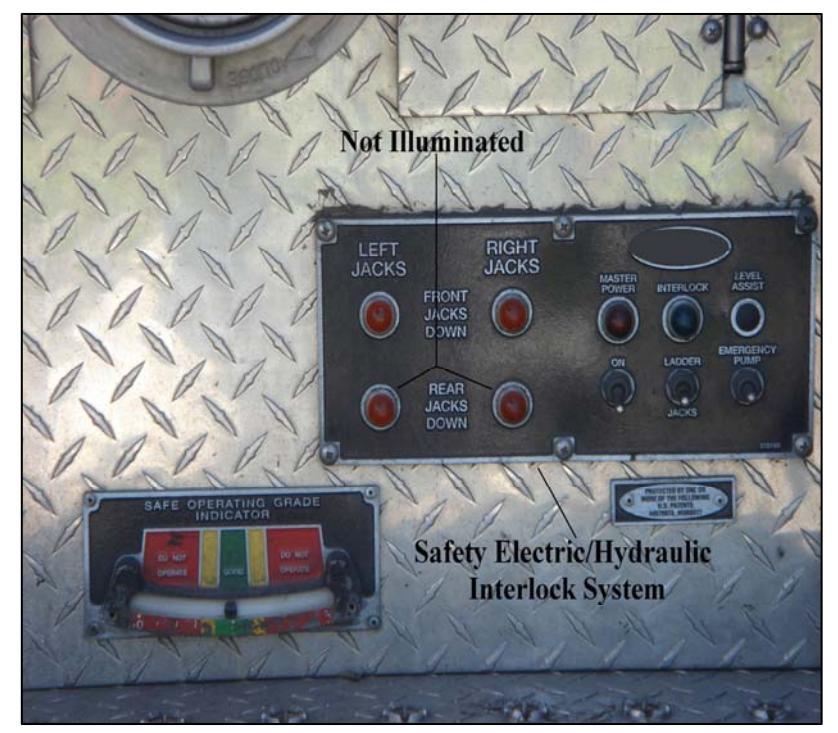
Photo 2. Safe operating grade indicator and safety interlock system. (NIOSH photo.)

A safe operating grade indicator was available at the tailboard along with a safety electric/hydraulic interlock system (see Photo 2). This system prevented the operation of the aerial ladder until all four outrigger jacks were set firmly for normal operating conditions. At that point, the hydraulic power is then transferred to the turntable so the aerial ladder can be operated. Note: The fire fighter who discovered the victim recalls the "rear jacks down" indicator lights were not illuminated when he mounted the apparatus. The light bulbs were functional.

The vehicle is stabilized by two sets of out-and-down, scissor style outriggers which are mounted under the frame. It is believed that the rear jack lights were not lit because excessive pressure was added to the front of the apparatus when the platform was wedged under the header of the bay door. This added pressure to the front of the apparatus caused the weight to shift to the front, thus relieving the pressure needed to actuate the rear jack lights. All are hydraulically operated with an electronic automatic leveling system.

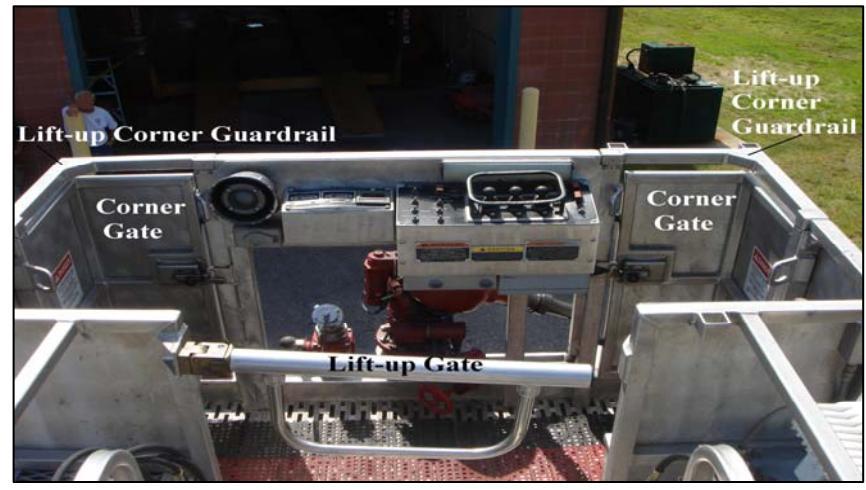
Photo 3. Aerial platform. (NIOSH photo.)

The platform is constructed entirely of aluminum with a protected working surface which measures 66 in (length) x 33 in (width) x 42 in (height); two front outward swinging corner gates protected by lift-up corner guardrails when in the opened position; and a tubular lift-up gate for access between the platform and ladder (see Photo 3). *Note: Once the tubular lift-up gate was lifted up it could be swung in/out to allow access to/from the platform.*

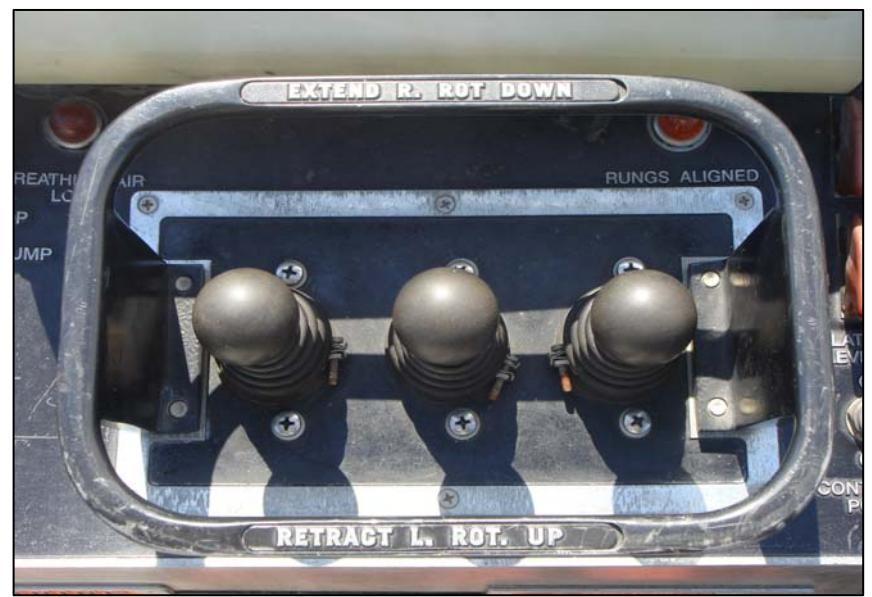
Photo 4. Control knobs located within the platform. (NIOSH photo.)

The aerial ladder could be operated from the rear-mounted turntable or from within the platform. The victim operated the aerial ladder while in the platform. The aerial ladder controls were electric-over-hydraulic. This type of control set-up allowed for a one-second delay to be incorporated in the system to reduce the shock load on the aerial ladder resulting when the hydraulic valve is operated from the fully closed to the fully open position and vice versa. The control panel contained three knobs that operated the ladder: (1) extension/retraction, (2) left/right rotation, and (3) up/down (see Photo 4).

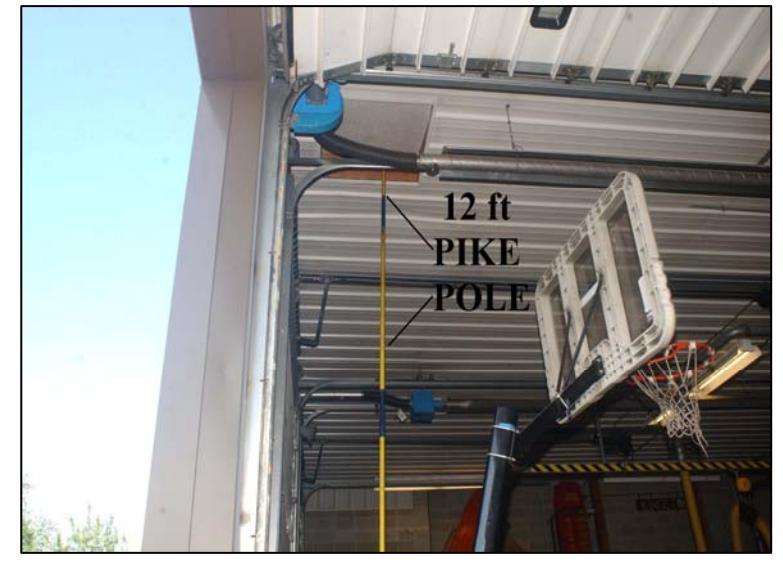
Photo 5. Pike pole stuck in scuttle hatch. (Photo courtesy of police department.)

On June 30, 2009, at approximately 1425 hours, it is believed that the victim was attempting to use a 12-ft pike pole to push open a scuttle hatch that was located within the fire apparatus bay ceiling when the pike pole slipped off the scuttle causing the scuttle to close against the wooden handle of the pike pole (see Photo 5). It is believed that the victim was unable to remove the pike pole due to it catching on the lip of the ceiling and scuttle hatch. At approximately 1430 hours, a nearby surveillance camera

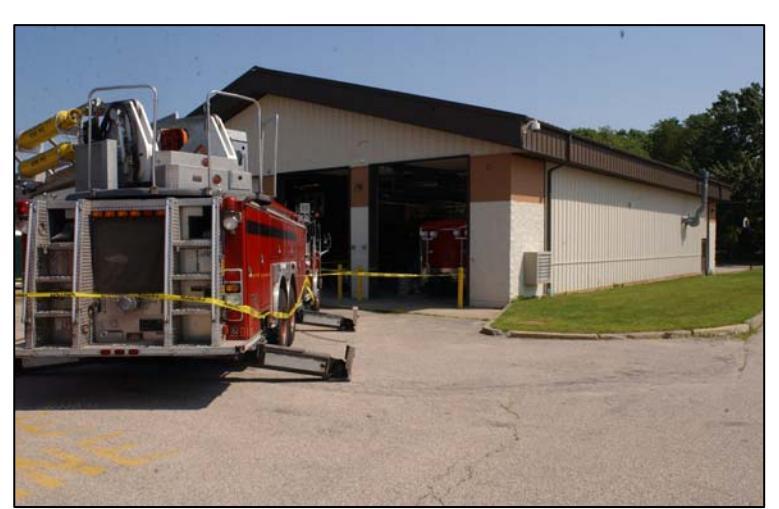
Photo 6. Position of platform aerial ladder. (Photo courtesy of police department.)

The apparatus was positioned on the apron at an angle facing the rear doors of the fire apparatus bay (see Photo 6). The victim was observed exiting the apparatus and then later operating the aerial ladder from within the platform. *Note: It is believed that the victim was intending on using the aerial apparatus to retrieve the pike pole.* A fire fighter, who had been at the fire station since 1330 hours, walked into the apparatus bay to find the bay doors up and the aerial platform positioned through the rear of the bay. He walked over to the apparatus and yelled up toward the platform to find out what the victim was doing. *Note: He assumed it was the victim because the victim was at the station on a daily basis.* There was no response from within the platform. The fire fighter walked down the driver's side of T2 and mounted the apparatus from the rear turntable. *Note: The fire fighter recalls the "rear jacks down" indicator lights were not illuminated when he mounted the apparatus; all four outriggers were set.* He started to ascend the ladder and noticed that the ladder was not bouncing. He thought this was odd because when the aerial ladder was elevated, in a cantilevered position, the ladder had a slight bounce to it.

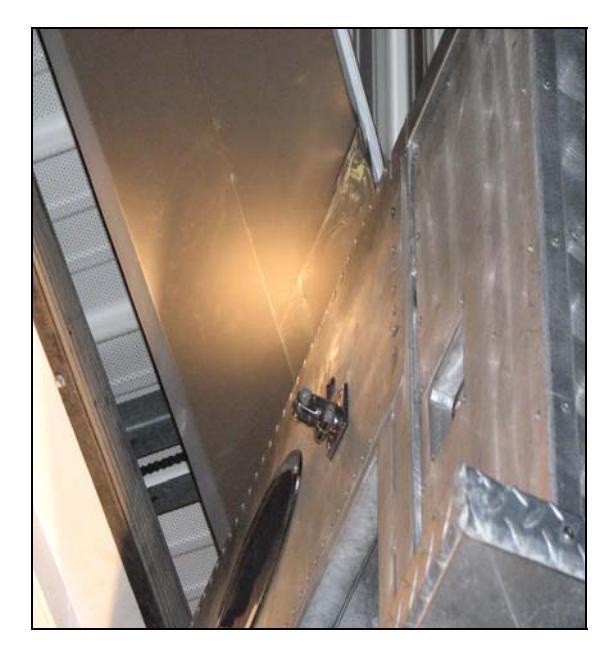
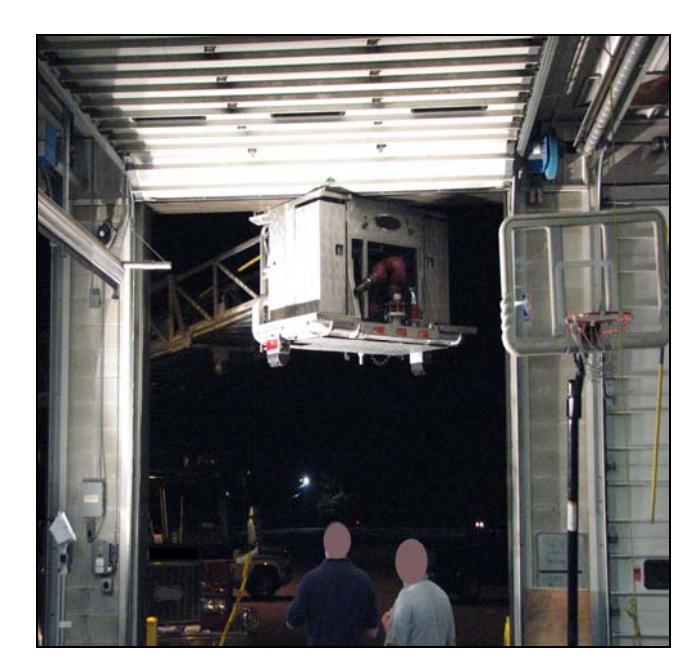
An outside consultant group was retained by the fire chief to perform a reconstruction of the events that may have led to the victim's fatal injury. The platform aerial ladder was placed in the exact position when the incident occurred. Individuals operated the aerial ladder from within the platform and were able to line the platform up to the damage marks received to the door header and platform guardrail (see Photos 7 and 8). Due to low clearance between the platform and door header, the victim could not have operated the platform while standing. He may have been kneeling or bent over while he was operating the platform controls. He would have had to make sure that he positioned himself below the 42-in platform guardrail height in order to clear the door header. It is believed that as he continued to extend and raise the platform, the victim may have lifted his head momentarily to visualize how close the top of the platform was to the door header when his head got pinned between the header and the platform guardrail. He was not wearing a helmet.

Photos 7 and 8. The photo on the left shows the platform lined up with the damage to the door header. The photo on the right shows the position the platform is believed to have been in when the victim's head got pinned. (Photos courtesy of consultant group.)

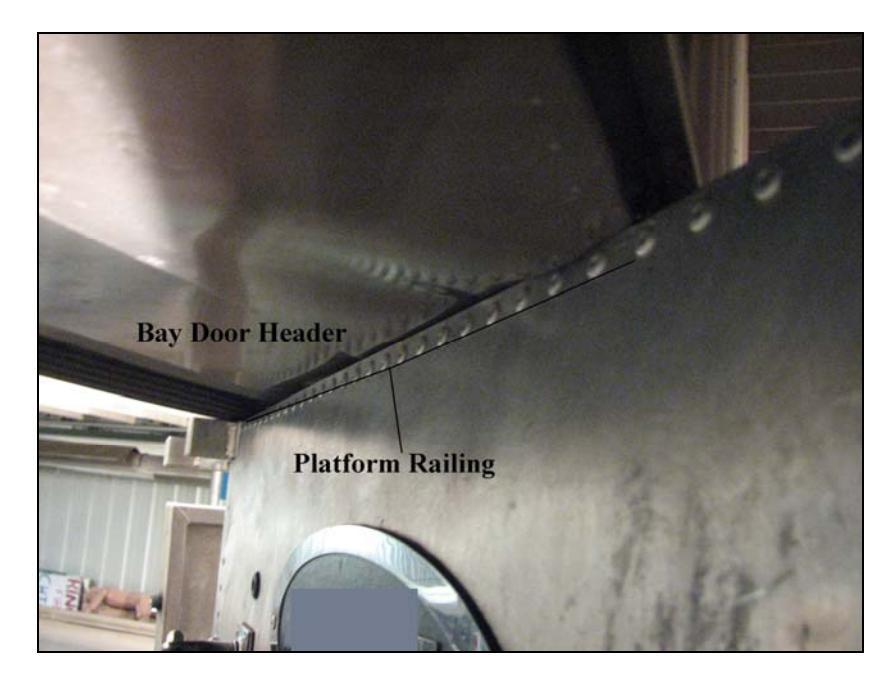
Photo 9. The level of clearance observed between door header and platform railing. (Photo courtesy of consultant group during reconstruction of the incident.)

During this incident, the victim was attempting to maneuver a platform aerial ladder into an apparatus bay while working from the platform. The door header did not provide ample clearance and posed a hazard. The victim was discovered with his head pinned between the door header and platform

guardrail. The victim was discovered without head protection, and it is feasible to believe that the injuries received may not have been fatal if the victim had been wearing an appropriate form of head protection (i.e., a fire helmet) because it may have taken the initial impact lowering the potential for the victim's head to have been pinned.

Fire departments should develop policies addressing when an apparatus, especially an aerial ladder, should be used during emergency and non-emergency situations. The use of a ground ladder may have been better suited to retrieve the pike pole. Carefully planning a task and identifying potential risks can be helpful.

Recommendation #2: Fire departments should ensure that members operating an aerial ladder wear appropriate personal protective equipment including head protection.
