# Death in the line of duty...

A summary of a NIOSH fire fighter fatality investigation

Revised on June 23, 2014 to add Protective Clothing Report Findings Career Lieutenant Dies Following Floor Collapse into Basement Fire and a Career Fire Fighter Dies Attempting to Rescue the Career Lieutenant – New York

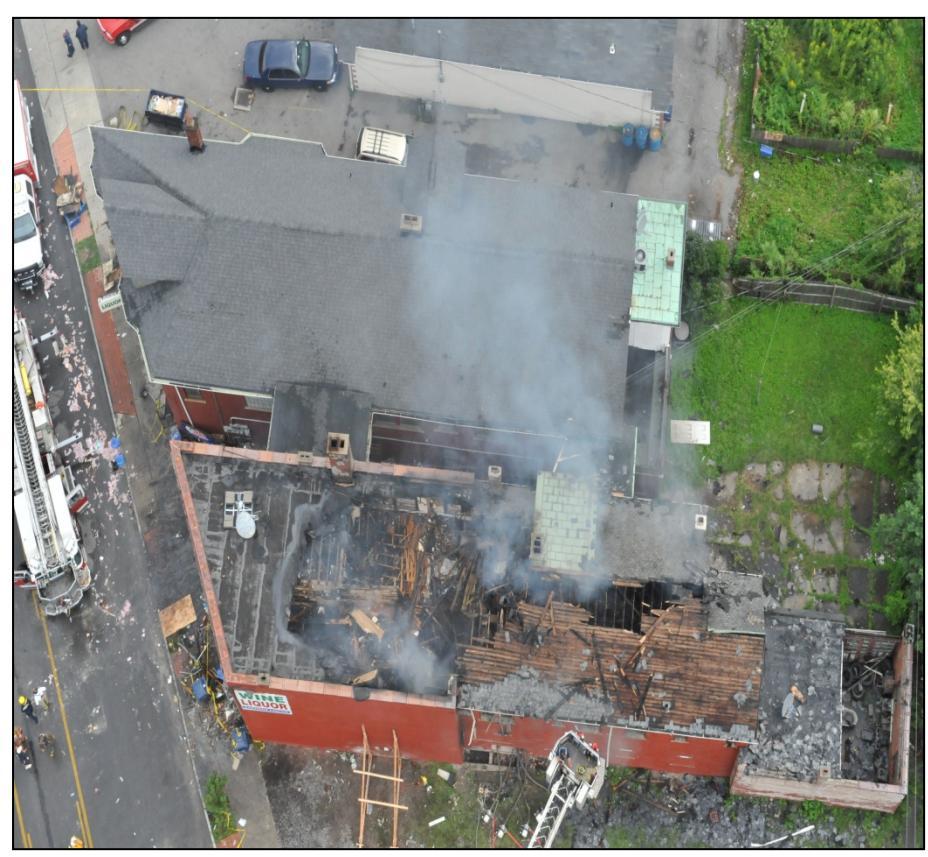
Photo 1. Aerial view of the fire structure and connecting Side 2 exposure. The street facing apartment on the 2<sup>nd</sup> floor, which was directly above the deli, had a flat roof, but the rear apartment had a pitched roof with attic space; this was quickly identified during the initial size-up. (Photo courtesy of police photographer.)

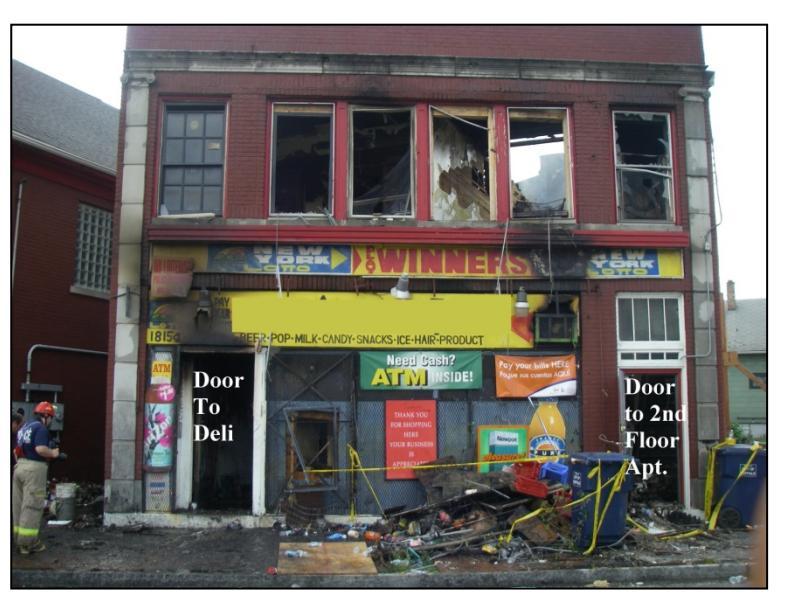
Photo 2. Doors located on Side 1 of structure. (Photo courtesy of police photographer.)

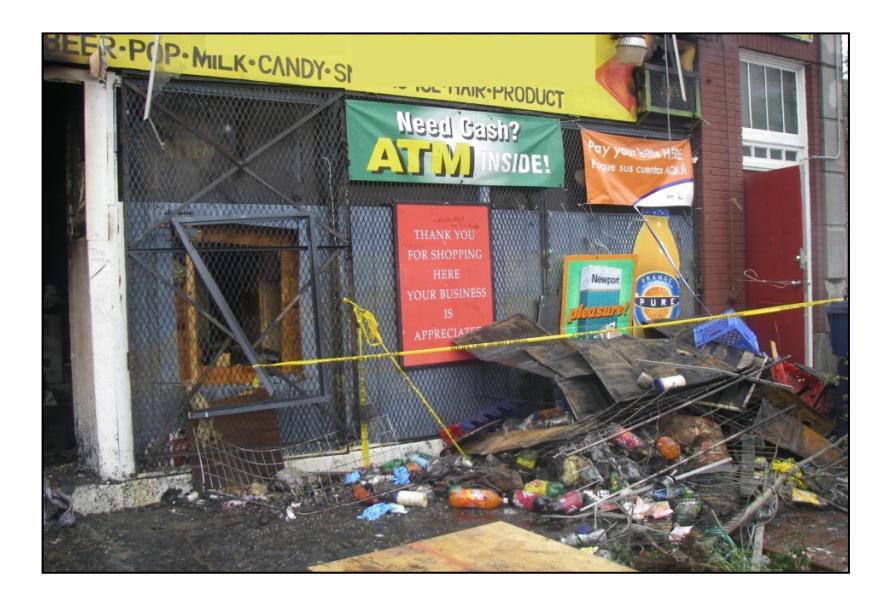
solid panels behind the plate glass store front (see Photo 3).

Photo 3. Close-up of secured store front showing security grating. (Photo courtesy of police photographer.)

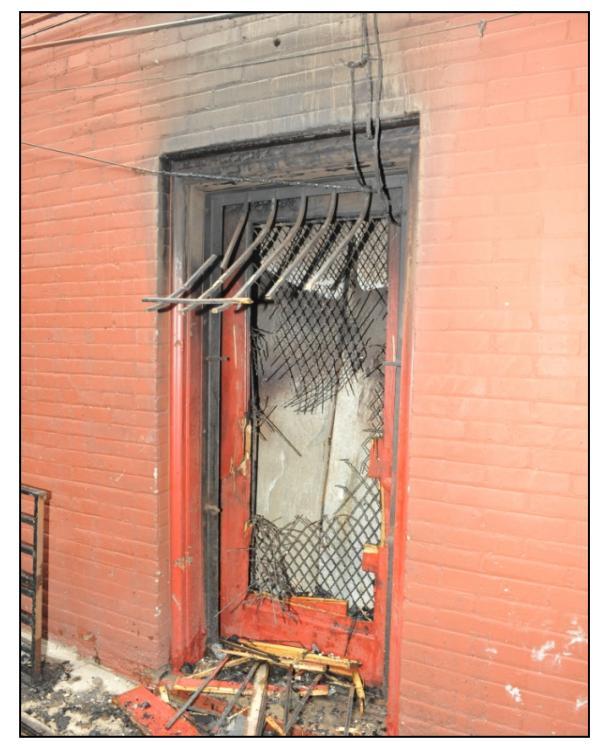
Photo 4. First door encountered by fire fighters on Side 2. (Photo courtesy of police photographer.)

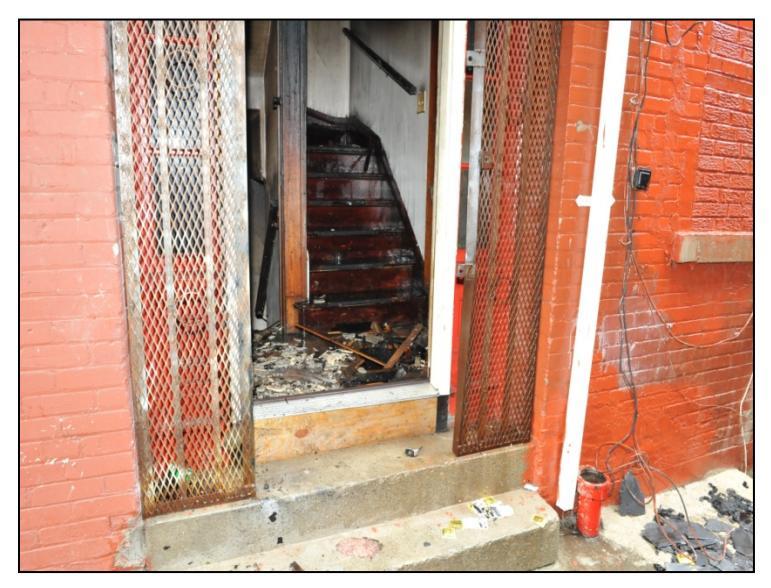
Photo 5. Second door encountered by fire fighters on Side 2. (Photo courtesy of police photographer.)

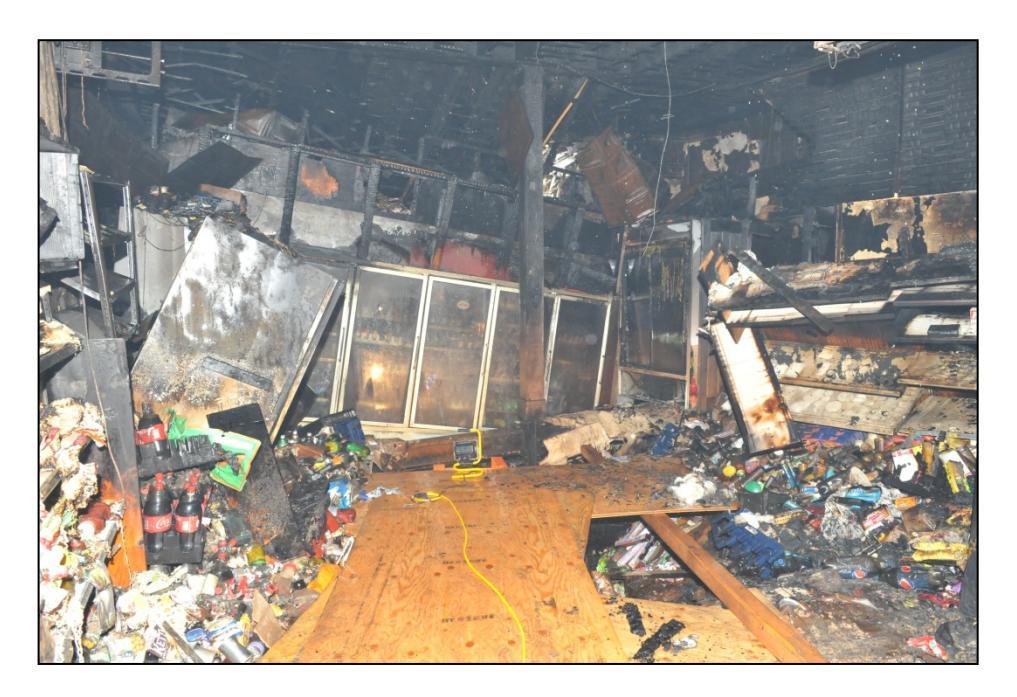
Photo 6. Interior view of deli following partial floor collapse and recovery operations. (Photo courtesy of police photographer.)

About 35 ft inside the deli, the crew came across a section of the deli floor that had opened up into the basement. The basement was full of fire and the hoseline appeared to be within the hole. They immediately backed out and advised B56 of what they found. B56 had E28 flake out a  $2\frac{1}{2}$ -in hoseline from E31 and take it in to the deli. E21 personnel backed up E28 as they took the  $2\frac{1}{2}$ -in hoseline inside the deli. Fire was now rolling across the ceiling of the deli and then without warning, blew out the deli door. E28 and E21 crews quickly evacuated the deli taking the  $2\frac{1}{2}$ -in hoseline was then operated from the deli door threshold.

## Recommendation #1: Fire departments should ensure that all personnel are aware of the dangers of working above a fire, especially a basement fire, and develop, implement, and enforce a standard operating procedure (SOP) that addresses strategies and tactics for this type of fire.

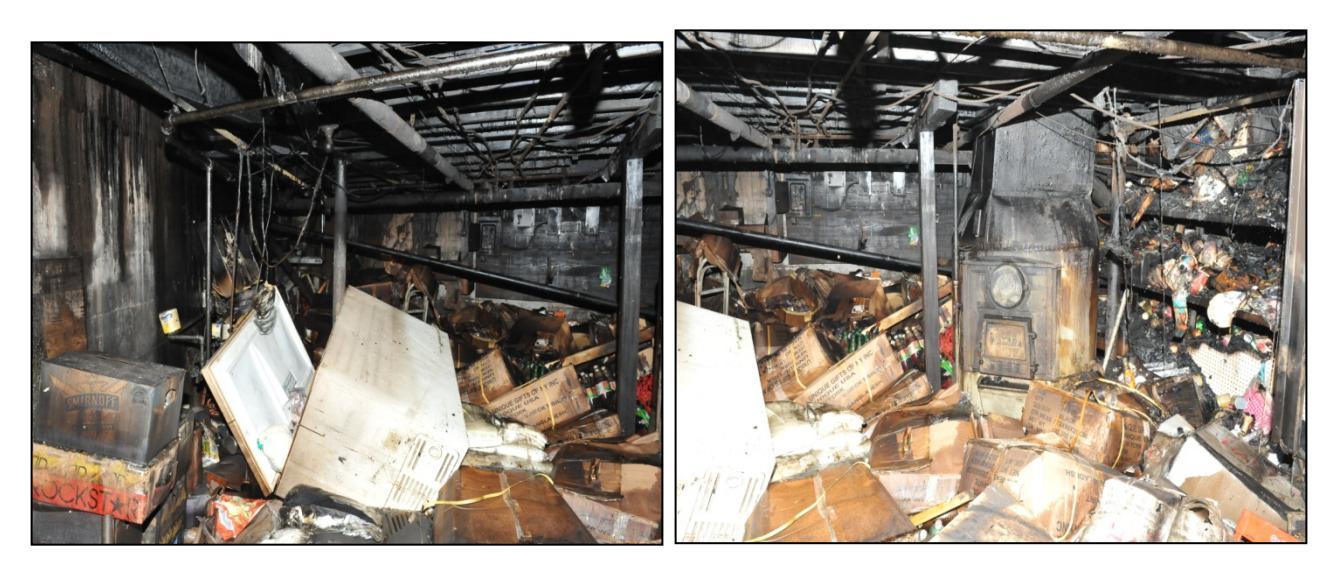
Photo 7 . Views of materials stored within basement. (Photos courtesy of police photographer.)

During this incident, fire fighters were unable to access the basement, unable to ventilate the basement fire, and unaware of the fire load found within the basement. Initially, the department did not cut a hole in the 1<sup>st</sup> floor apartment or deli and use their Bresnan distributor, in fear of injuring reported trapped civilians. *Note: The Bresnan distributor is a type of cellar nozzle used to suppress fire through steam conversion.* The use of a cellar nozzle, like a Bresnan distributor, during the initial stages of the basement fire may have assisted in containing the fire and/or allowing better operating conditions for fire fighters to access the basement.<sup>2</sup> Attempts were made to flow water on

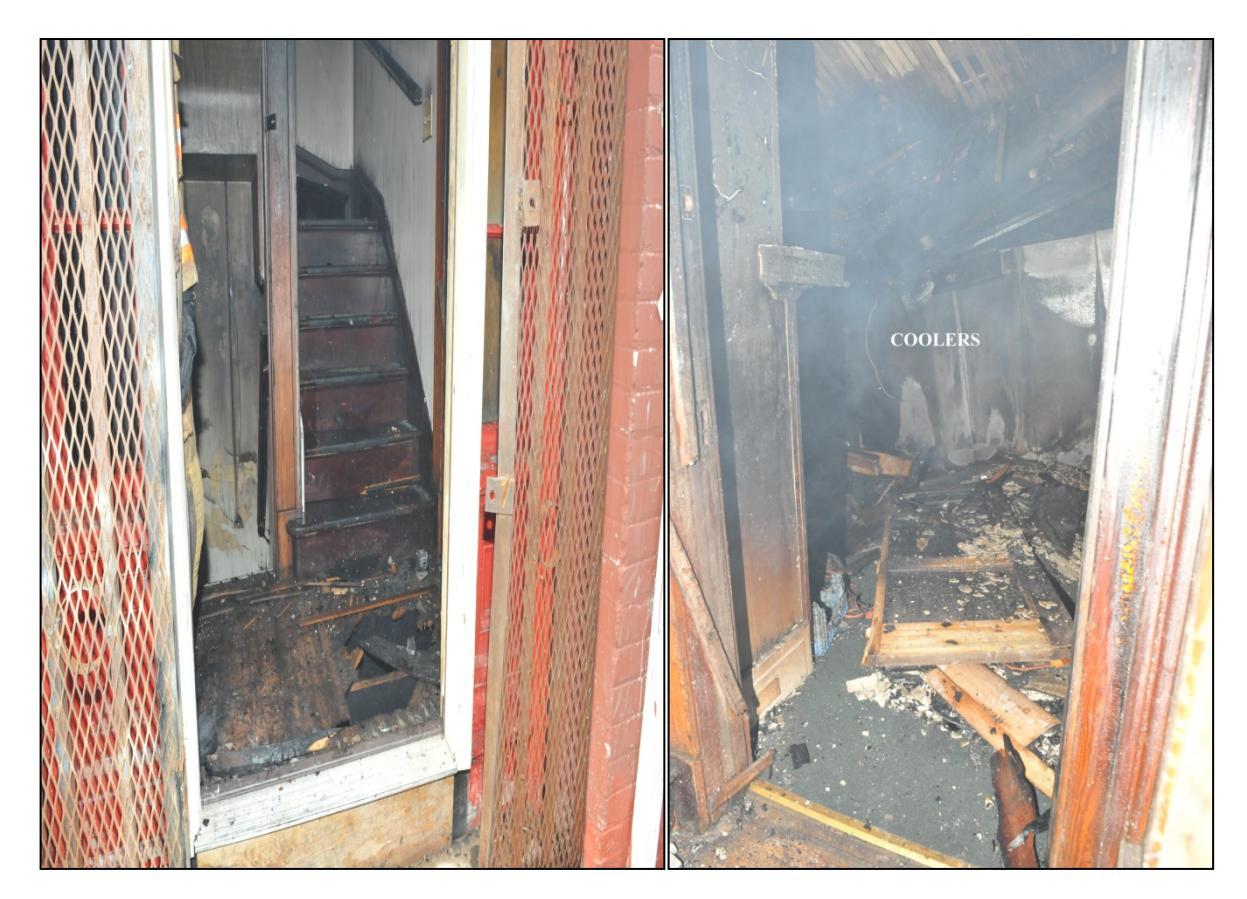
Photos 8 and 9. Photo at left, shows the door that E22, E31, and L14 crews entered through. Personnel from E31 and L14 went down the stairs; the search crew for L14 went up the stairs, and the officer of L14 and crew from E22 made an immediate right to access the 1<sup>st</sup> floor apartment. Photo at right shows the wall of coolers that separated the deli and apartment. *(Photos courtesy of police photographer.)*

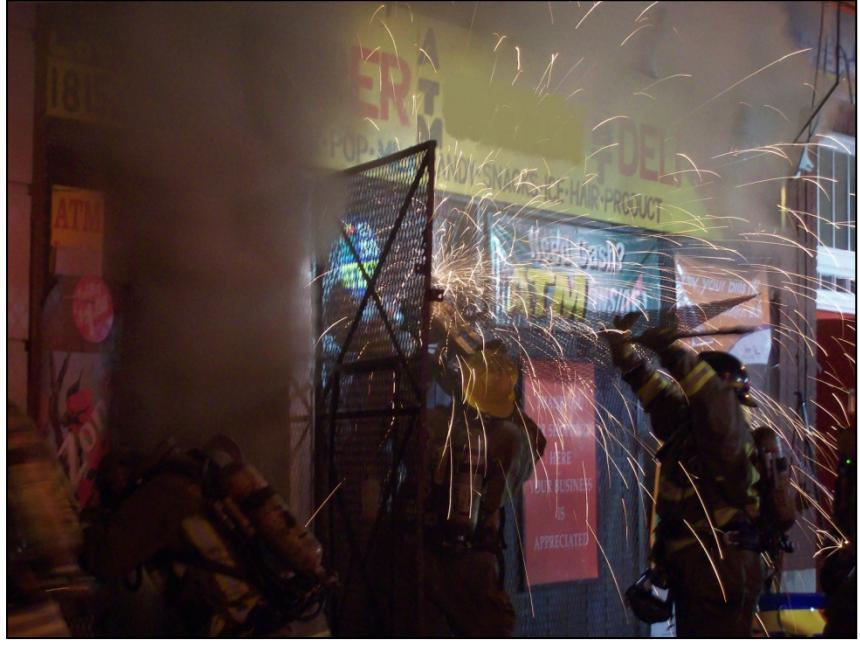
Photo 10. L7 officer and fire fighter from FAST working on store front just before Mayday. (Photo courtesy of off-duty fire fighter.)

#1. After Victim #1 and #2 exited the deli, B43 ordered the FAST to open up the deli store front. The FAST had to cut through metal bars and mesh, and the store front plate glass was actually protected from the inside with paneling, which caused difficulty in gaining access for ventilation (see Photo 10).

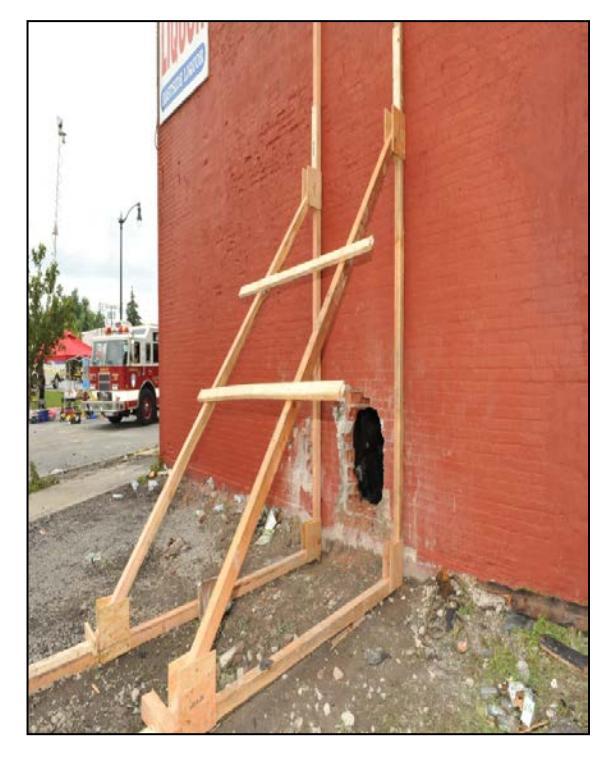
An emergency head count was conducted following the collapse and it was determined that Victim #1 from R1 was missing. It was not until a third head count was conducted that Victim #2 was confirmed missing. Victim #2's exact whereabouts within the structure were still unknown. Rescue/recovery efforts continued while crews attempted to breach the basement door on Side 2 and breach the Side 4 wall into the basement. A technical rescue crew was also dispatched to the scene to assist in breaching and shoring a wall on Side 4 (see Photo 11).

Photo 11. Photo shows Side 4 point of entry and shoring during rescue/recovery operations. (Photo courtesy of police photographer.)
