A report from the NIOSH Fire Fighter Fatality Investigation and Prevention Program

January 23, 2017

Career Fire Fighter/Engineer Dies After Falling Through Translucent Corrugated Roof Panel While Searching for Fire Extension—Colorado

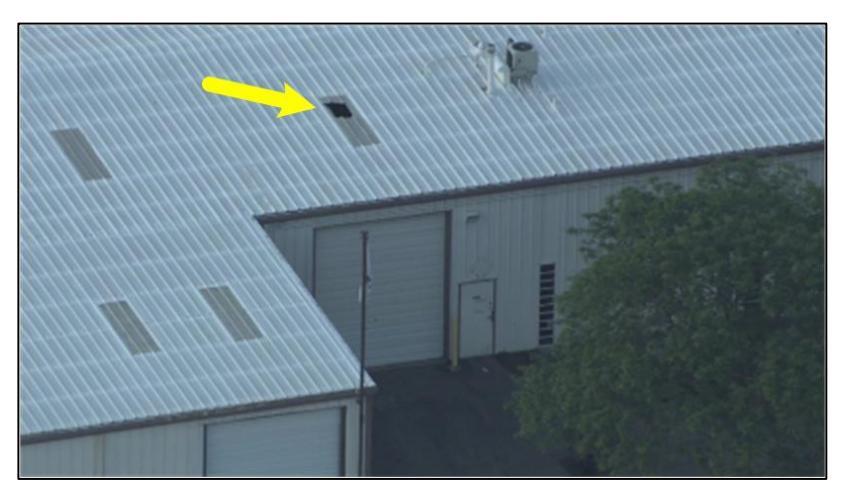
Location on roof where 46-year-old Truck 8 engineer fell through a translucent corrugated roof panel. Note how translucent roof panels blend in with rest of roof. (Photo courtesy of fire department.)

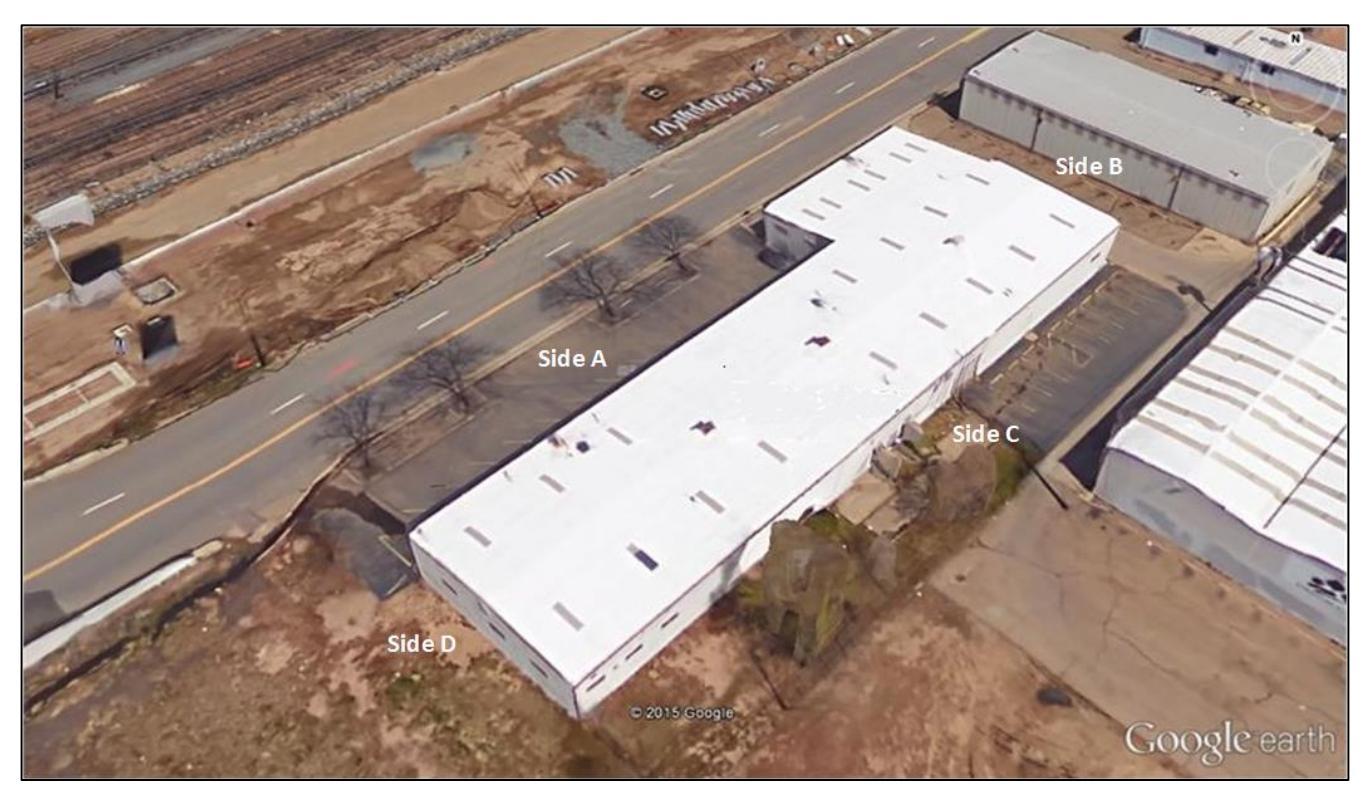
Photo 1. Overhead view of the L-shaped commercial structure. Note that the surrounding buildings also contain translucent corrugated roof panels. This type of structure is common throughout the city where this incident occurred. (Source: Google Earth.)

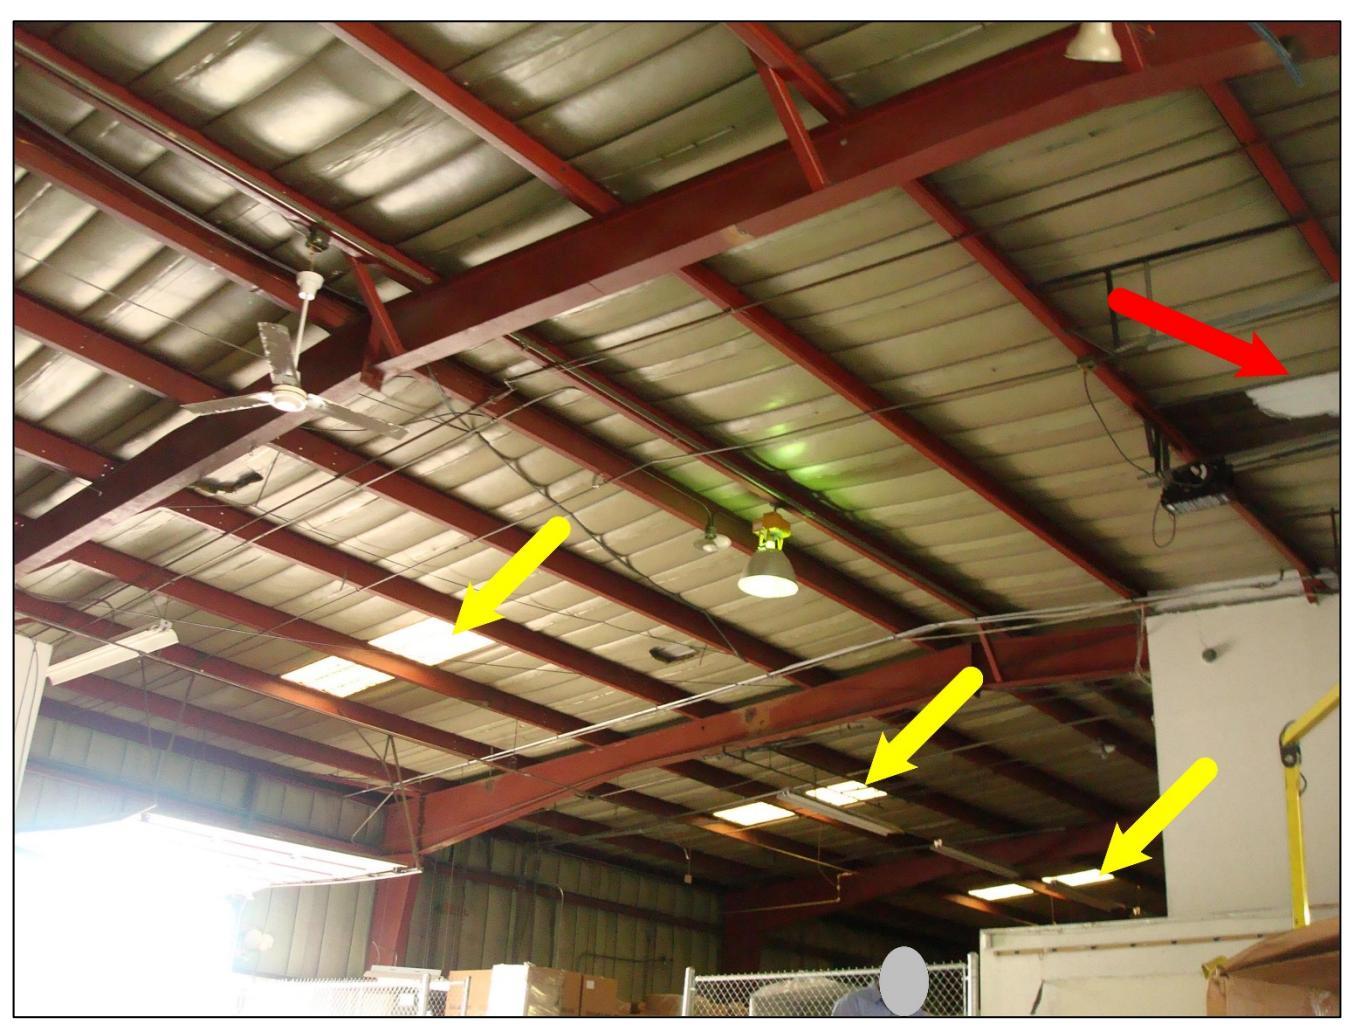
Photo 3. Interior view looking up at roof support system. Note the translucent corrugated roof panels indicated by yellow arrows and the panel where the engineer fell marked by red arrow. The panel that broke has been covered with a sheet of corrugated roof metal. (*Photo source: NIOSH.*)

The engineer fell approximately 17 feet 4 inches from the roof to the cement floor below (see Photo 3, Photo 7, and Diagram 1). The roof was constructed of corrugated metal with 23 intermittently spaced translucent corrugated roof panels (see Photo 1). The engineer fell through the translucent corrugated roof panel, and tried to break his fall with his right arm. Members from Tower 9, Truck 4, Truck 8, and District Chief 4 all reported either hearing or seeing something fall through the roof, but it was not immediately clear that a fire fighter had fallen. Many fire fighters also reported not being unable to see the hole in the translucent corrugated roof panel because it blended in with the roof, especially in the low-light conditions at night (see Photo 7 and Photo 8).

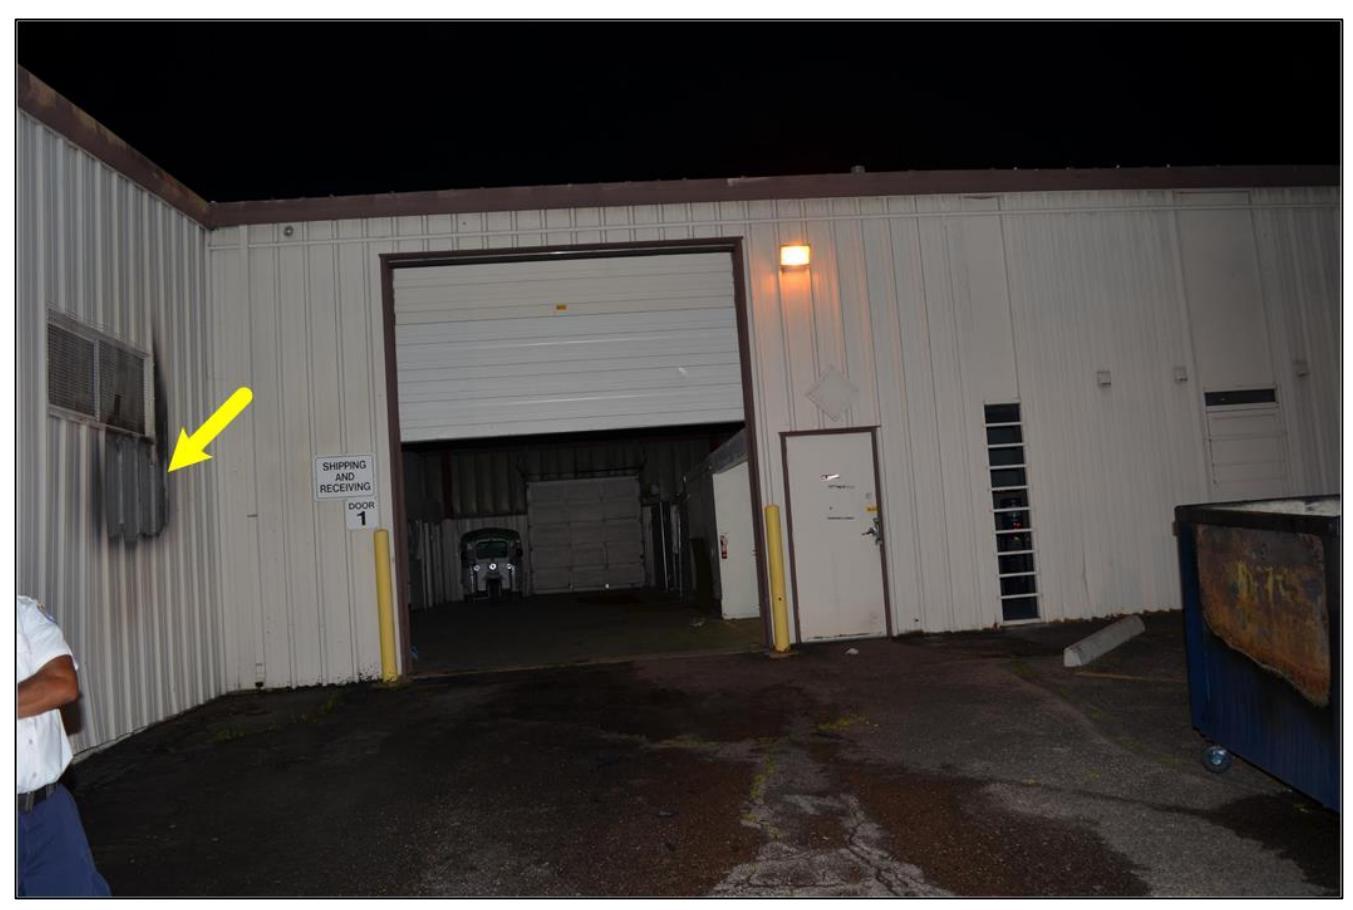
Photo 4. Exterior view of Side A. Yellow arrow at left indicates where the dumpster was located against the exterior wall at the time companies arrived. The dumpster can be seen at the right of the photo. (Photo courtesy of the fire department.)

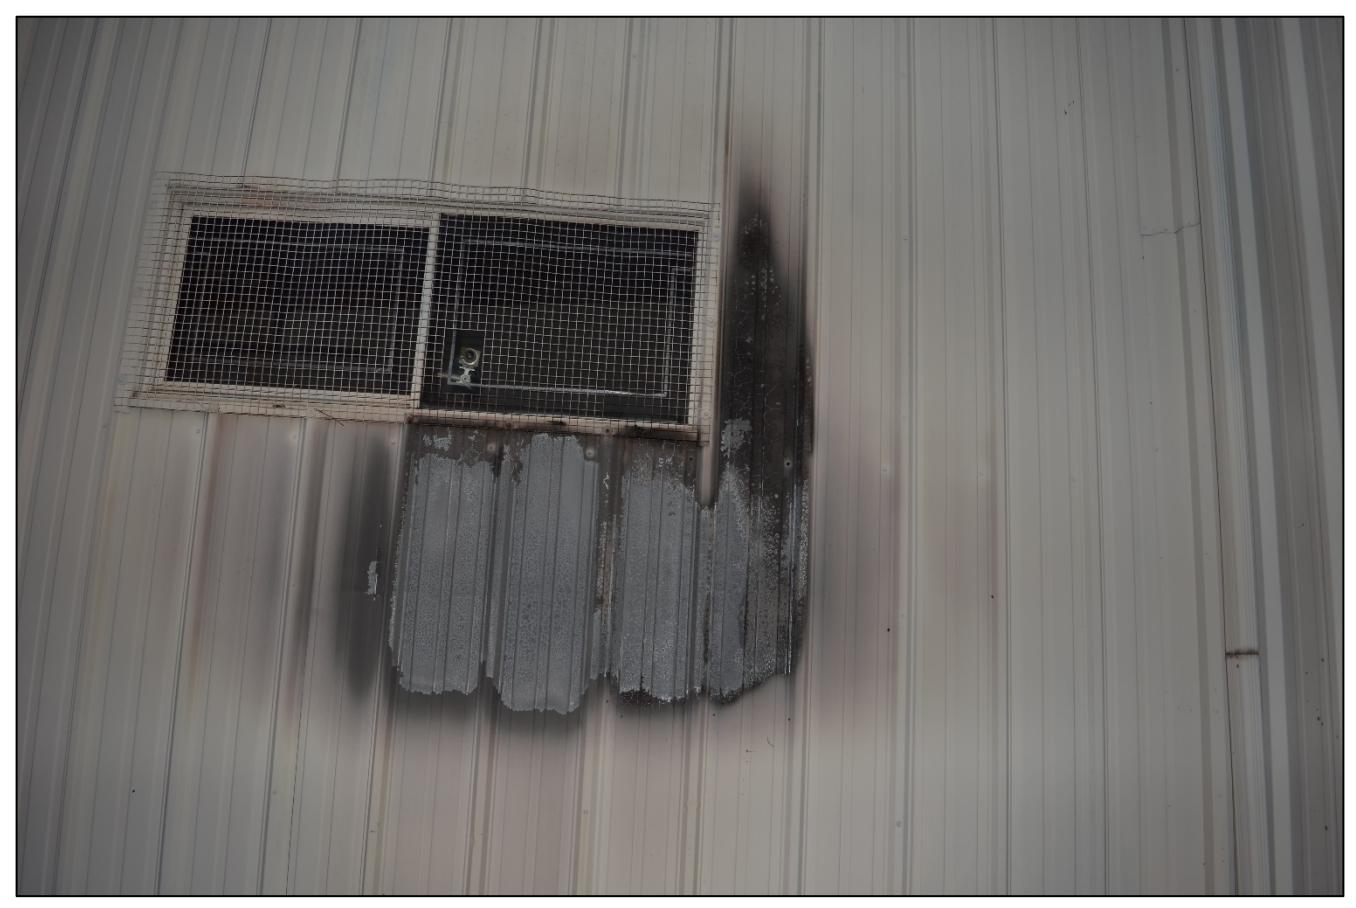
Photo 5. Photo shows extent of fire damage to exterior wall. (Photo courtesy of the fire department.)

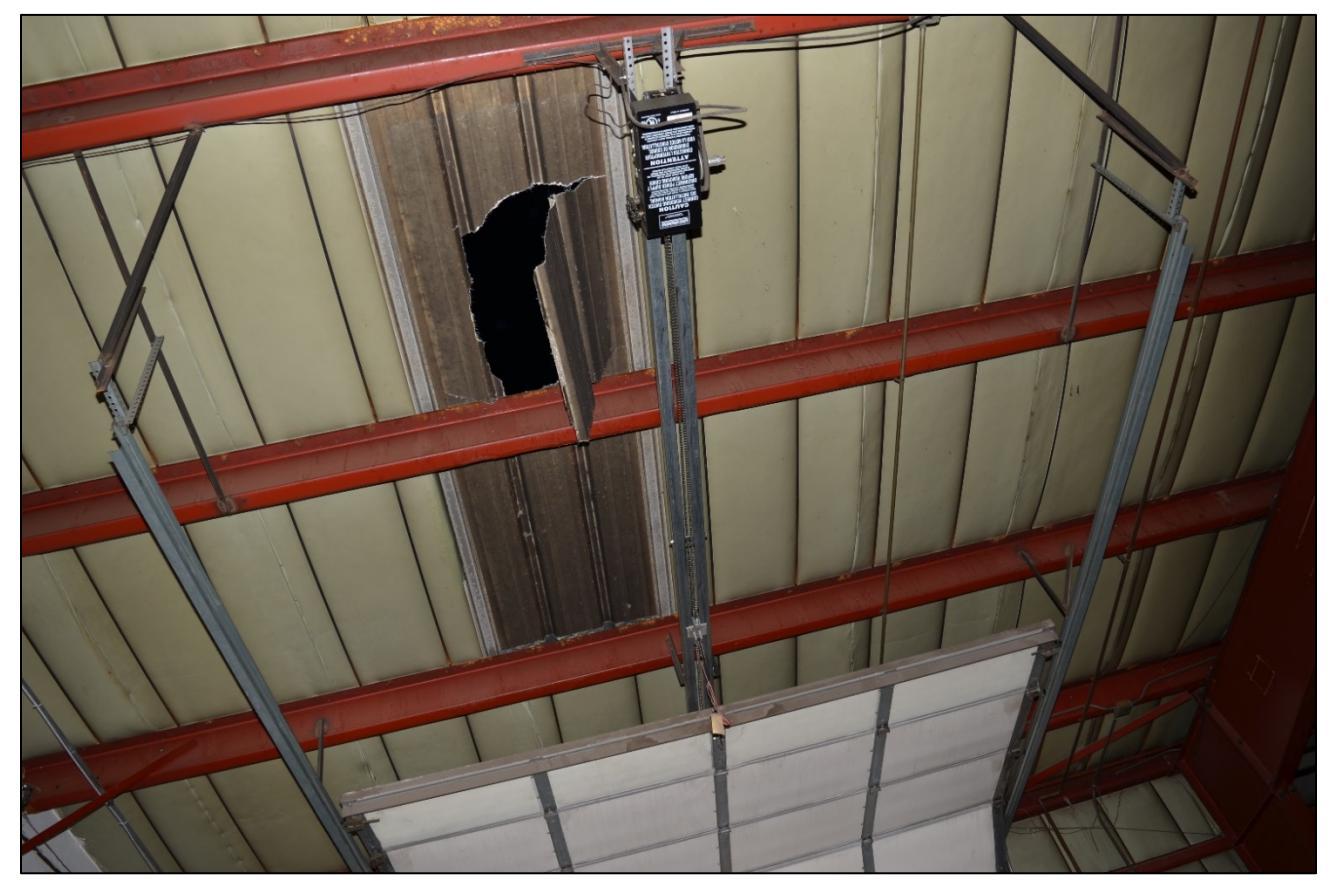
Photo 7. Interior view looking up at the translucent corrugated roof panel where the engineer fell. Photo taken the night of the incident. (Photo courtesy of the fire department.)

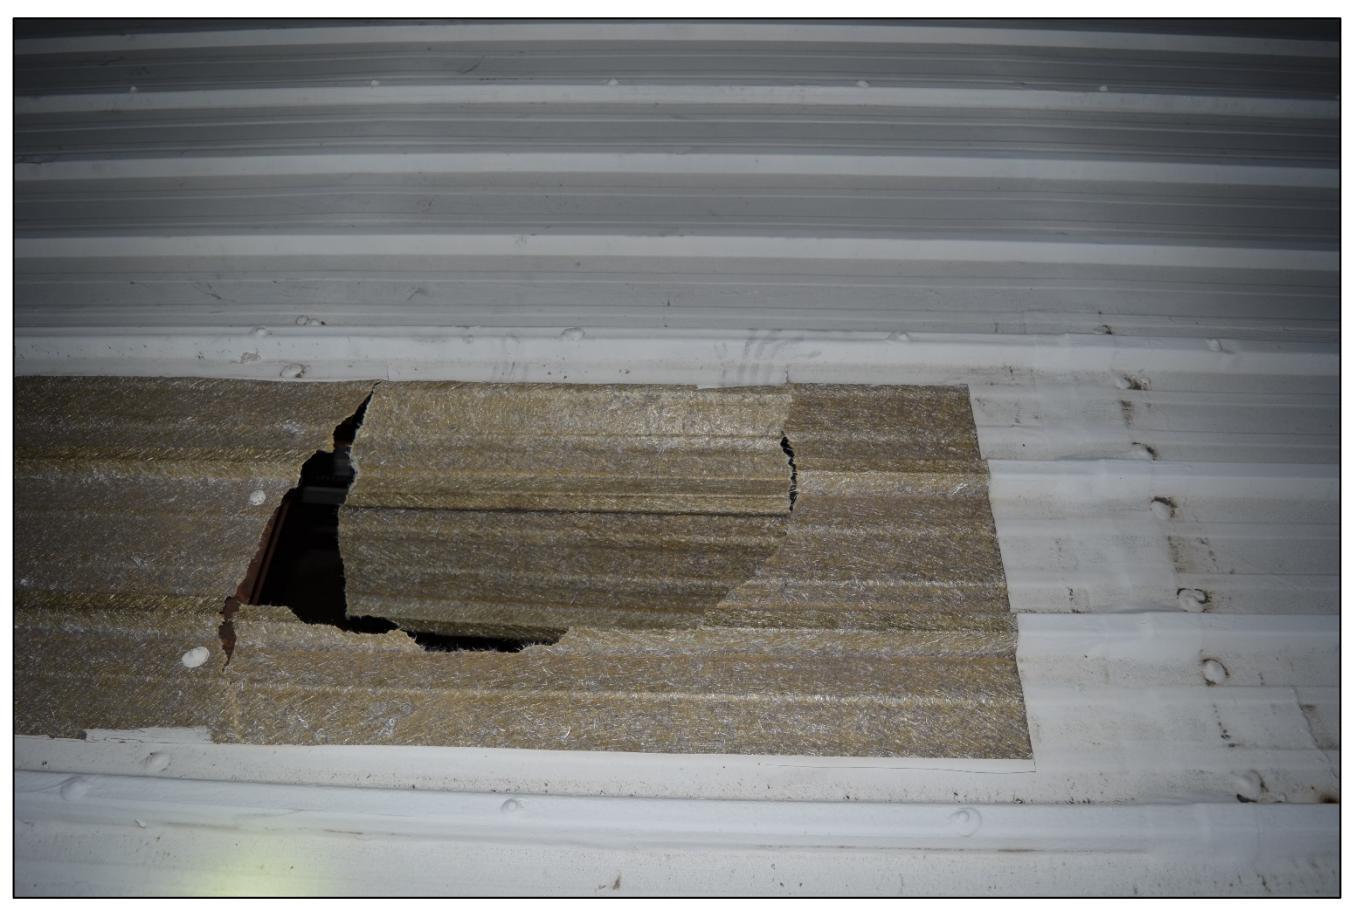
Photo 8. Close-up of translucent corrugated roof panel taken from the roof on the night of the incident. Note how the translucent corrugated roof panel lacks a frame or other indicator of its presence, allowing it to blend with the rest of the roof. (Photo courtesy of the fire department.)

Recommendation #12: Municipalities, states, authorities having jurisdiction, and code setting organizations should consider modifying local, national, and international building codes to require the perimeters of skylights, scuttles, and translucent panels be appropriately marked with reflective markings to delineate their locations on a roof.

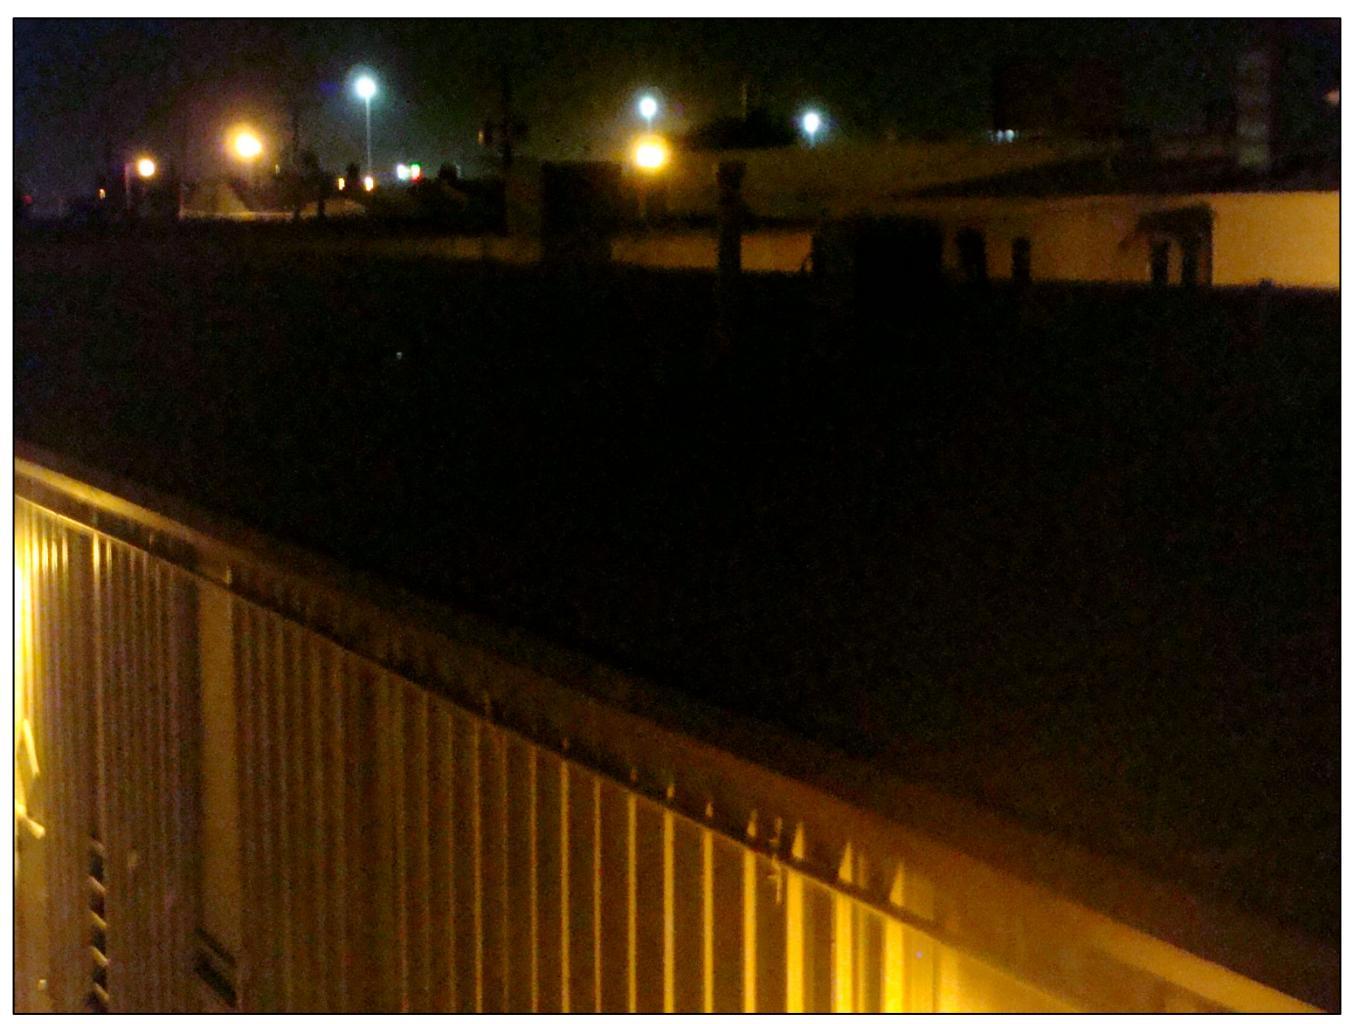
Photo 10. Photo taken of the structure's roof during NIOSH investigation at approximately the same time in the evening that the fall occurred. Note that under low-light conditions, the translucent corrugated roof panels are indistinguishable from the surrounding sheet metal roof. (*NIOSH photo.*)
