Brick Gable End Collapses at a Residential Fire Killing a Fire Captain and Seriously Injuring Three Other Firefighters – Illinois

Executive Summary

Brick Gable End Collapses at Residential Structure Fire Killing a Fire Captain and Injuring Three Fire Fighters – Illinois

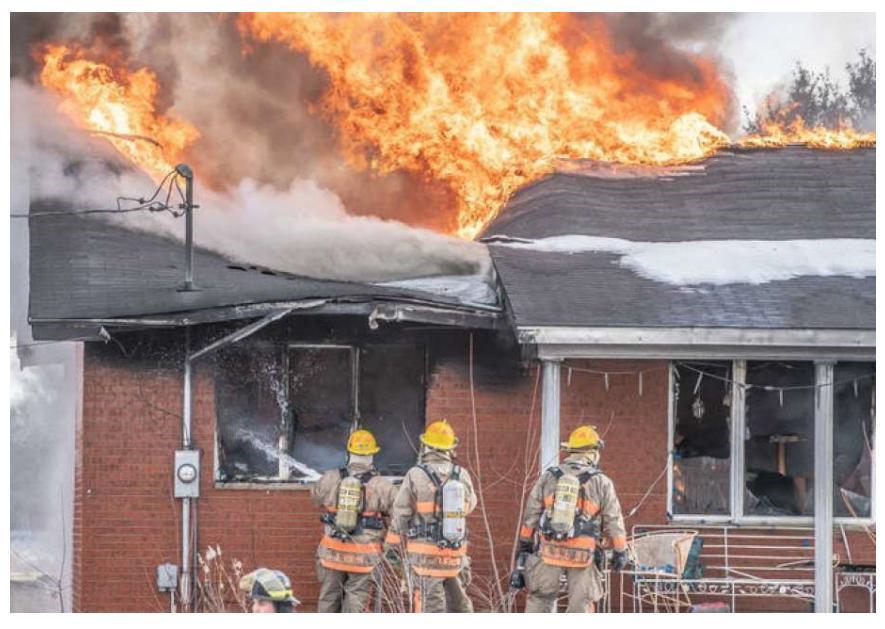
Firefighters flowing water through a window on Side Alpha. The roof had partially collapsed, but no collapse zone had been established. (Photo courtesy of the fire department.)

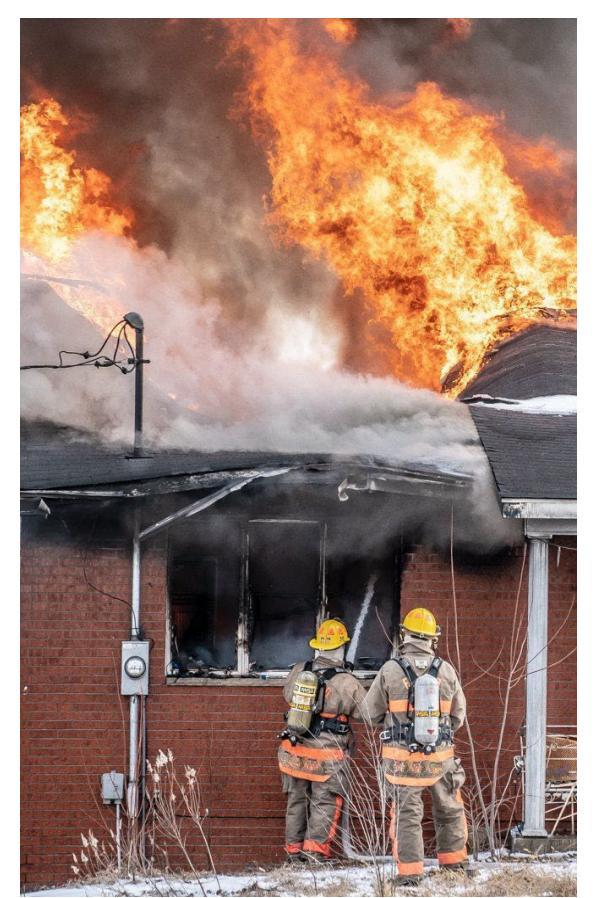
Photo 1. Firefighters from county FPD 23 operating a hoseline into the picture window near Side Alpha and near the Side Alpha/Bravo corner. Time is approximately 1630 hours. (Photo courtesy of the fire department.) Two engines from district 23 responded at 1619 hours: E2311 (PAR 2 – chief and probationary firefighter) and E2312 (PAR 1 - captain). While E2311 was enroute, the fire chief requested county FPD 16 (volunteer), and FD 22 (career) respond to the structure fire. In addition to sending these units, an ambulance was dispatched to the address. Medic 74, who happened to be in the area, selfdispatched. Arriving at 1622 hours, Medic 74 reported heavy smoke and fire. The county deputy sheriff arrived at the same time and reported the homeowners were out of the home at 1624 hours.

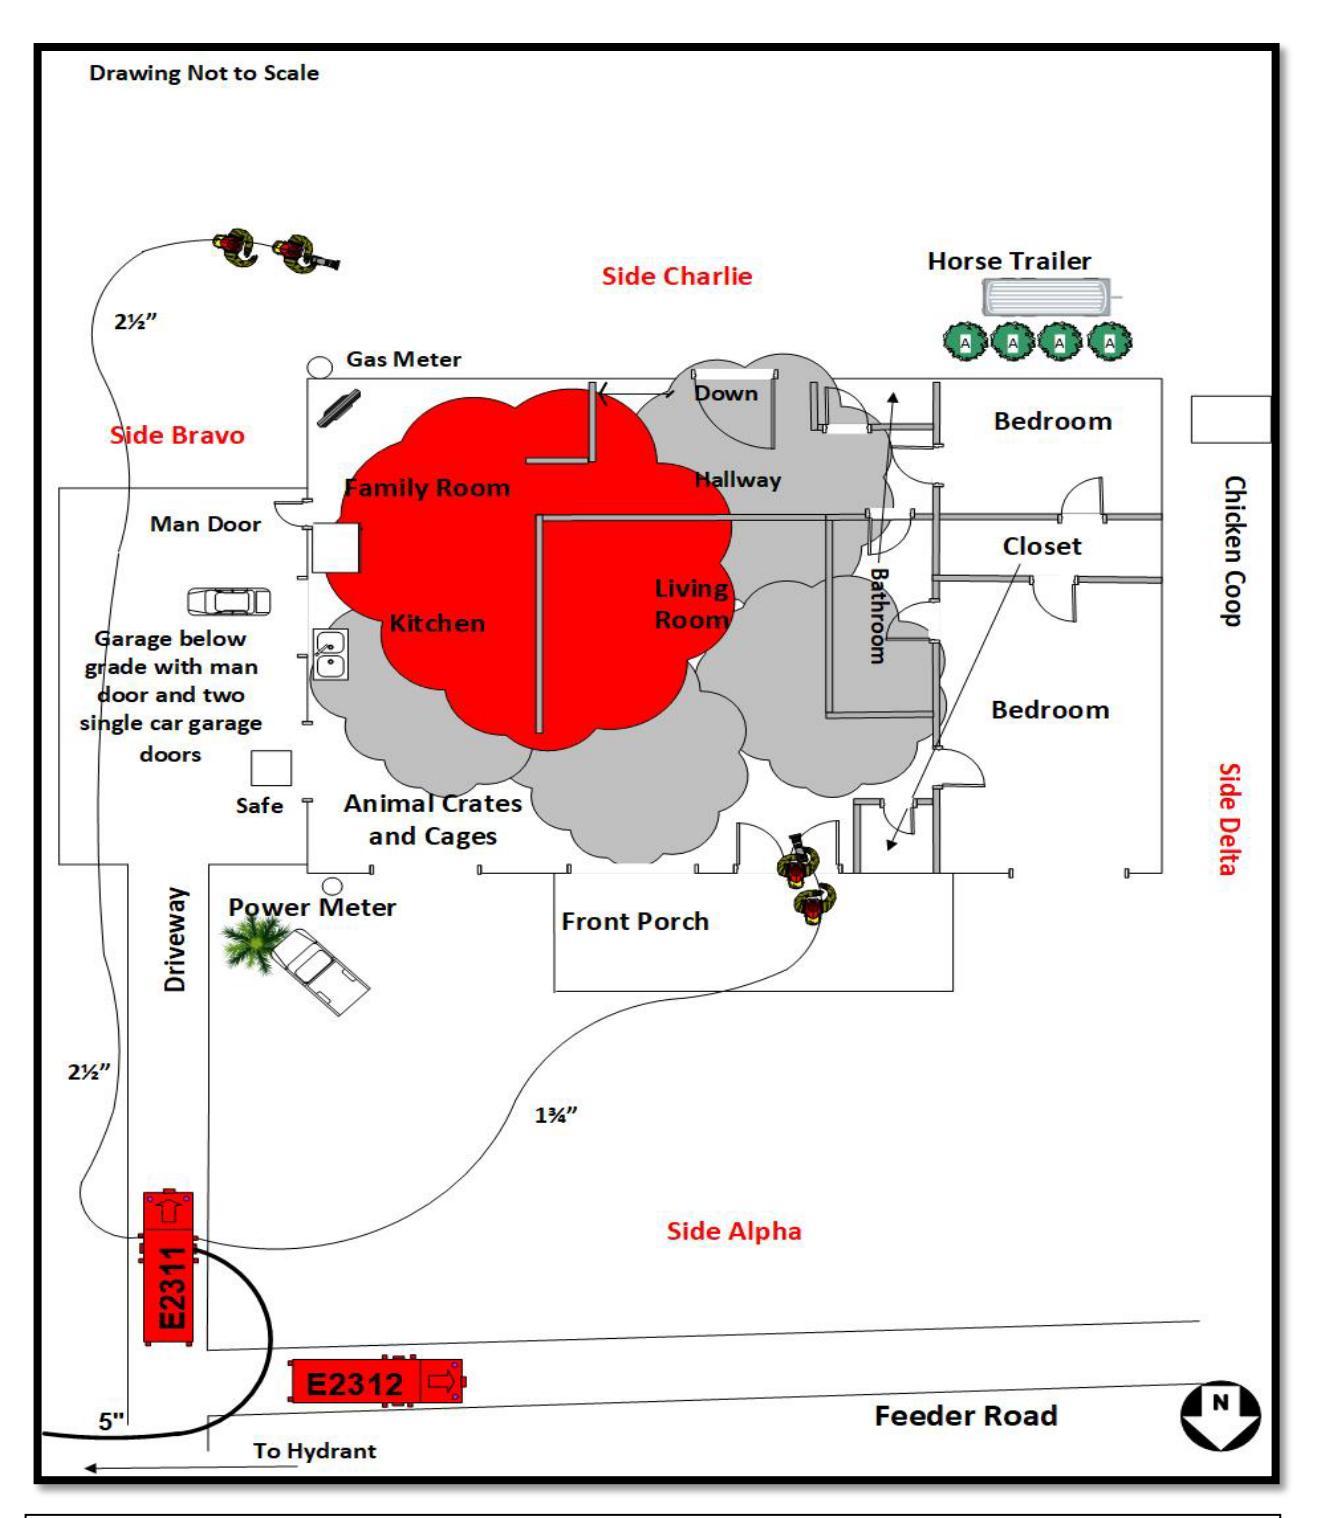
Diagram 2. Sketch of the fire suppression equipment and personnel on the nozzles of the hoselines.

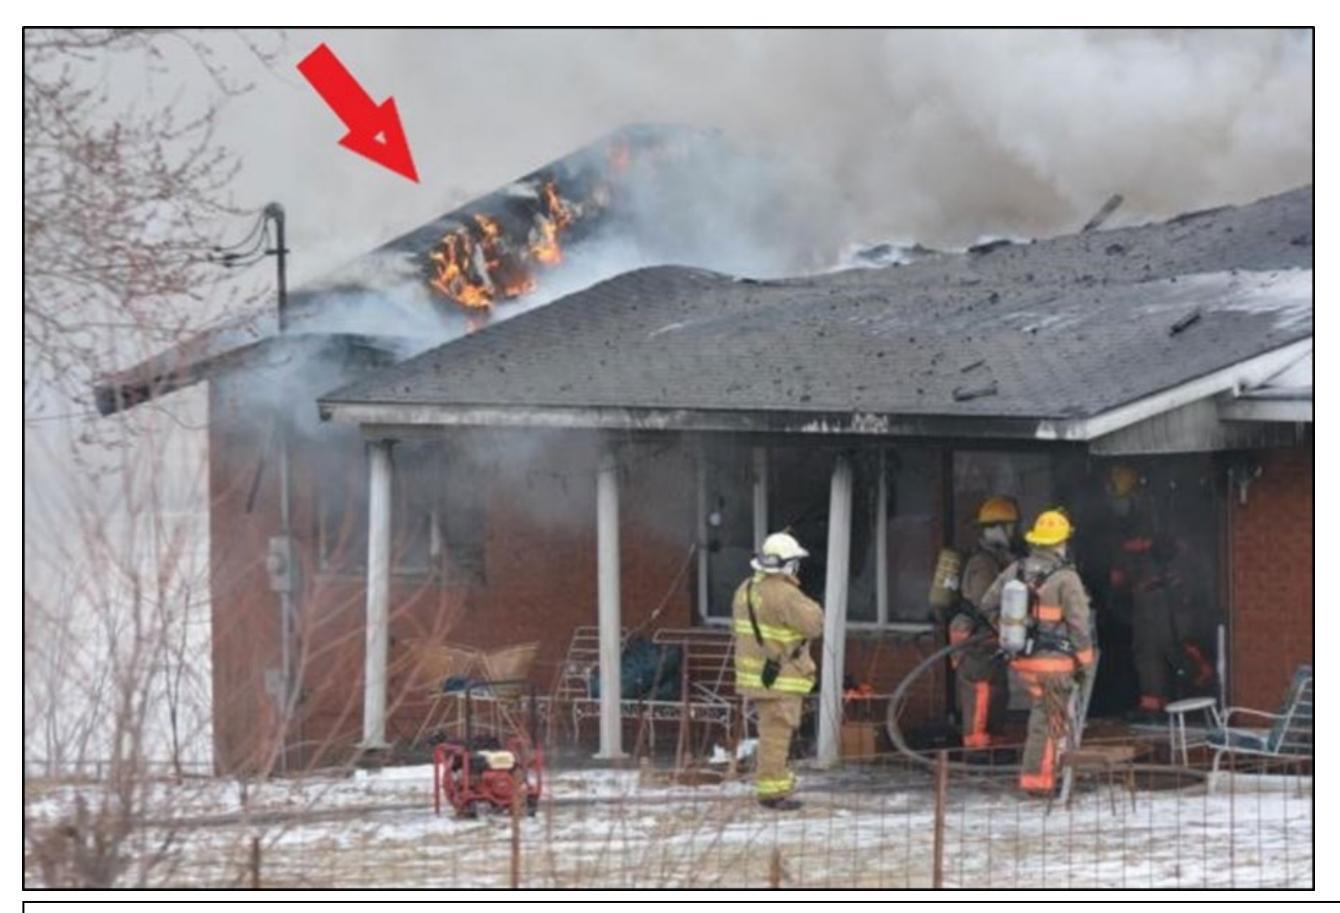
Photo 3. Firefighters conducting interior operations thru the front door even though approximately 45 to 50% of the roof had collapsed into the 1st floor. Red arrow indicates the end of the bricked gable rafter that eventually collapsed onto the driveway on Side Bravo. (Photo courtesy of the fire department.)

The roof on Sides Bravo and Side Bravo/Charlie corner roof continued to collapse onto the 1st floor (See Photo 3). Firefighters on the Side Bravo/Charlie corner could see the 1st floor starting to burn and collapsing into the lower-level garage/basement. This information was not reported to the IC.

Recommendation #1: Fire departments should ensure the IC establish collapse zones including exclusion zones or no-entry zones at defensive fires as needed due to dangerous or hazardous conditions.

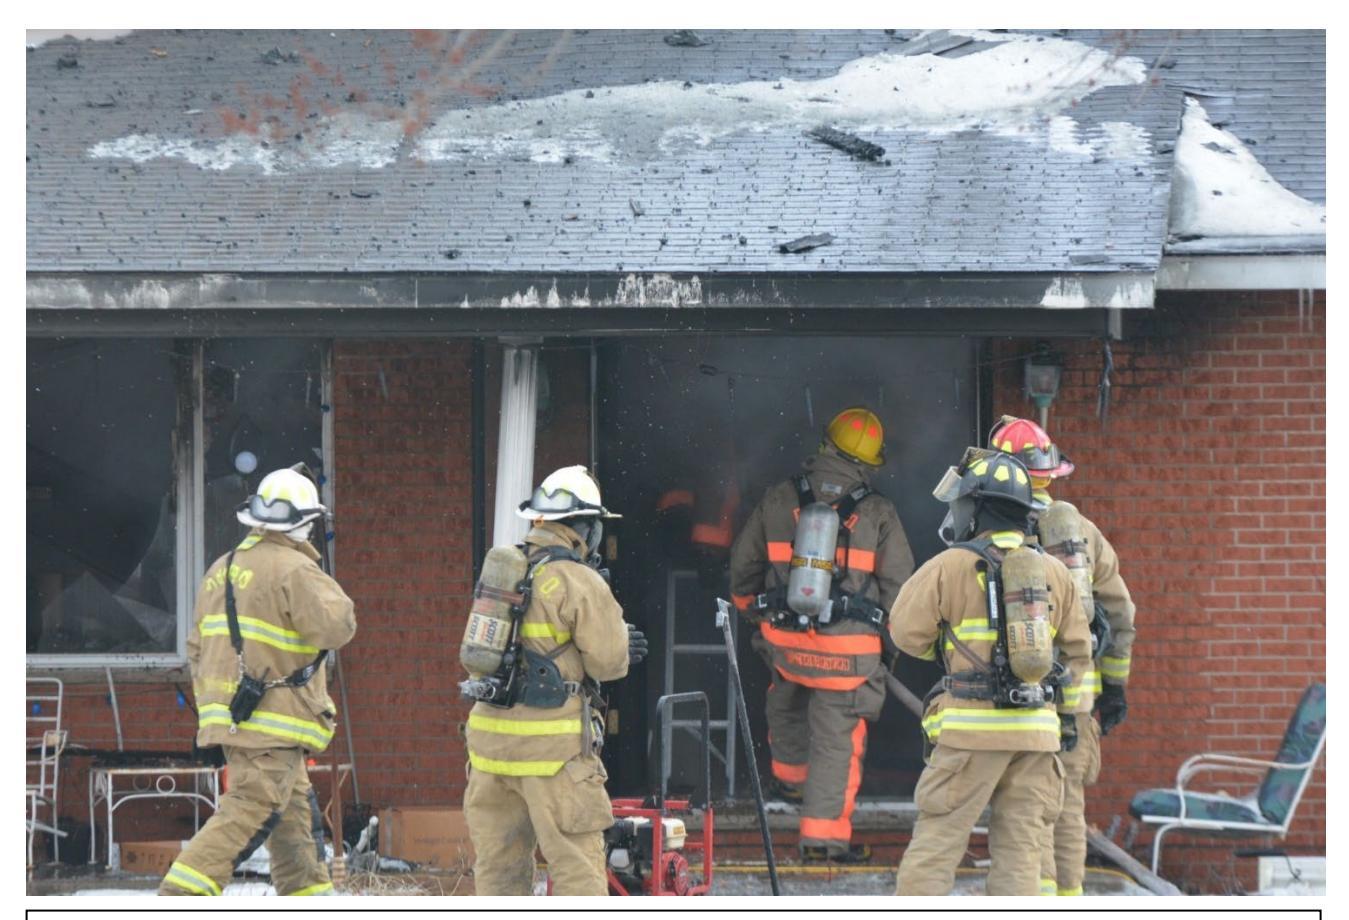
Photo 4. Crews are operating interior and using an attic ladder to gain access to the attic. Crews are attempting to stop the fire from spreading to Side Delta via the attic. (*Photo courtesy of the fire department.*)

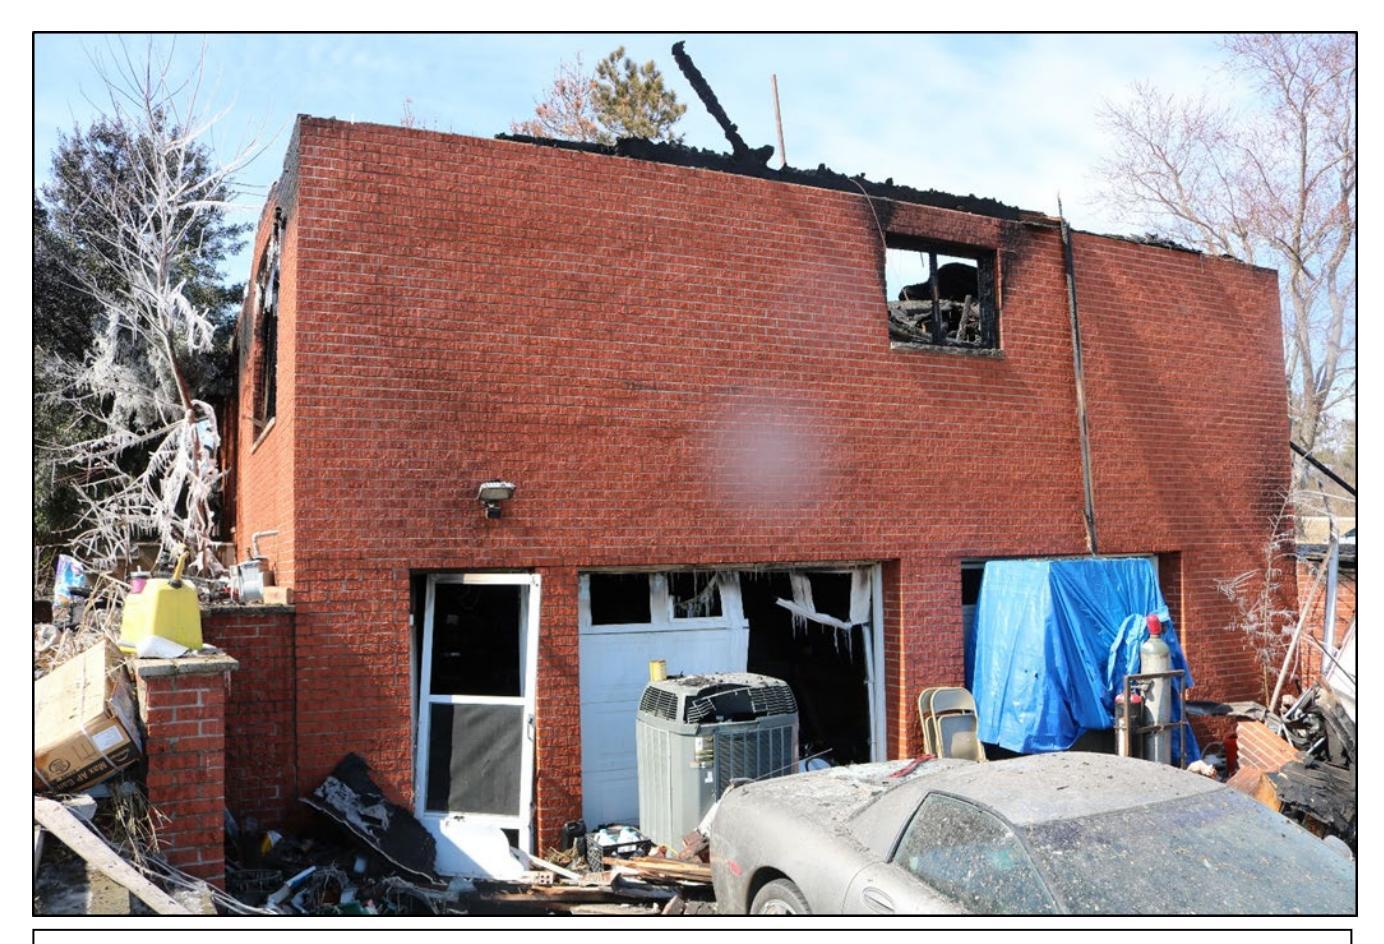
At approximately 1703 hours, the triangular brick gable rafter tipped outward as one piece fell outward onto the driveway on Side Bravo. It fell approximately 21 feet striking four firefighters (a captain and one firefighter from 1412; a captain and one firefighter from E2211). The fifth firefighter from E1412 was not injured.

Photo 5. Side Bravo showing below grade man door on the Side Bravo/Charlie corner, as well as the left and right garage doors. The photo was taken after the brick gable had collapsed. The right side of the garage door has been cut open. (Photo courtesy of the Office of the State Fire Marshal.)

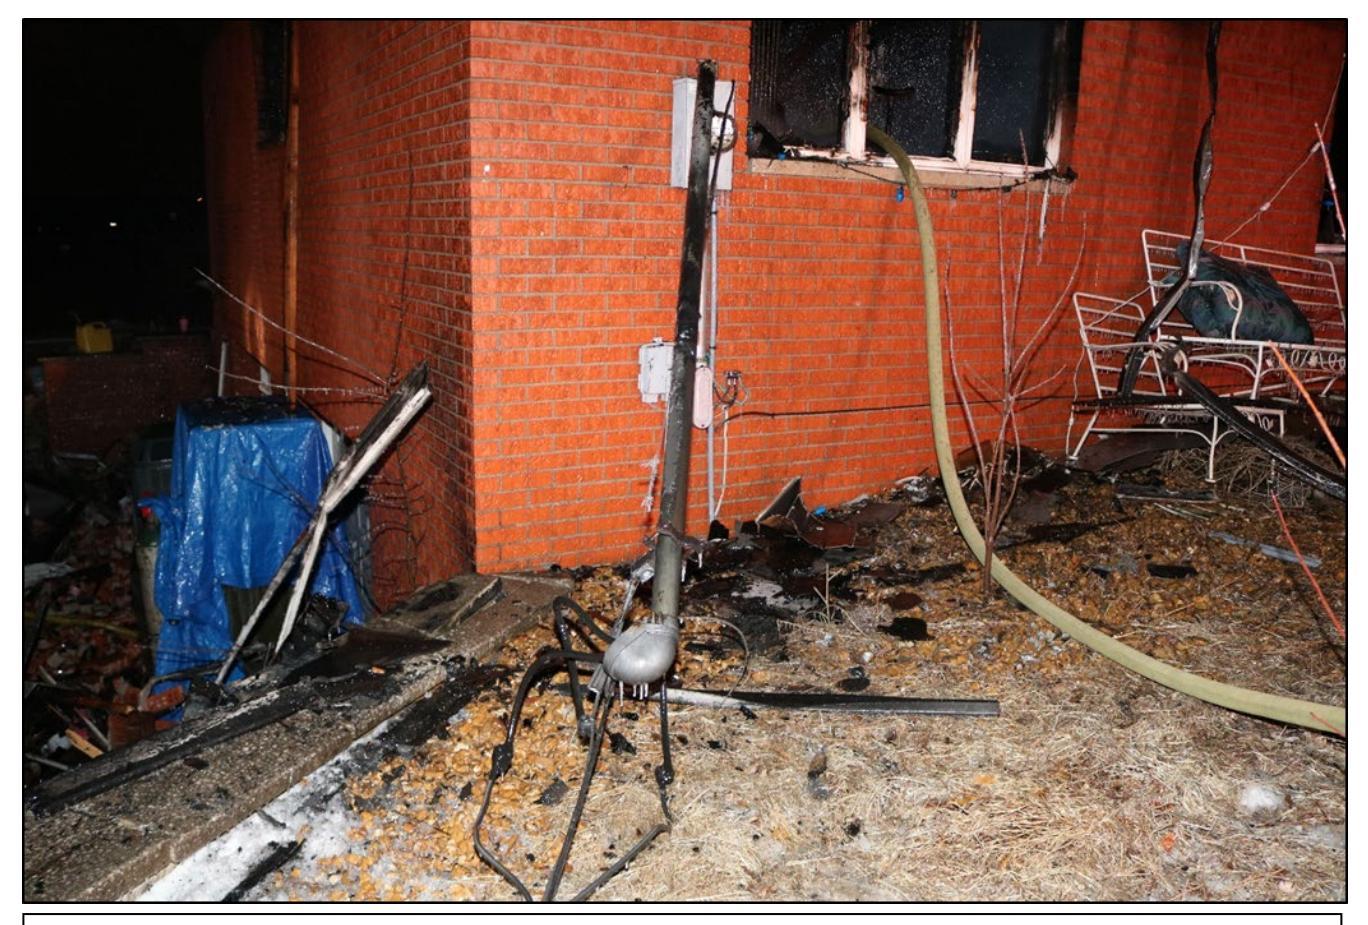
At approximately 1659 hours, the electrical service line that entered the house on the Side Alpha/Bravo corner, fell across the driveway (**Photo 6**). The IC requested dispatch to send the power company to the scene. Pending arrival of the power company at 1724 hours, the IC radioed on-scene firefighters about the downed line and assigned two firefighters from FPD 23 to safeguard the area. Power to the house was disconnected at 1732 hours.

Photo 6: Downed power line entering the home at the Side Alpha/Bravo corner. (*Photo courtesy of the Office of the State Fire Marshal.*)
