**IN-DEPTH SURVEY REPORT OF CARBON MONOXIDE EMISSIONS
AND EXPOSURES ON EXPRESS CRUISERS UNDER VARIOUS
OPERATING CONDITIONS**

January 2006

EPHB 289-11a

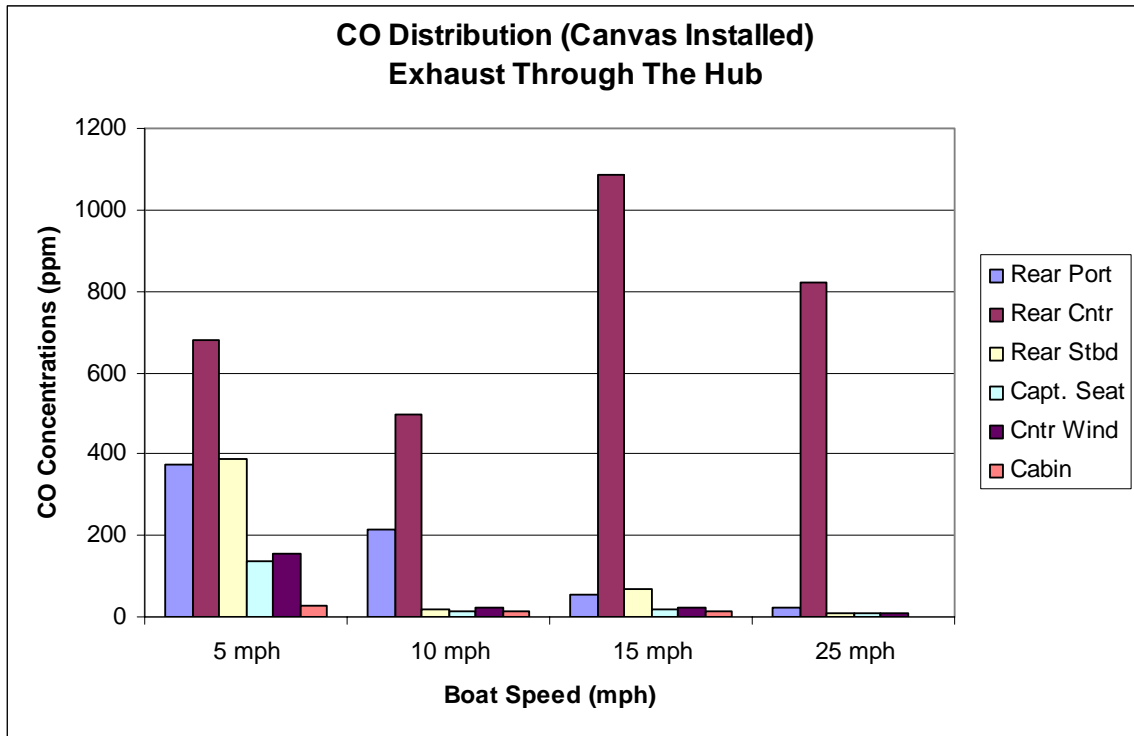
Figure 6: Boat 2 (30') Twin Mercruiser 5.0L Exhausting Through the Hub.

Exhibiting a trend seen on other tested boats, CO concentrations were higher on the stern of the vessel (near source), and tended to decrease toward the front of the vessel. The engine compartment consistently exhibited CO concentrations above 150 ppm, with a couple peaks at 1100 ppm; this might be indicative of a problem with the powered ventilation of this compartment. More details about this particular boat can be found in Tables 6 and 7 and the graphs in Figure 6.
