# Transmission of SARS-CoV-2 through Floors and Walls of Quarantine Hotel, Taiwan, 2021

We investigated a cluster of SARS-CoV-2 infections in a quarantine hotel in Taiwan in December 2021. The cluster involved 3 case patients who lived in nonadjacent rooms on different floors. They had no direct contact during their stay. By direct exploration of the space above the room ceilings, we found residual tunnels, wall defects, and truncated pipes between their rooms. We conducted a simplified tracer-gas experiment to assess the interconnection between rooms. Aerosol transmission through structural defects in floors and walls in this poorly ventilated hotel was the most likely route of virus transmission. This event demonstrates the high transmissibility of Omicron variants, even across rooms and floors, through structural defects. Our findings emphasize the importance of ventilation and integrity of building structure in quarantine facilities.

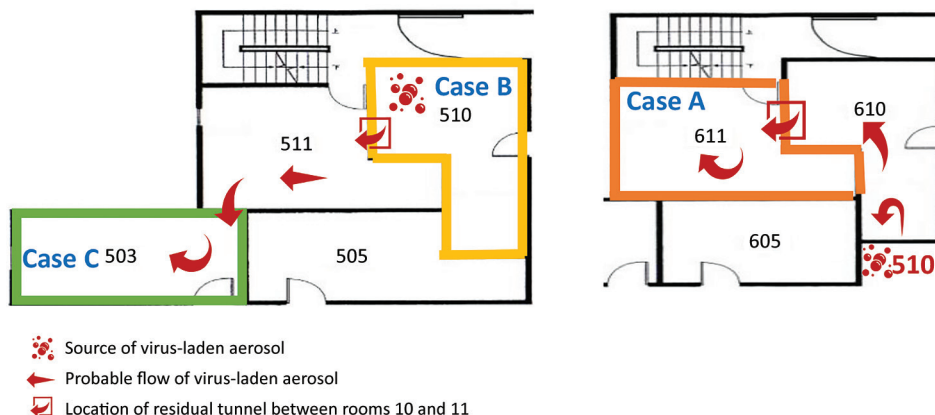
**Figure 3.** Simulation of probable air flow (arrows), implicating how virus-laden aerosol transported from the room of the primary case to the rooms of secondary cases in a quarantine hotel in Taipei City, Taiwan, December 2021. The bubbles symbol indicates the location of the source of transmission.

Room 611 (case A) and room 503 (case C) are not directly adjacent to room 510 (case B). We found truncated pipes above the ceiling in the room 510 bathroom, which might have connected to room 610, and a residual tunnel above the ceiling that might connect room 610 to room 611 (case A). A residual tunnel in

the same location was also found in the middle of room 510 (case B) and room 511, and another tunnel connected room 511 and room 503 (case C). Because the air conditioners in each room are constantly pushing the air, the airflow carries the virus-laden aerosol. This aerosol might penetrate wall defects or go through old tunnels to reach other rooms (Figure 3), even nonadjacent rooms that appear to be independently isolated. When exhaust fans are not running at the same time (persons usually turn them on only when using the bathroom), it can result in pressure differences between rooms.

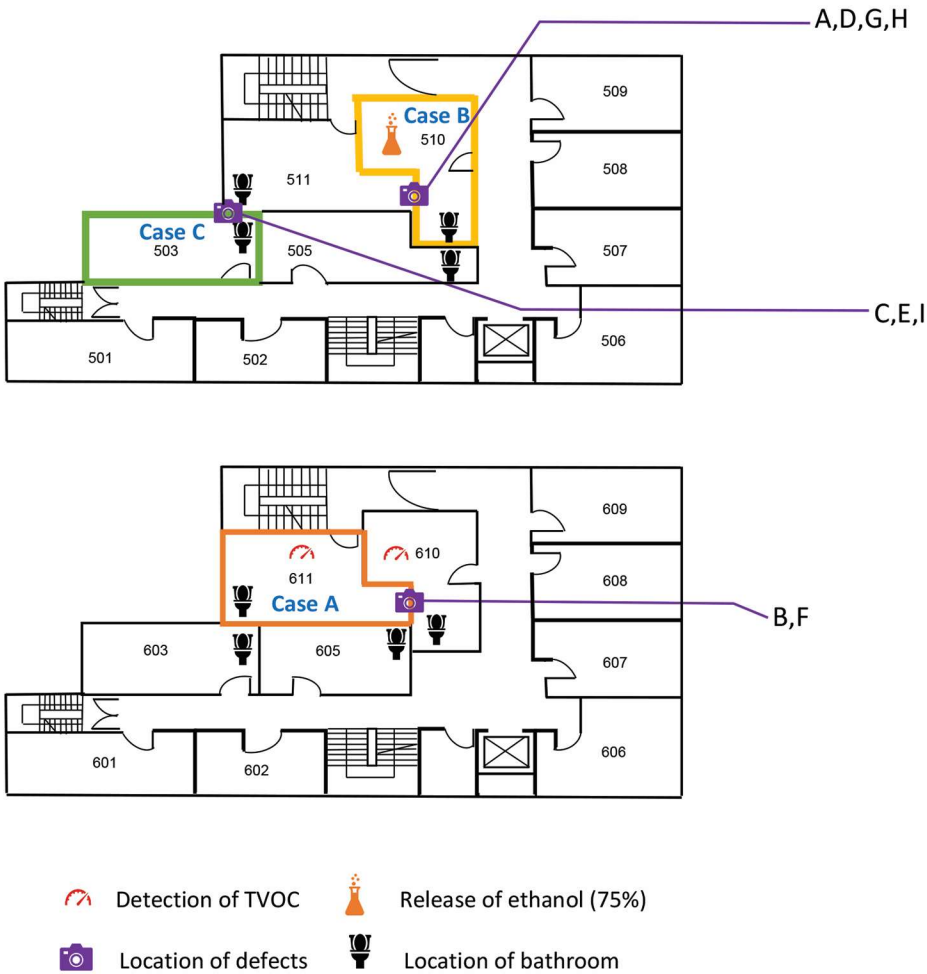
**Appendix Figure 1.** Layout of floors 5 and 6 of a quarantine hotel in Taipei City, Taiwan, December 2021, showing the relative locations of the tracer-gas experiments. Symbols indicate where investigators released ethanol (75%), location of the bathrooms, and where tracer gas was detected.

Ethanol (75%) from a spray can of hand sanitizer was used as an indicator. Ethanol is a volatile organic compound and is detectable by the air quality monitor. The volume of a single press of the spray releases  $\approx 0.9$  mL of ethanol. To simulate the real situation during the cluster, we turned on the bathroom exhaust fan and the air conditioner of each test room during the experiment. We released ethanol with 10–15 presses in room 510 (case B, suspected index patient) and took measurements in room 610 and room 611 (case A).

Before the tracer-gas experiment, the concentrations of TVOC in the air were extremely low. After the ethanol (75%) was released from room 510, a detectable concentration of TVOC was observed in rooms 610 and 611 (Table).

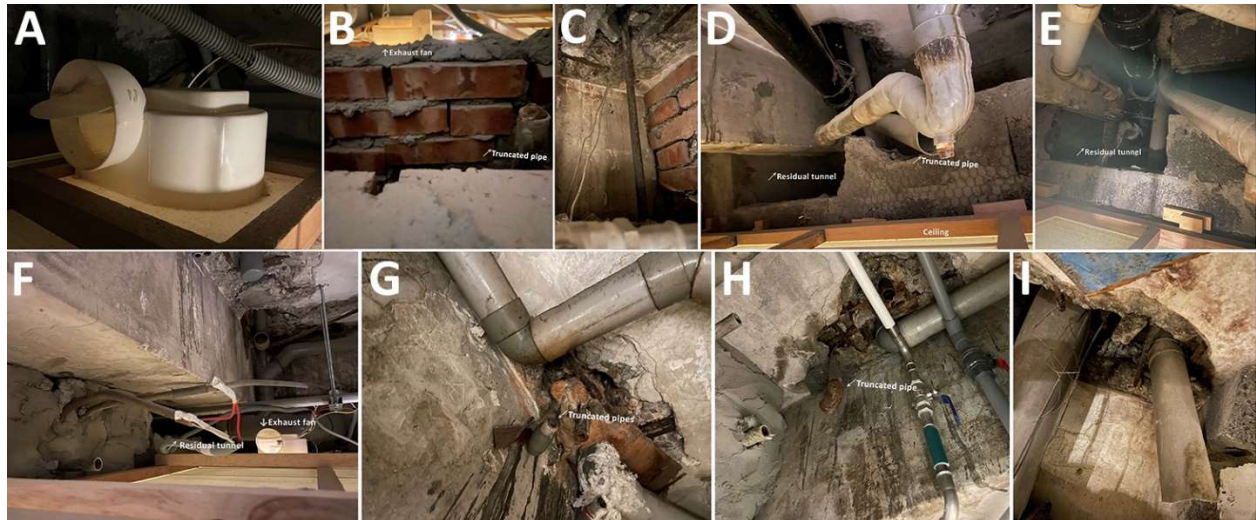
**Appendix Figure 2.** Photographs showing the tunnel between rooms and the structural defects between floors 5 and 6 of a quarantine hotel in Taipei City, Taiwan, December 2021. (A) Exhaust fan without collecting tube; (B) Bathroom, room 611. The wall above the ceiling was made up of bricks and cements in a rough way, truncated pipe from nowhere, and exhaust fan without a collecting tube; (C) Room 511. Wall defects with naked rebar; (D) Tunnel between room 510 and room 511 and truncated pipe (might connect to room 610); (E) Tunnel between room 503 and room 511; (F) Tunnel between room 610 and room 611; (G and H) Truncated pipes between room 510 and room 610; (I) Wall defects between room 503 and room 511.

We found that partition walls above the ceiling, made of bricks and cement, had defects or gaps, mostly around pipes and electrical wires (Appendix Figure 2, panels B, C). Residual tunnels connected rooms 410 and 411, 510 and 511, 610 and 611, and 503 and 511; these tunnels might have been left when old pipes were removed (Appendix Figure 2, panels D, E, F). We also noted some abandoned and truncated pipes with protruding openings underneath the bottom of the bathtub in room 610 when we checked the ceiling of room 510 (Appendix Figure 2, panels G, H). We also noted some defects located in the partition wall between rooms 503 and 511 (Appendix Figure 2, panel I).
