**ORAU TEAM
Dose Reconstruction
Project for NIOSH**

**Potential Neptunium Exposure to Plutonium
Fuel Facility Construction Workers in
Building 235-F at the Savannah River Site**

ORAUT-RPRT-0080

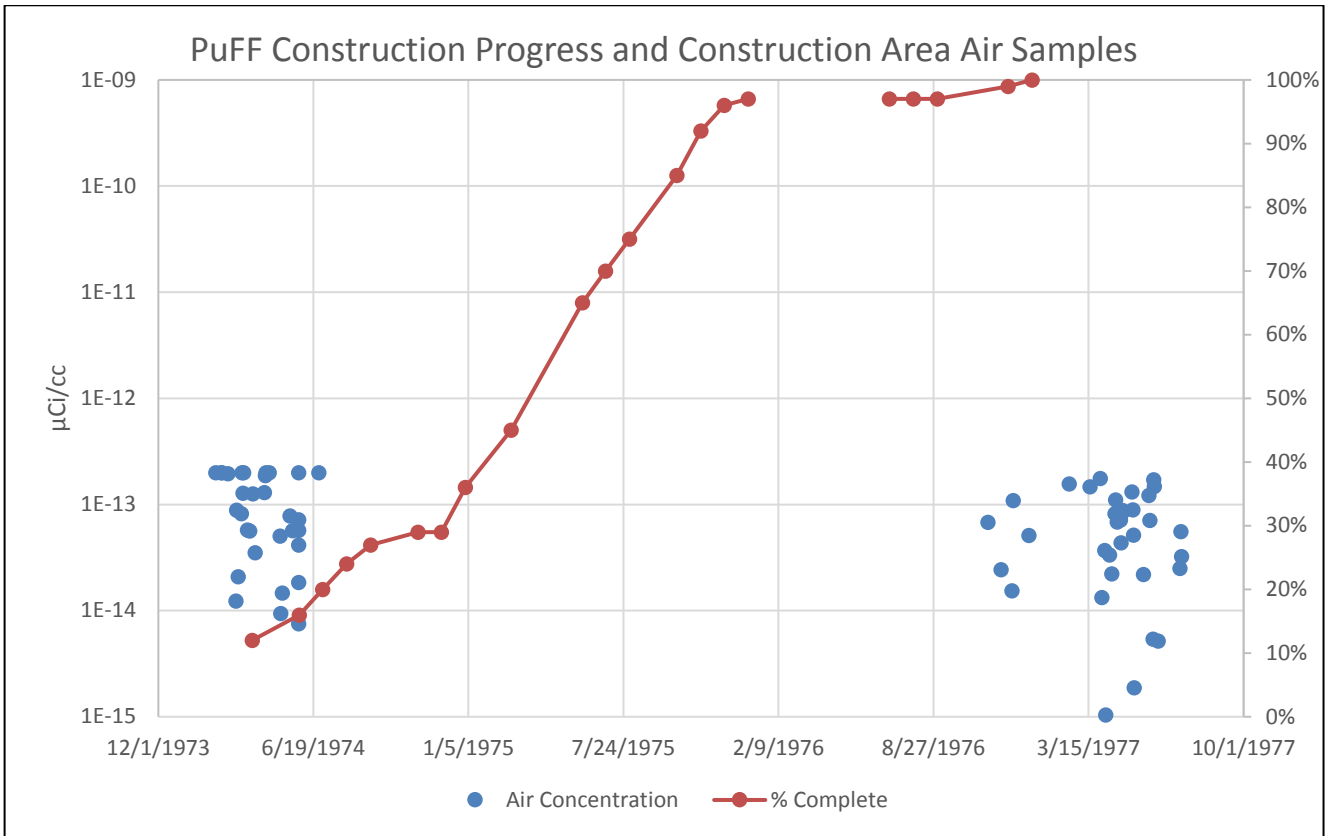
Figure 3-1. PuFF construction progress and air sample results in the construction area (based on Table D-1).

As seen in Figure 3-1, construction in 1974 proceeded at a steady but slower pace than in 1975. During 1974, the effort consisted of preparatory work including removing existing structures, pouring foundations for columns and walls (Figure E-1), embedding conduit, stripping floor coverings, installing the concrete air-duct housing on the top of Building 235 (Figures E-2 and E-3), installing high-efficiency particulate air (HEPA) filter housings, pouring the concrete base under the cells and the walls of the trench under the cells, pouring concrete for the building-supply fans and air conditioning equipment, installing the electrical conduit from the substation, installing base plates for the front-shield walls and framing for the back-shield walls, and refinishing the stainless-steel cell

liners. This work accomplished during 1974 made up approximately 29% of the overall construction effort.

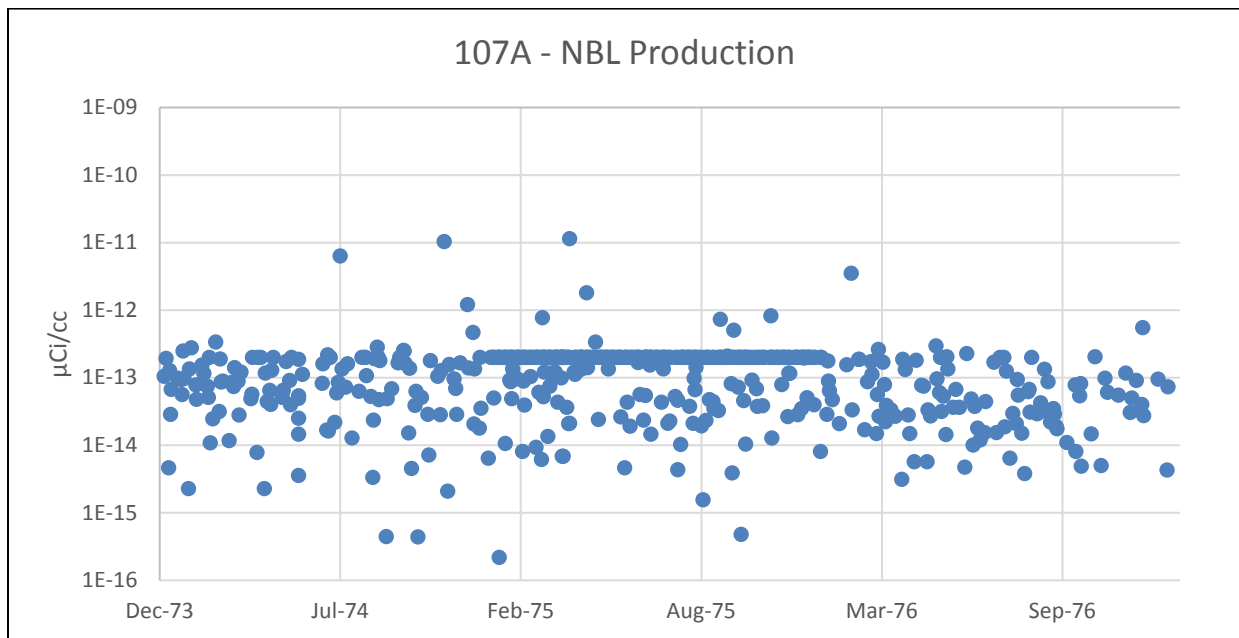
Figure A-4. Room 107A air concentrations, December 28, 1973, to January 28, 1977.

Four results exceeded the administrative limit of 2×10^{-12} $\mu\text{Ci}/\text{cm}^3$. These had the following notations on the air sample forms:

- On 07/16/1974, $6.38\text{E}-12$: "Air activity to 400×10^{-12} acpm/cc air during glove change."
- On 11/08/1974, $1.04\text{E}-11$: "Glove Ruptured. Floor cont. to 1×10^5 trans."
- On 03/27/1975, $1.15\text{E}-11$: "Glove rupture on 4-12 shift."
- On 02/02/1976, $3.55\text{E}-12$: "High air activity during glove change. 165×10^{-12} uCi/ml."

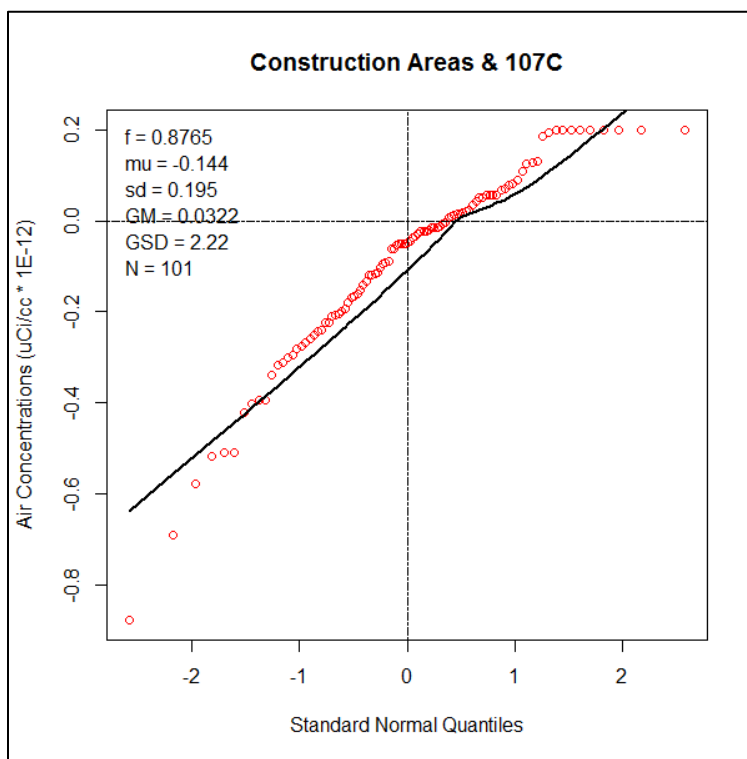
Provided on the graphs are statistical values resulting from the models:

- f is the fraction of the model that is fit with the normal distribution.
- mu is the mean of the normal distribution.
- sd is the standard deviation of the normal distribution.
- GM is the geometric mean of the lognormal distribution.
- GSD is the geometric standard deviation of the lognormal distribution.
- N is the number of results for that location; the number of red dots in the plot.

Figure C-1. Air concentrations against standard normal quantiles, construction areas and Room 107C.

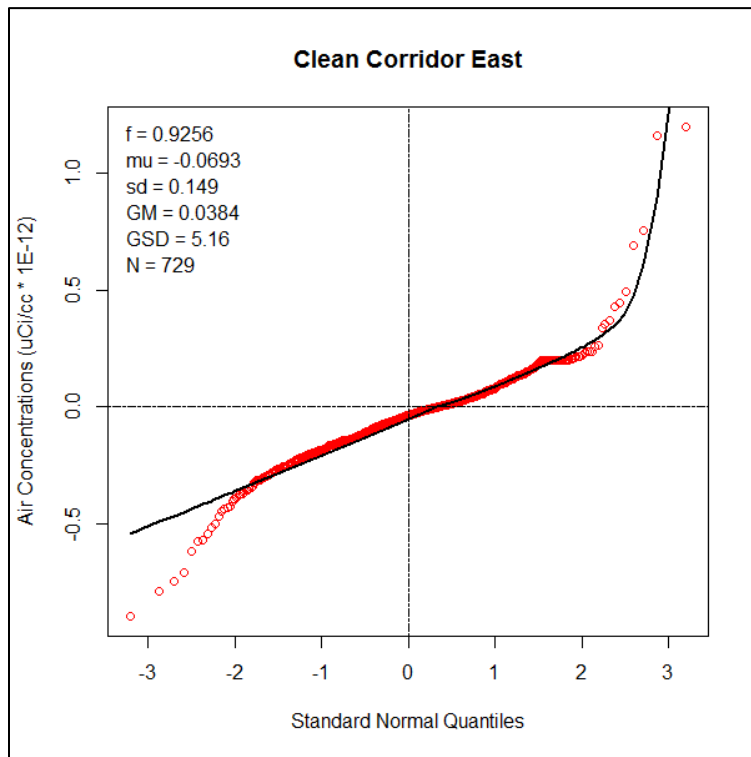
Figure C-2. Air concentrations against standard normal quantiles, Clean Corridor East.

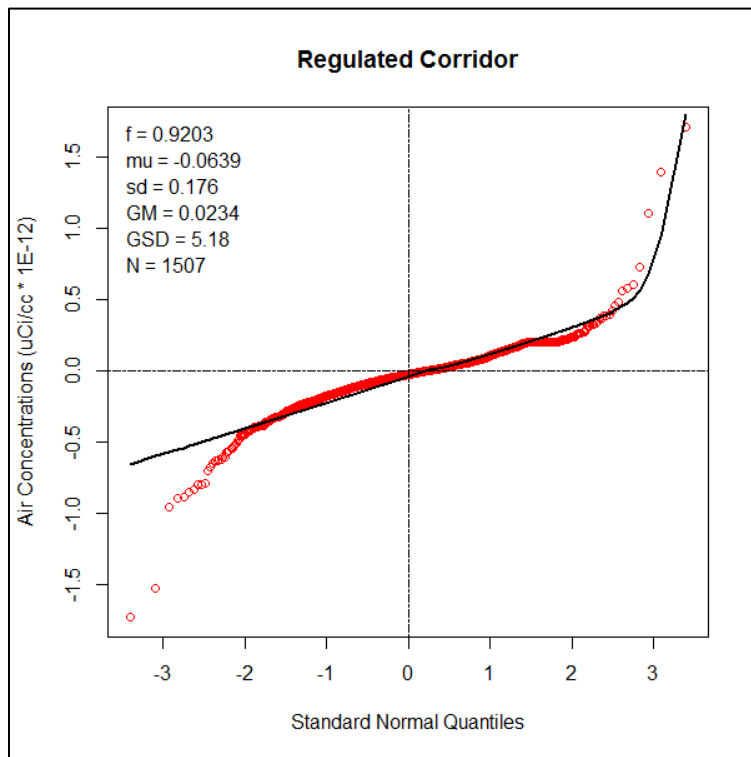
Figure C-3. Air concentrations against standard normal quantiles, Regulated Corridor.

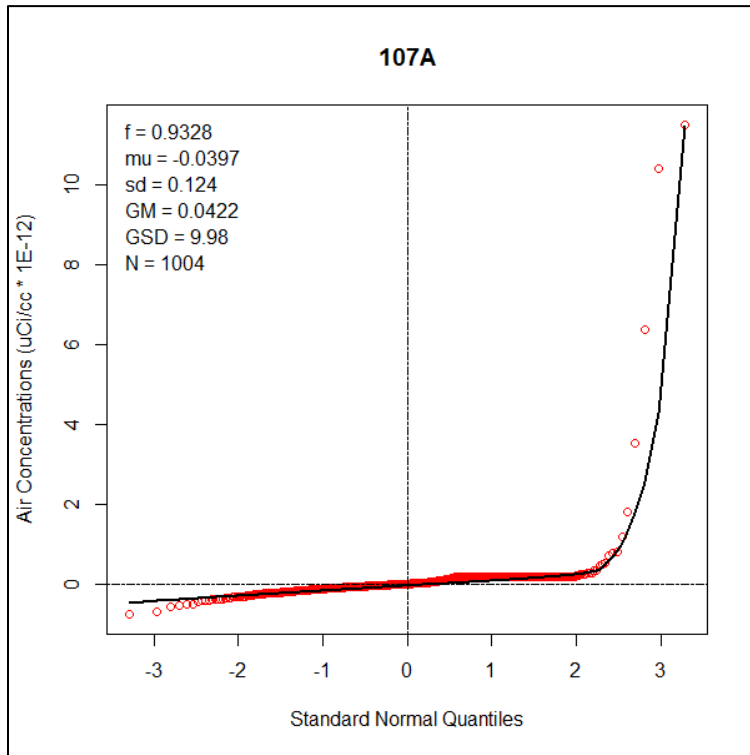
Figure C-4. Air concentrations against standard normal quantiles, Room 107A.

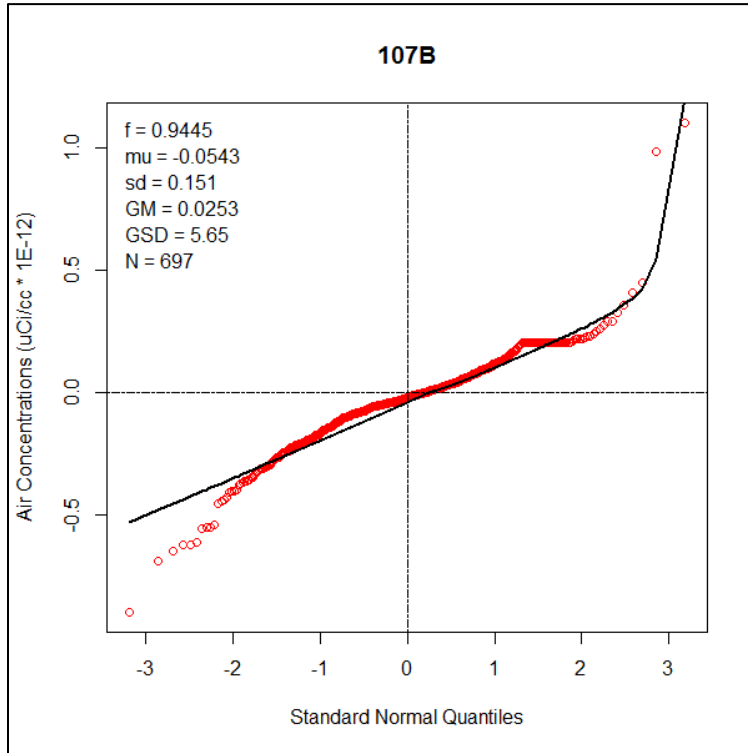
Figure C-6. Air concentrations against standard normal quantiles, Room 107B.

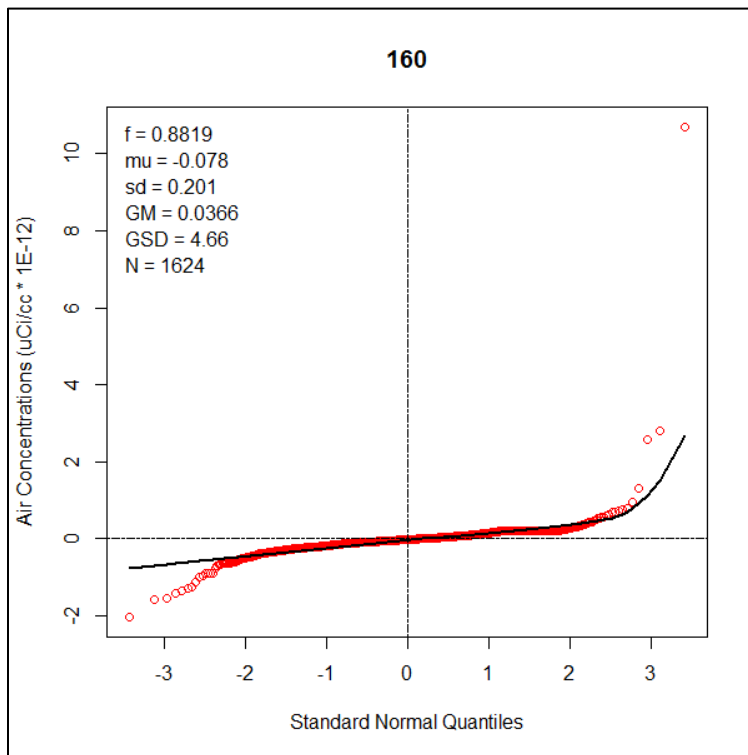
Figure C-7. Air concentrations against standard normal quantiles, Room 160.

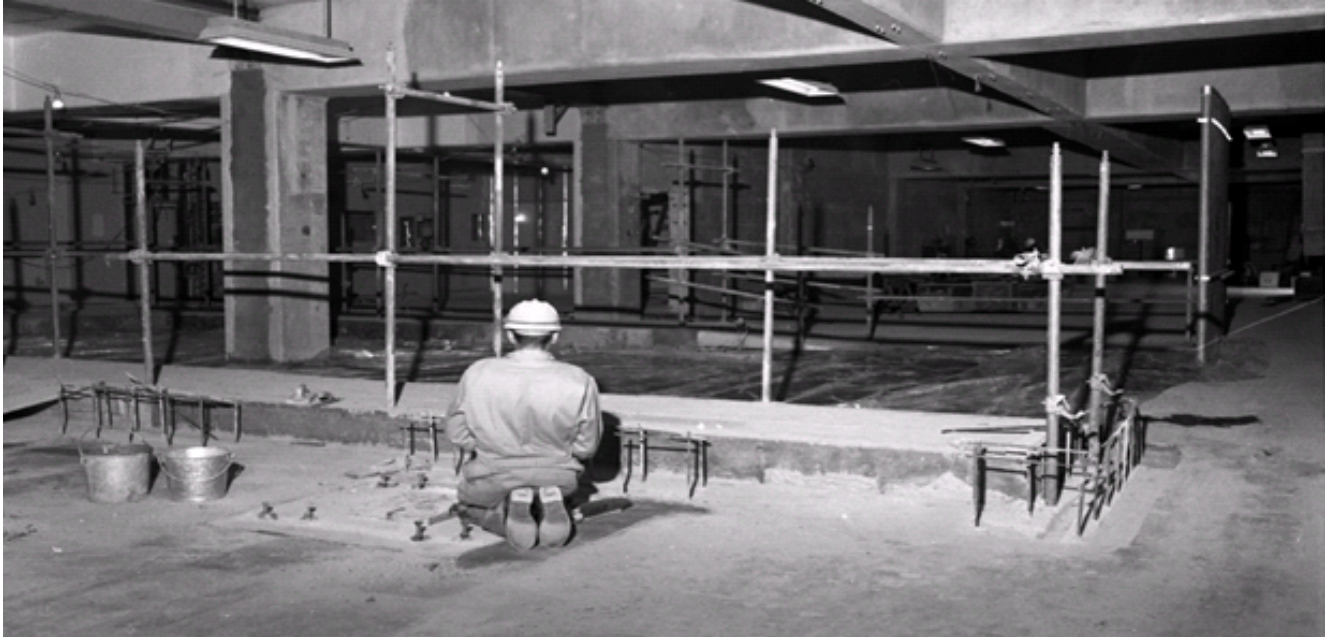
Figure E-1. Worker readying to pour concrete, April 4, 1973 (DuPont 1973b). Note that the worker does not appear to be wearing protective clothing for the prevention of radioactive contamination (DPSPF 17880-4).

The following photographs show the PuFF facility in various stages of development. As shown, the construction areas were clean with little to no debris. There are no radiation barriers or signs in the photographs, which indicates they were not radiation or contamination areas. The workers in Figures E-1 and E-4 appear to be in regular rather than protective clothing.

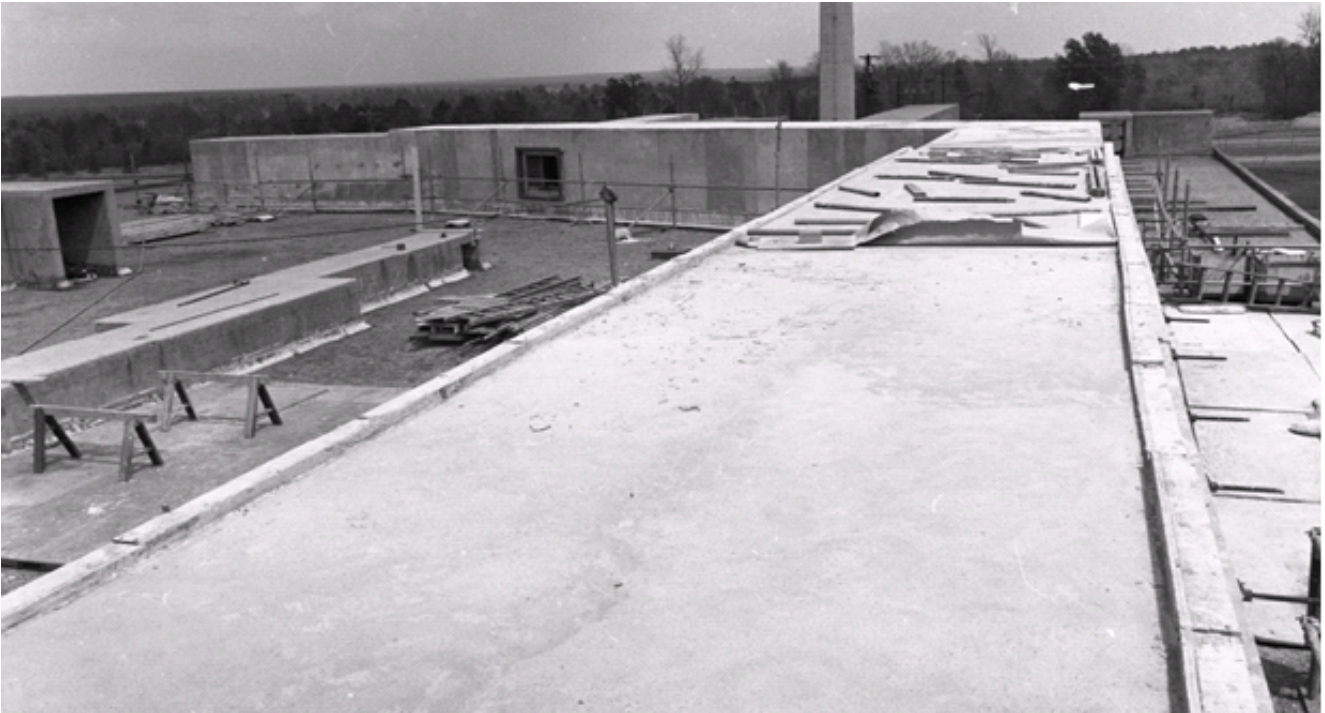
Figure E-2. Roof above the PuFF Facility in Building 235-F, April 4, 1973 (DuPont 1973c). Maintenance access and exhaust piping were installed later (DPSPF 17880-11).

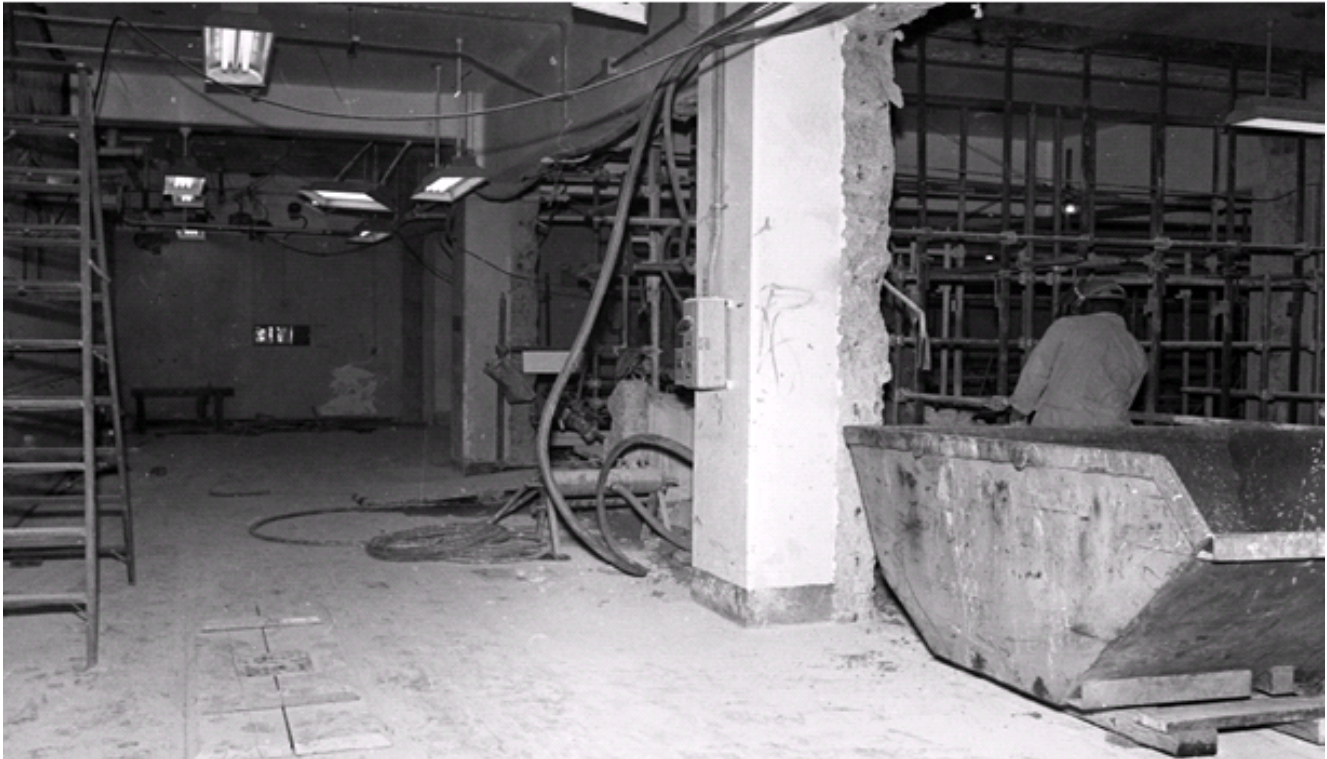
Figure E-4. Glovebox housing area during construction, December 11, 1973 (DuPont 1973e). Note that the worker does not appear to be wearing protective clothing for the prevention of radioactive contamination (DPSPF 17564-8).

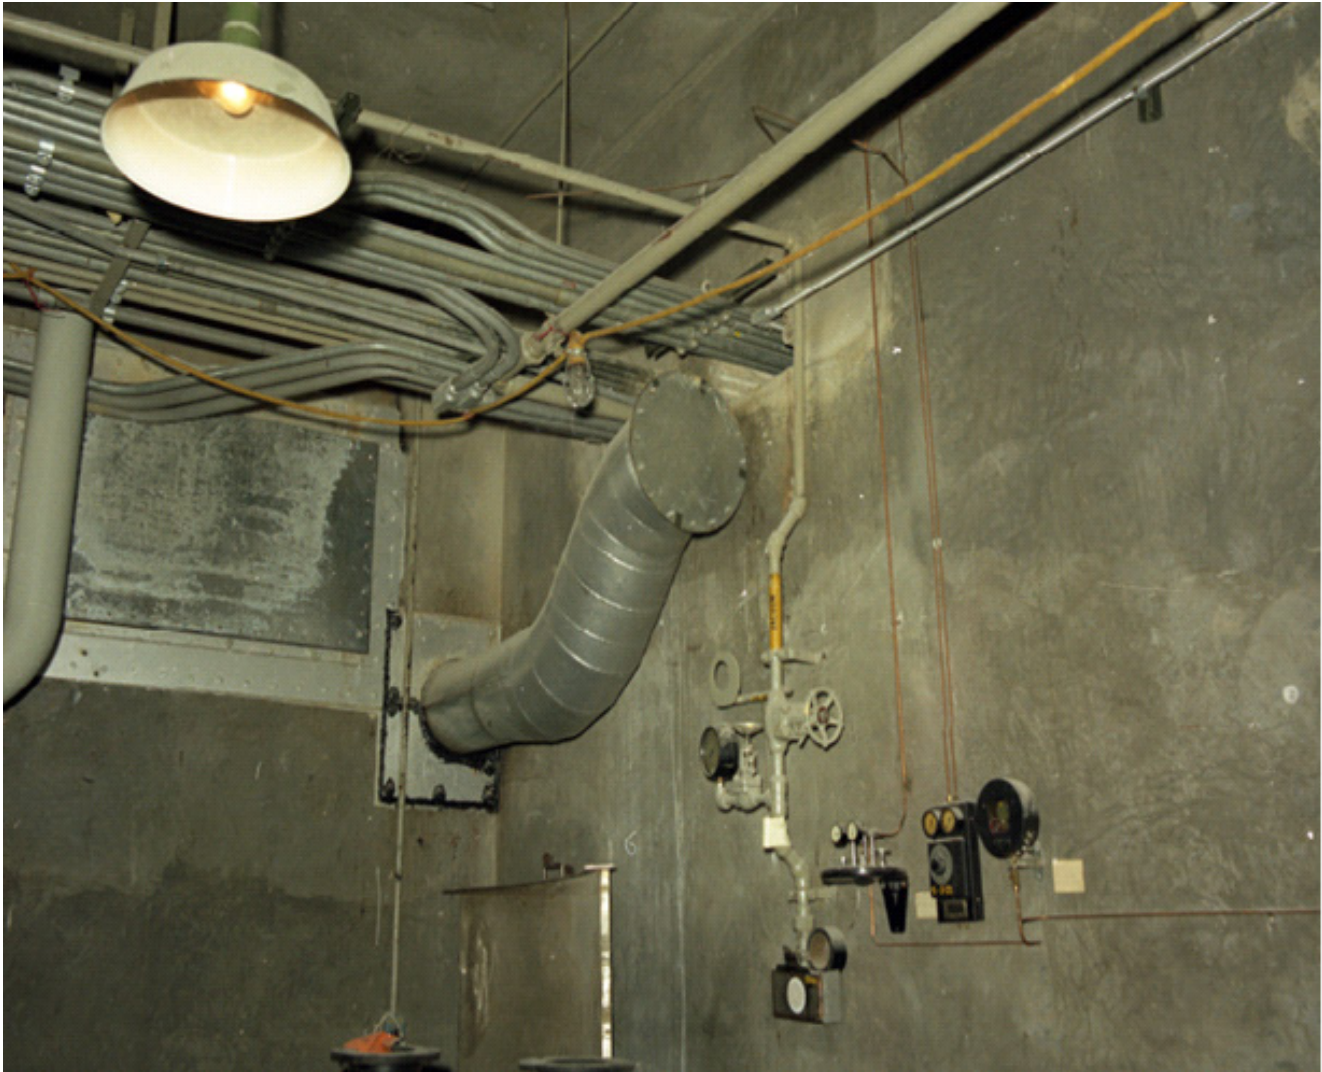
Figure E-8. Duct work in construction area, November 20, 1976 (DuPont 1976g). Note the duct to other parts of the building is closed off (DPSPF 18678-4).

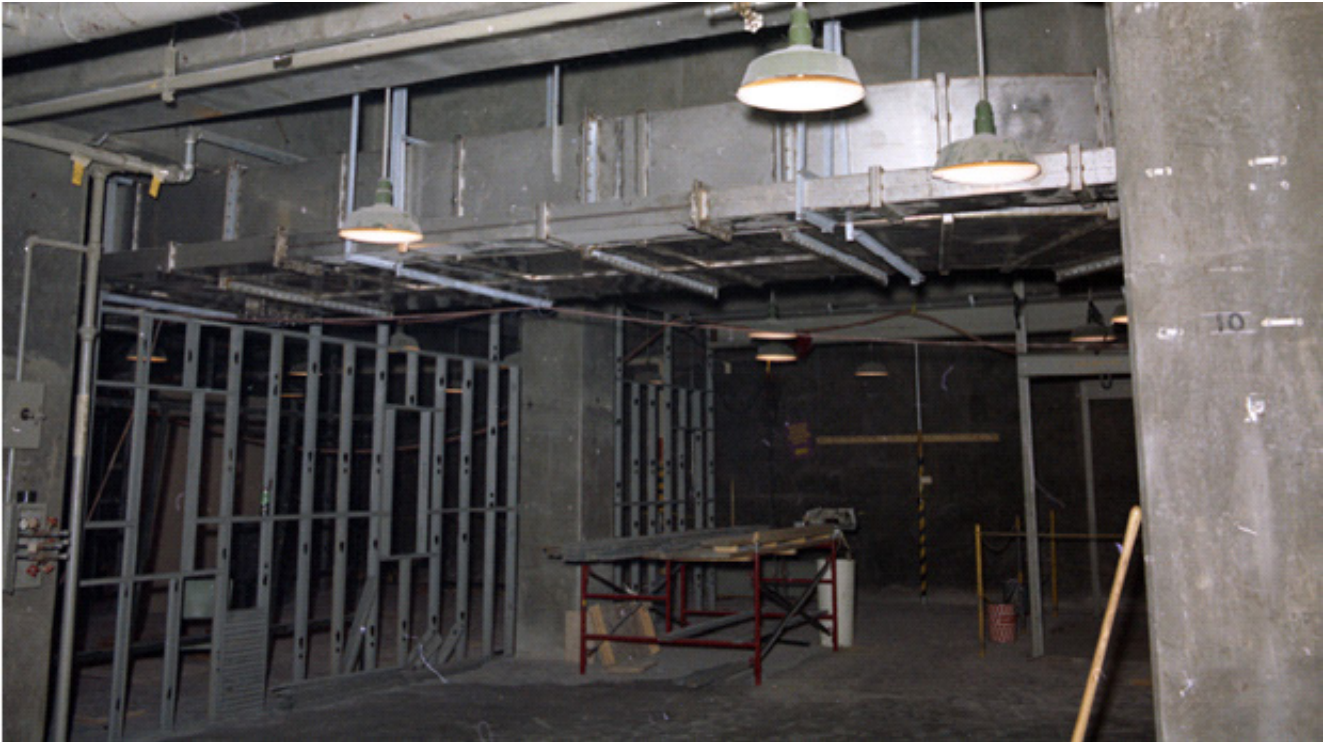
Figure E-9. Room construction, November 20, 1976 (DuPont 1976h). It is not clear what this particular room was used for. Note the clean conditions in the work area (DPSPF 18678-11).

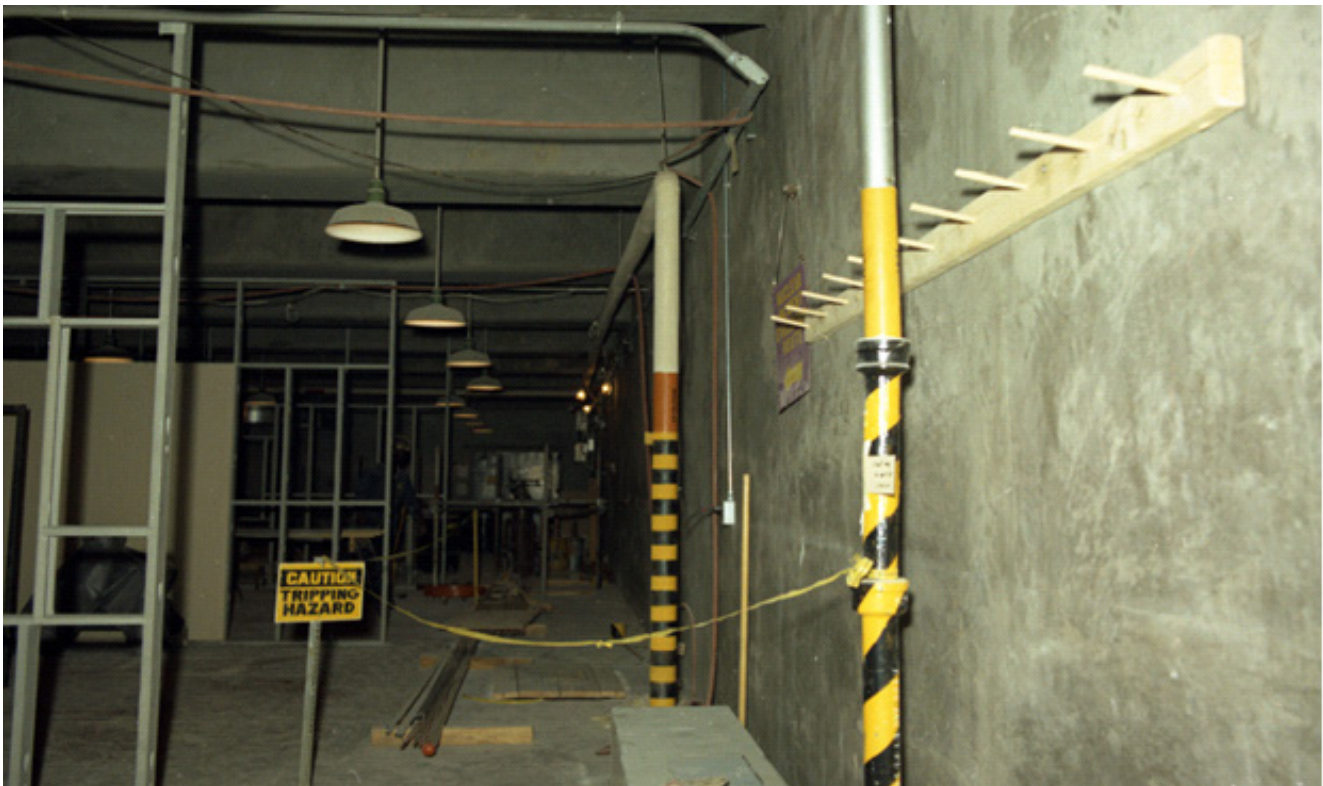
Figure E-10. Room construction demonstrating safety awareness and hazard markings, November 20, 1976 (DuPont 1976i) (DPSPF 18678-24).
