Officer Struck By a Motorhome While Establishing Temporary Traffic Control on Interstate—Tennessee (NIOSH LEO 2016-01)

Law Enforcement Officer
Vehicle Struck-by Investigation

Division of Safety Research 1005 Wilkowdale Road Morgantown, WV 26505 304 285 5918
LEO 2016-01
November 7, 2017

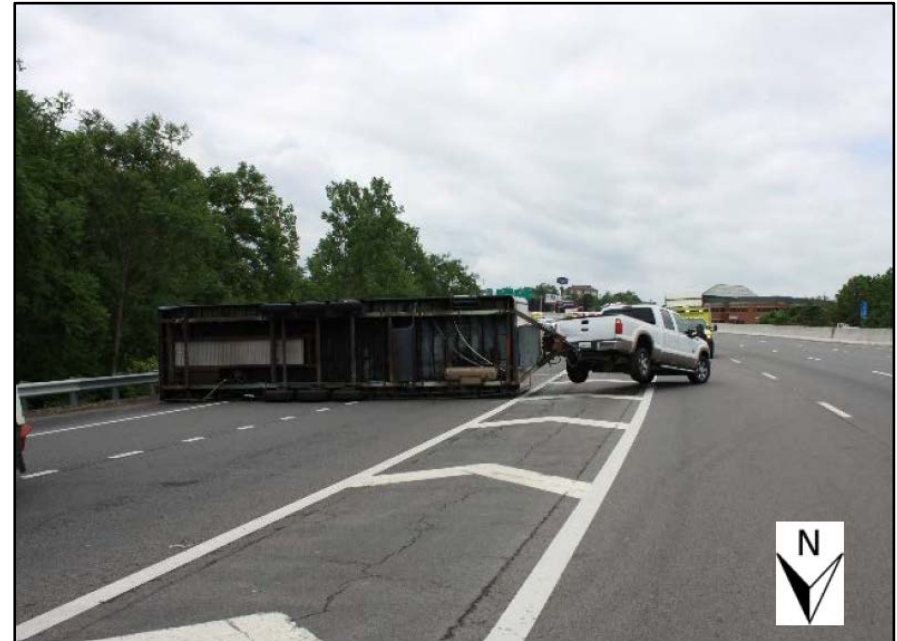
- 25-year-old police officer was fatally injured when he was struck by a motorhome and dragged under the trailer it was pulling on a four-lane interstate highway.
- The officer had responded to a jackknifed and overturned pickup/trailer combination that was blocking an entrance ramp to the interstate northbound lanes.

Initial incident the officers responded to, looking southbound in the northbound lanes.

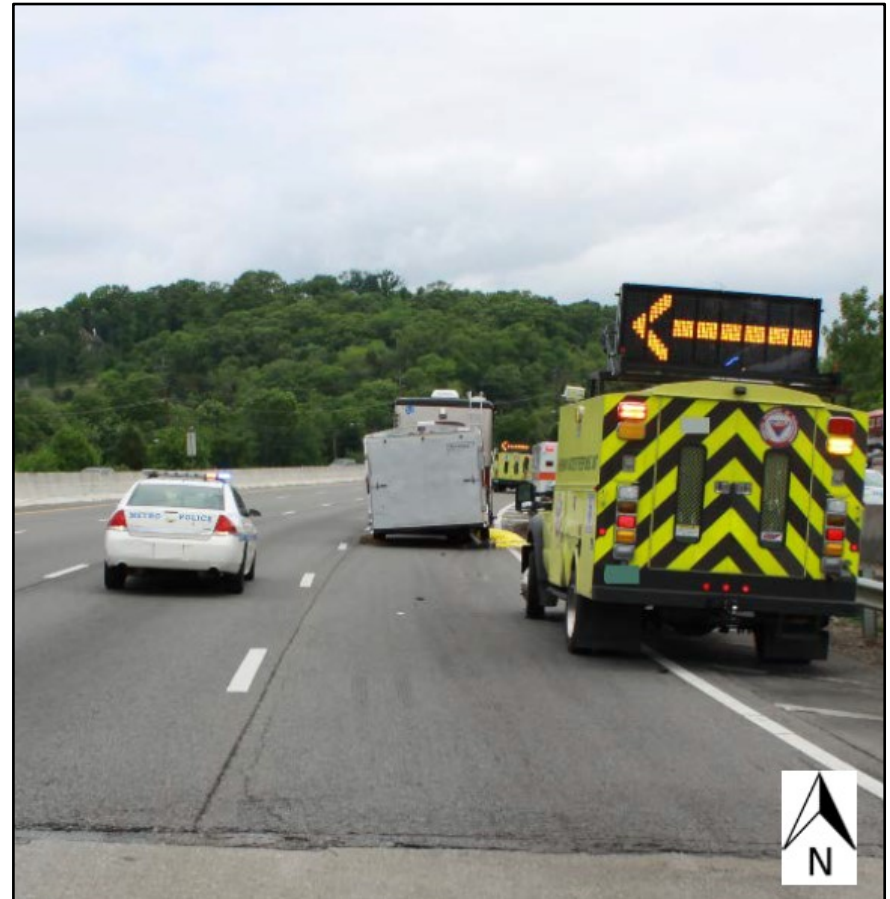
- To assist with traffic control, the officer positioned his patrol unit south of the entrance ramp in lane three, and a Tennessee Department of Transportation help truck operator positioned his vehicle next to the patrol unit to block the shoulder and lane four.

The incident scene showing the position of the patrol unit and the help truck.

- The officer and help truck operator were standing between their vehicles, when a motorhome pulling a trailer approached the scene in lane three (lane second from the right).
- The motorhome and trailer sideswiped the help truck and struck the officer. The officer was dragged underneath the trailer for 116 feet before the motor home came to a stop. He died at the scene.

- Motorhome driver did not slow down and merge left.
- Positioning of patrol unit.
- Law enforcement officer standing in partially open lane.
- Law enforcement officer looking away from oncoming traffic; discussing traffic control with help truck operator.
- Delay in updating dynamic message sign.

- State, county, and municipal authorities should consider promoting public awareness campaigns to inform motorists of the risks that law enforcement officers face while operating along the roadside and of the need to follow “Move Over” laws.
- Law enforcement officers and other emergency responders should identify and move to a safe area within an established temporary traffic control zone that minimizes their exposure to oncoming vehicle traffic and should maintain situational awareness.

- Law enforcement agencies should consider developing a standard operating procedure that includes guidance on how to properly establish a temporary traffic control plan, including advance warning and transition areas for highway/roadway emergency incidents.
- Emergency responders should consider positioning patrol units and other emergency vehicles as they arrive on-scene to maximize the protected work zone for the emergency responders.

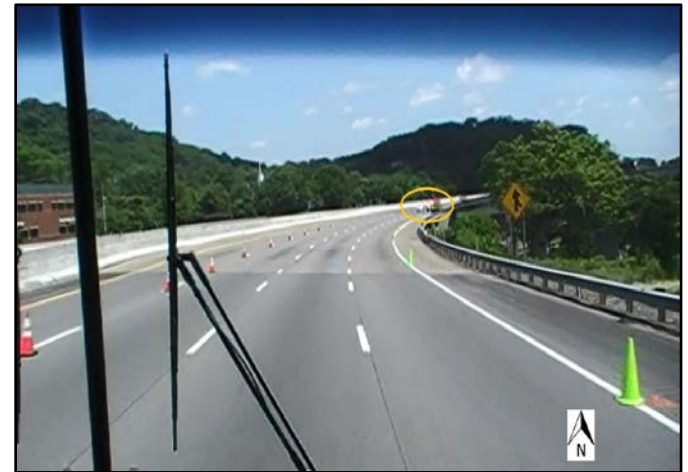
Recreation of motorist visibility; 900 feet south of crash site.
(Photo courtesy of Metropolitan Police Department.)
