FACE IT: Report Slides

Officer Struck While Assisting with Temporary Traffic Control on an Interstate— Texas (NIOSH LEO 2021-01)

REPORT#: L2021-01 **REPORT DATE: August 22, 2022**

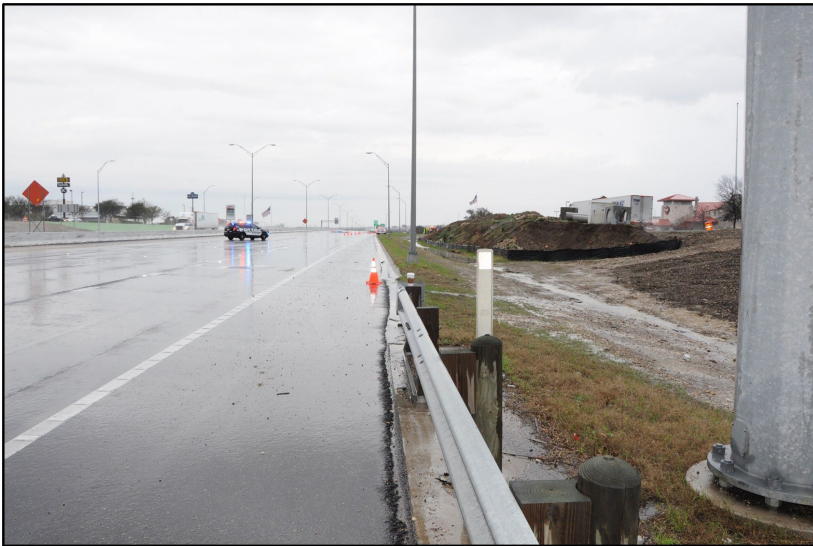
Initial motor vehicle-pedestrian scene in the distance.
(Photo courtesy of the city police department)

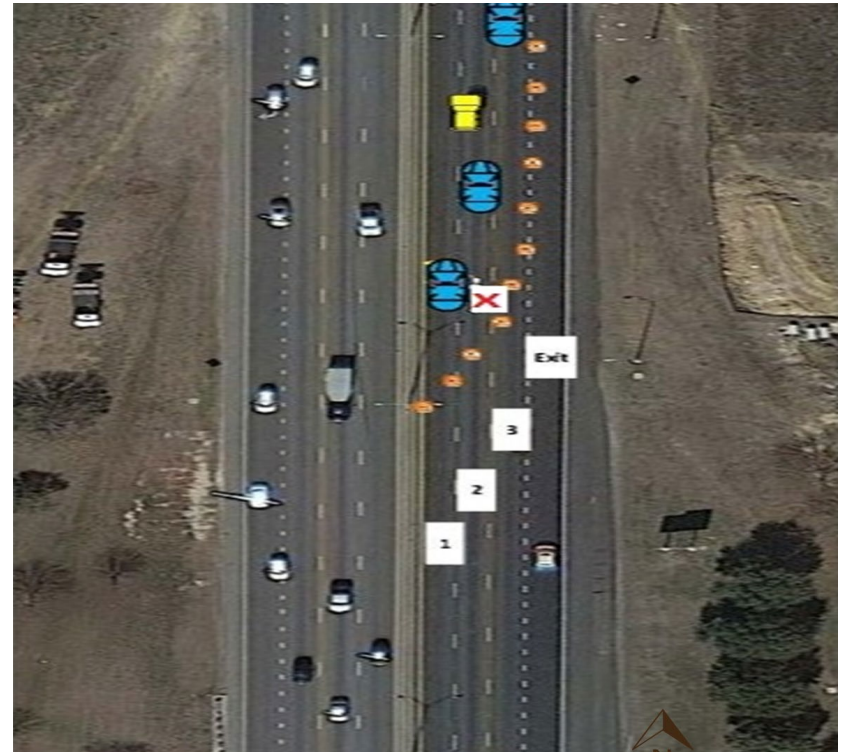
- A vehicle that was driven by an individual under the influence of a prescription drug affecting the central nervous system, traveling at approximately 68 mph, approached the scene, and failed to funnel off the interstate exit lane, striking the officer.
- The officer was transported to the hospital in serious condition and succumbed to his injuries on April 27, 2018.

Incident scene. (Not to scale or exact placement of cones and vehicles)
(Photo courtesy of the city Police Department. Labels added by NIOSH
FACE)

- Emergency responders should position patrol units and other emergency vehicles as they arrive on-scene to maximize the protected work zone for the emergency responders.
- Law enforcement agencies should ensure their standard operating procedure (SOP) provides step-by-step guidance on how to properly establish a temporary traffic control plan, including advance warning and transition areas for highway/roadway emergency incidents.
- Law enforcement officers and other emergency responders should maintain situational awareness within the established temporary traffic control zone to ensure they minimize their exposure to oncoming traffic.

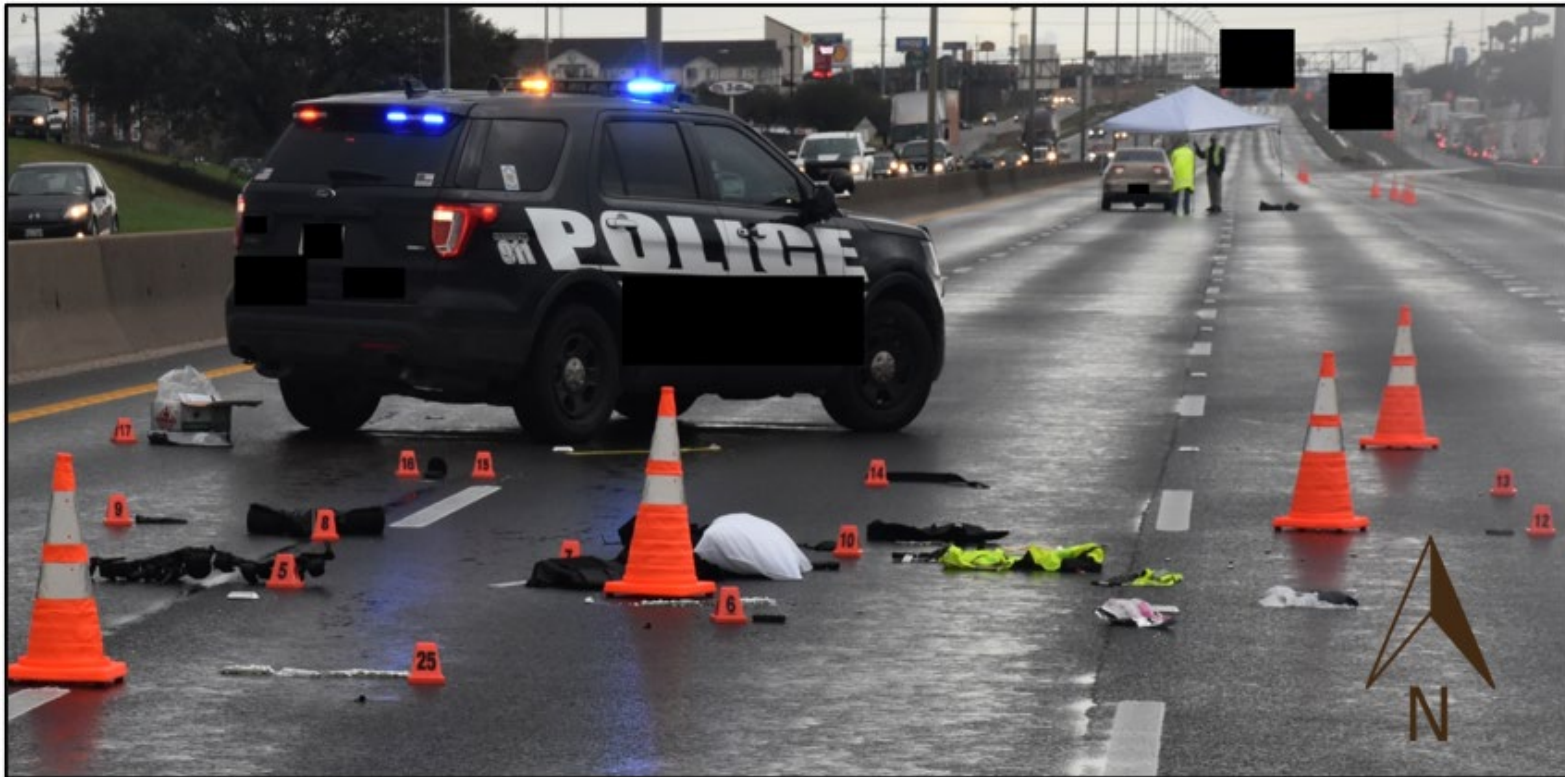
Scene with Officer A's patrol unit in Lane 1-2 and the vehicle that struck him in lane 2 in the distance. (Photo courtesy of the city Police Department.)
