# 17th CONFERENCE ON GROUND CONTROL IN MINING

## A Case Study of Bolt Performance in a Two-entry Gateroad

### ABSTRACT

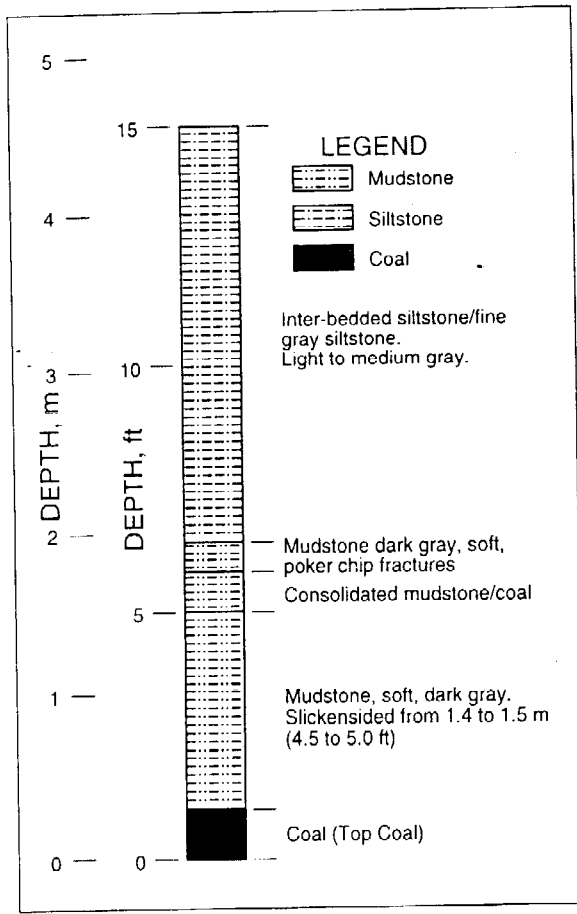
Figure 1.—Core log near crosscut 59

Geology may have been a significant factor in the localized roof degradation. Several 2.7- to 4.6-m (9- to 15-ft) deep core-holes were drilled, and AX core was removed and tested to assist in a geological assessment of the roof. The immediate roof in the bad areas had layers of very weak mudstone, carbonaceous mudstone, and coal. Immediately above these weak layers was a very strong siltstone-sandstone member that had an average compressive strength of 179 MPa (24,600 psi). The mudstone was too weak to allow recovery of a sample large enough to test. The core log near crosscut 59.5 is shown in figure 1.

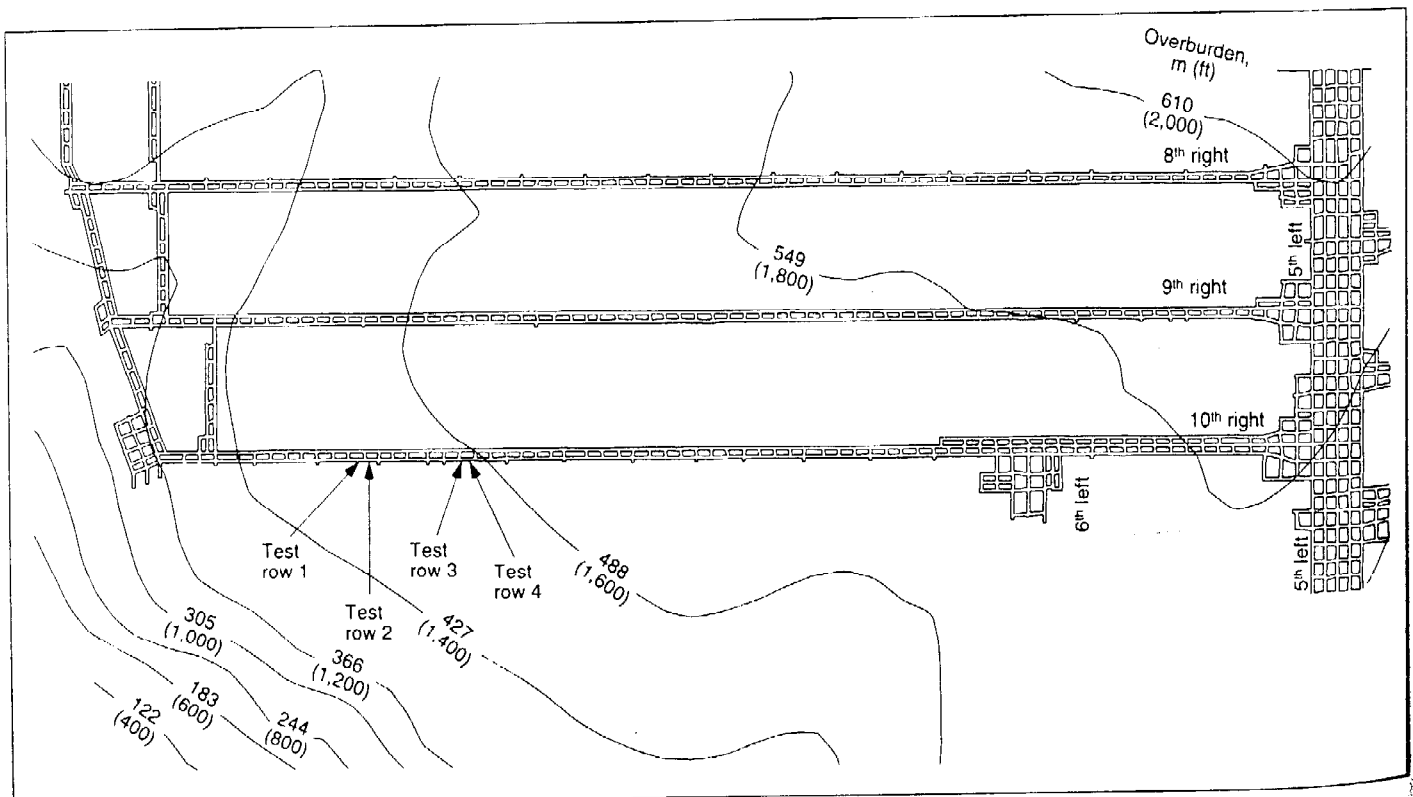
Figure 2.—Plan view of test areas

Sixteen instrumented, fully grouted bolts, as well as sagmeters and pressure pads, were installed on-cycle in three test areas in the 10th Right gateroad to measure loading on bolts in the existing support pattern and to determine if cable bolts could be used to improve roof stability. This gateroad was the last in a sequence of longwall panels (figure 2).

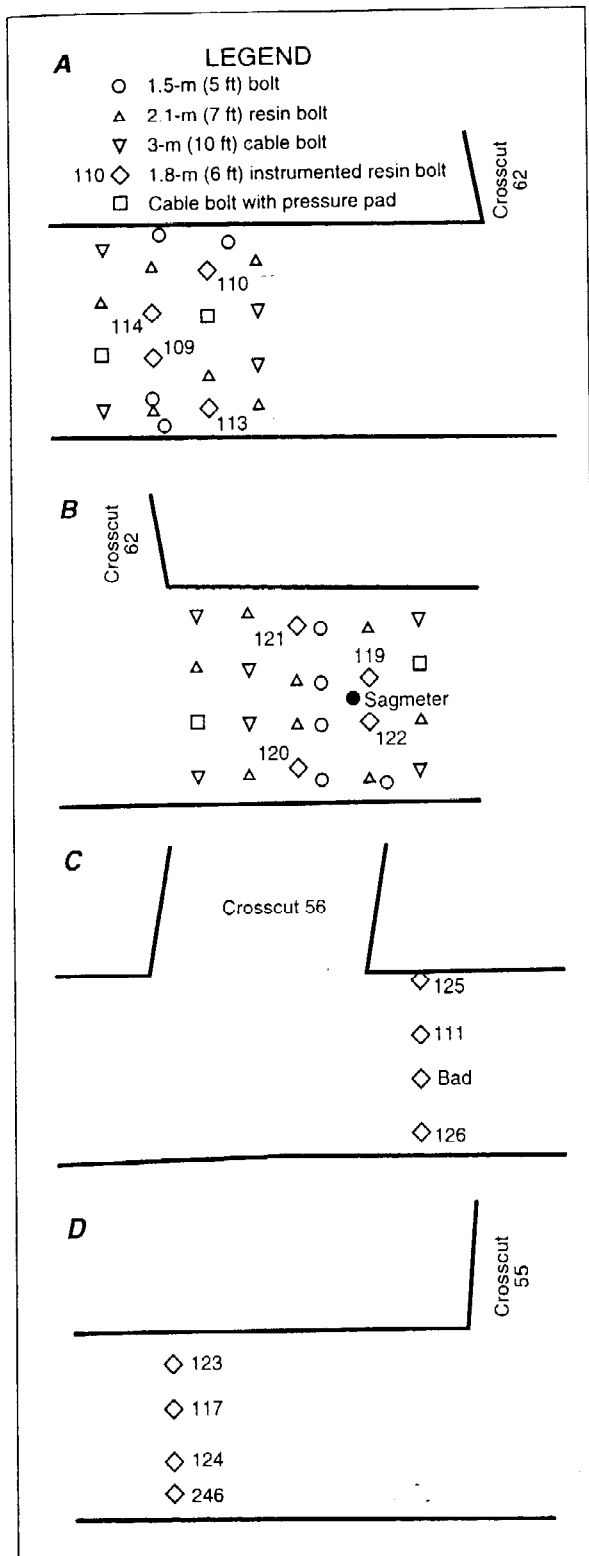
Figure 3.—Test rows. A, Fully grouted bolts; B, partly grouted bolts; C, resin bolts, row 3; D, resin bolts, row 4.

In the first test area, a combination of fully grouted cable bolts and resin bolts was used (table 1). Two rows of instruments were located approximately 12 m (40 ft) outby from the center of crosscut 62. The resin bolts and cable bolts were alternated as shown in figure 3A.

In the second test area, a combination of partly grouted cable bolts and resin bolts was used (table 1). Two rows of instruments were located approximately 8 m (27 ft) inby from the center of crosscut 62 (figure 3B).

Two rows of instrumented No. 7, grade-60, 6-ft-long resin bolts were installed in the third test area as the primary support. The first row was 4.9 m (16 ft) inby the center of crosscut 56, and the second row was 19.8 m (65 ft) inby the center of crosscut 56 (figure 3C-D). The connector to an instrumented bolt in this test area was severed during installation. The uninstrumented resin bolts were 2.1-m (7-ft) long and were No. 6, grade 60. Entry development and longwall pass of the test rows are shown in table 2. This gateroad had only one longwall panel pass.

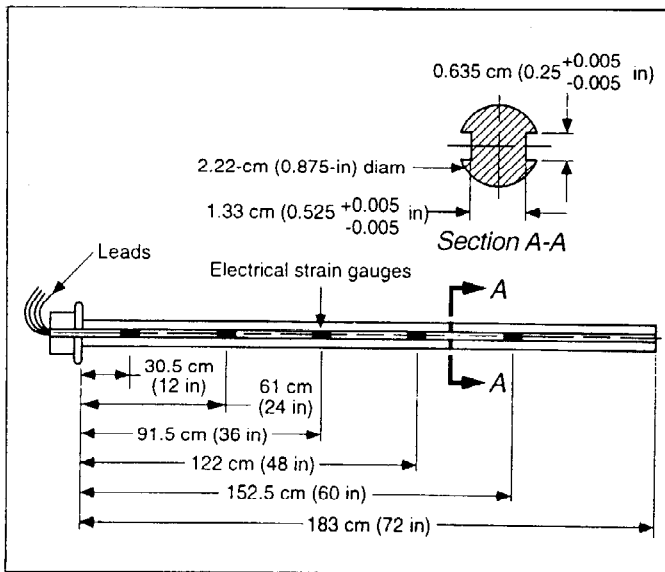
Figure 4.—Instrumented bolt

The resin bolts were modified by milling a slot 6.4 mm (1/4 in) wide and 3.2 mm (1/8 in) deep. Five strain gages were attached on both sides, as shown in figure 4. Because these bolts were used for primary support, No. 7 bolts were used in place of the No. 6 bolts. Table 3 describes the properties of the two bolts. Note that the No. 7 bolt has an increased capacity of approximately 28%.

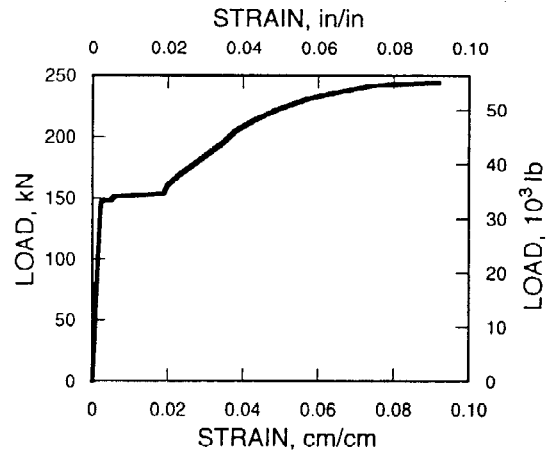
Figure 5.—Load strain plot for No. 7, grade 60, slotted bolt

Another, equally important, aspect of selecting bolts for roof support is the evaluation of strain levels in the bolt (figure 5). Typical engineering design limits strain to a percentage of the yield point. Previous evaluations of strain measured on roof bolts show that, in many cases, the yield point of the steel bolt is exceeded where the roof remains stable. Fully grouted roof bolts are a stiff support system in which loads increase quickly as the bolted strata move. Rebar bolts are made from a ductile steel that can reach strain levels of 100,000 to 160,000 microstrain at ultimate load. Yielding occurs at approximately 2,000 microstrain on grade 60 rebar. Immediately after yielding, the bolt will continue to stretch, with very little increase in load until the steel begins to work harden. Thus, design strain limits should take bolt loading mechanisms (i.e., axial, bending, and/or shear) into consideration. Bolts loaded axially with little bending or shear

Data from each instrumented bolt were evaluated in several different ways. Each bolt was calibrated in a uniaxial testing machine to correlate voltage change to load change. This calibration factor was used below the steel yield point to convert voltage data to load at each of the 10 strain gages. If a bolt section exceeded the steel yield point, the strain was calculated and load estimated from the stress-strain relationship shown in figure 5.

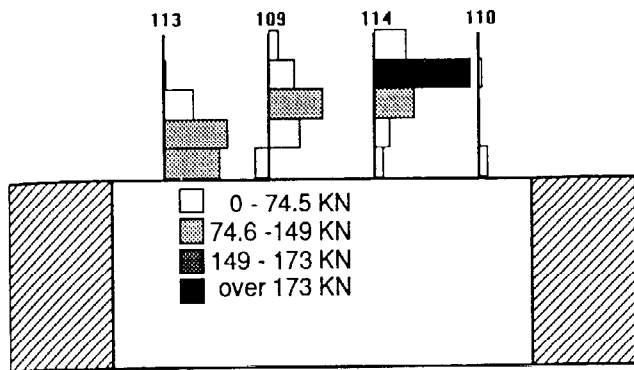
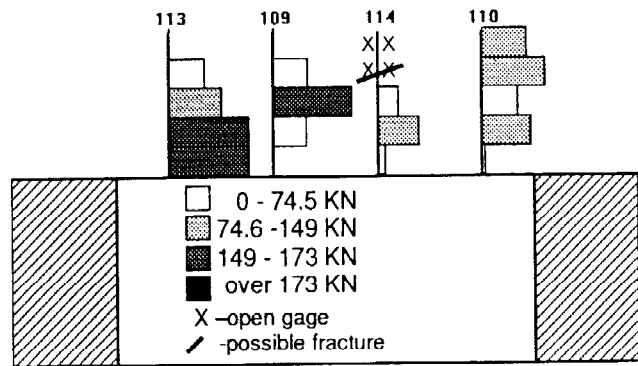
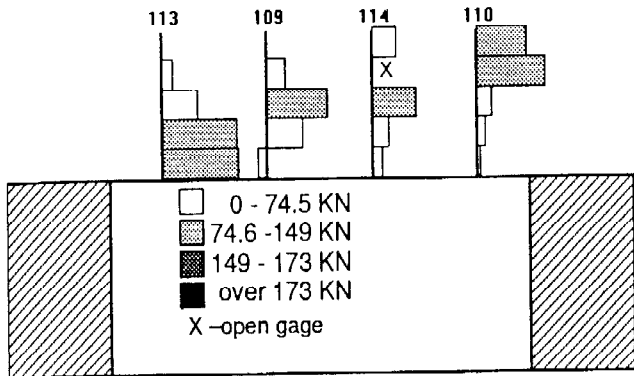
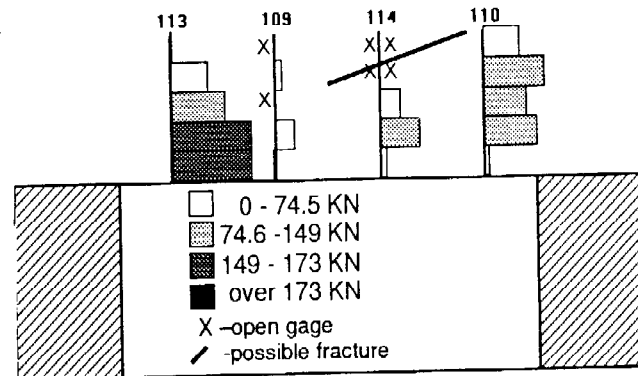
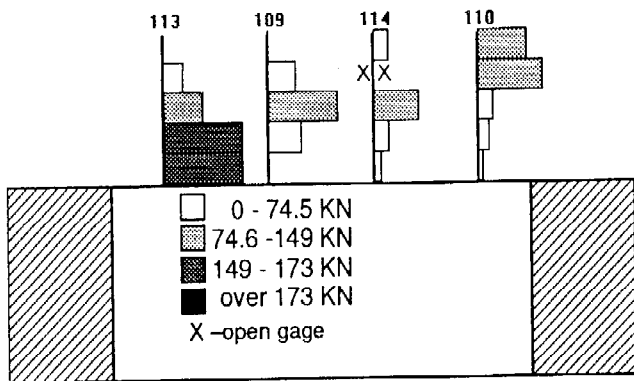
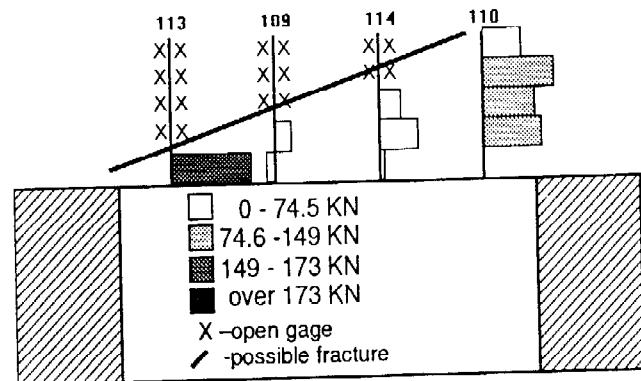
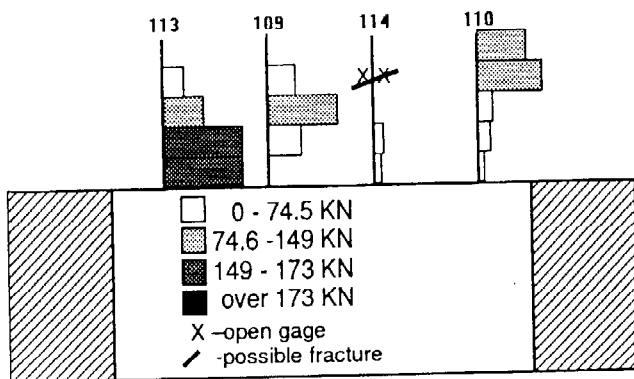
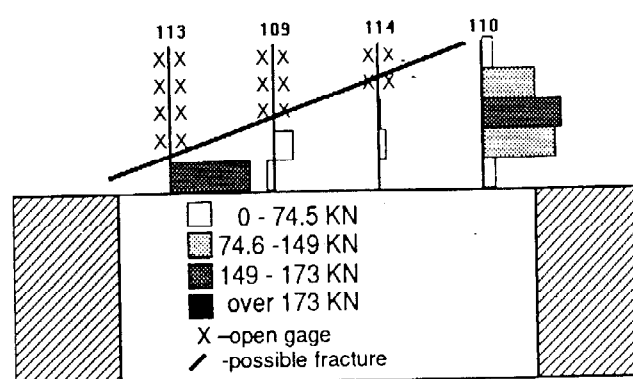
Bolt loading is shown in figures 6 through 22 as a cross-sectional view. Each test row is shown at various time intervals. Figures 6 through 13 show the development of axial loading in the row of fully grouted cable bolts. On December 12, gage 4 on bolt 114 had reached 43,000 microstrain, well into the strain hardening phase of the steel. When that bolt was read again 4 days later, that gage had an open reading and axial loading on the adjacent bolts had increased. Three weeks later, the strain gage

opposite gage 4 had an open reading. Six days later, the load level in bolt 114 dropped significantly, which may indicate that the bolt was beginning to break. On April 19, the last four gages were open, and loading increased in the adjacent bolts. Two days later, loading on adjacent bolt 109 dropped significantly and two open gages were recorded. Then on April 23, many of the strain gages had an open reading, which could have been caused by shear movement along a possible fracture plane (figure 13).

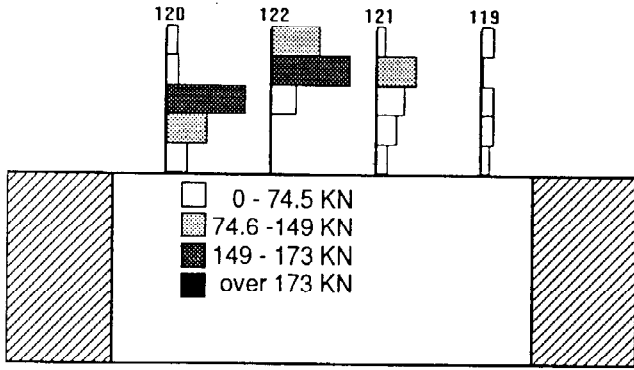
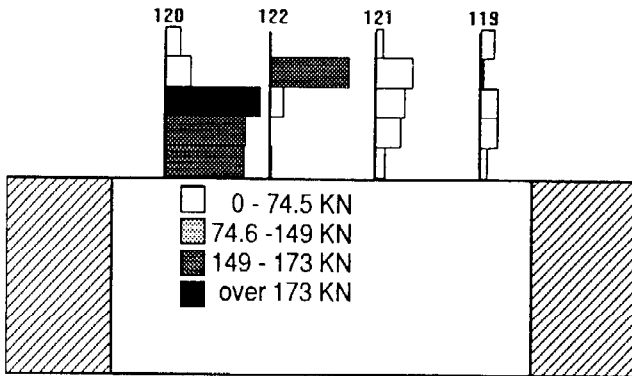
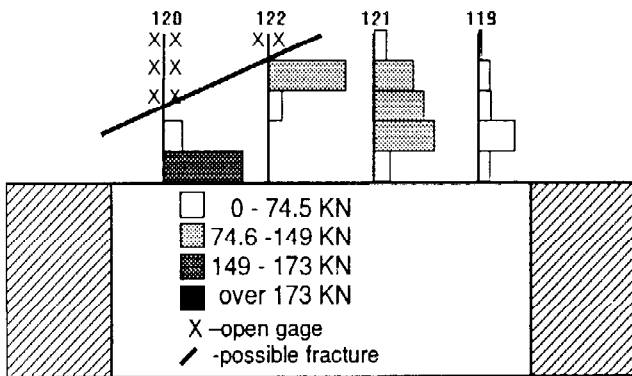
This sequence was repeated at test row 2, but only three time shots are shown. At this test site, the possible fracture plane was higher in the roof and affected only two instrumented bolts. A similar sequence was repeated at test row 3, but this time on the other side of the entry. In this test row, bolt 125 broke and was recovered on the mine floor. Test row 4 did not show any strain gage failures, and loading was more evenly distributed along the length of the bolts.

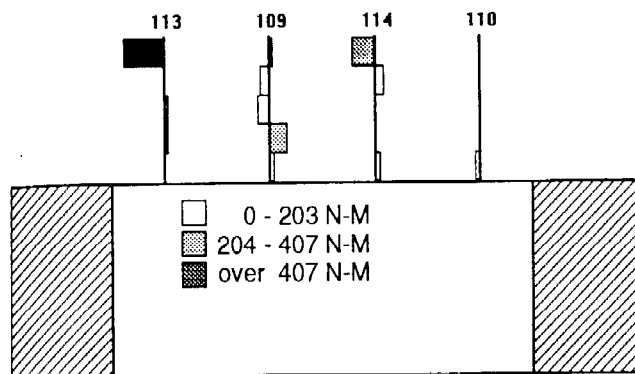
Figure 23.—Bending moments on test row 1 on 12/12/97

A typical plot of the bending moments is shown in figure 23. If shear forces caused by joint planes were the primary means of bolt failure, then the bending moments would be very localized and might not be detected because of the large spacing of the strain gages. Resin bolts will not fail under pure bending because of the high ductility of the steel. For this reason, axial loads are a better indicator of bolt failure.

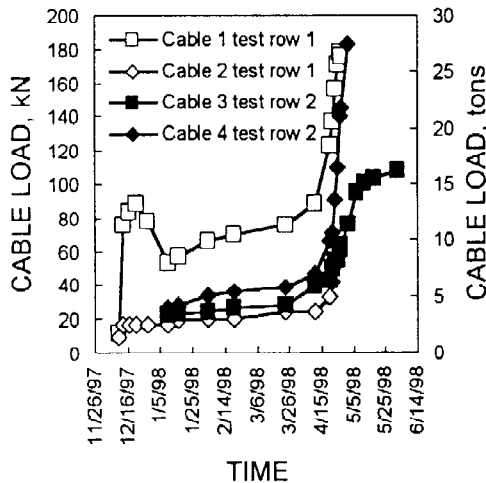
Figure 24.—Cable bolt loads

Loading on the cable bolts in test rows 1 and 2 is shown in figure 24. Loading was fairly low until the abutment stress from the longwall panel approached the test areas, at which time the load increased rapidly and the pressure pads failed to work on all but cable 3. Several uninstrumented cables broke in both test areas along with instrumented cable 4.
