SUBJECT: A Female Material Handler Dies When She is Crushed Against a
Podium by a Backing Forklift.

SUMMARY
California FACE Report #07CA008

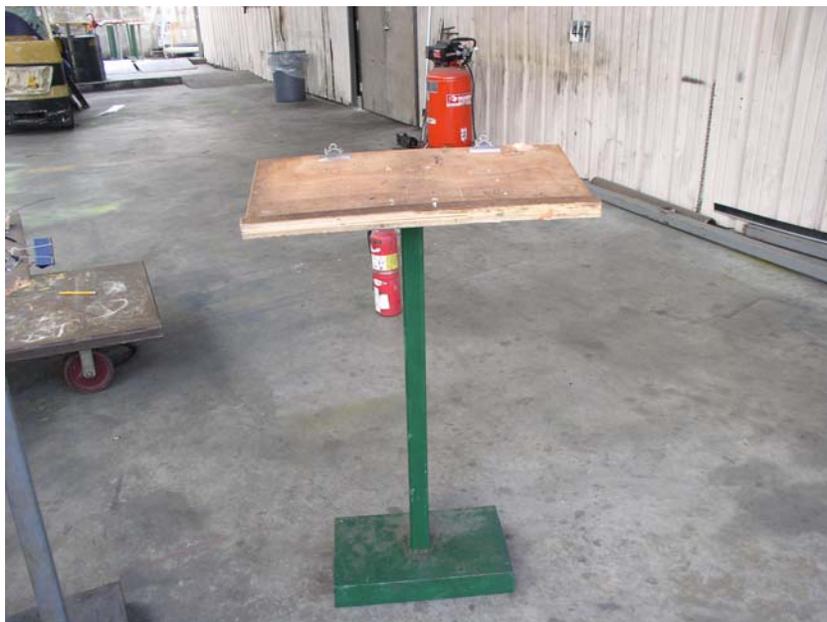
Exhibit 1. The podium that was attached to the steel column on the edge of the dock.

Discussion: In this particular case, the podium was anchored to the steel pillar that supported the roof over the dock. These podiums had been in place since the structure had been built in the early 1970s. Part of the material handlers' responsibilities was to log on the manifest all the cargo they loaded into the trailers. This activity had been done for many years in the same manner without incident. The installation of portable clipboards attached to the steel pillars would allow material handlers to maintain eye contact with any forklift in the area and to move out of the way. Employers should always strive to limit worker exposure to moving equipment.

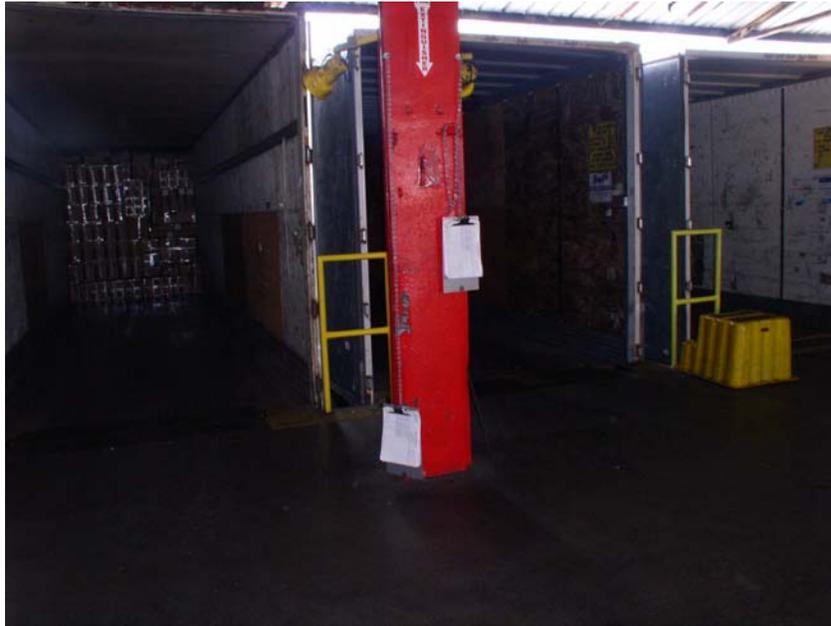
Exhibit 2. The steel column where the podium was secured.

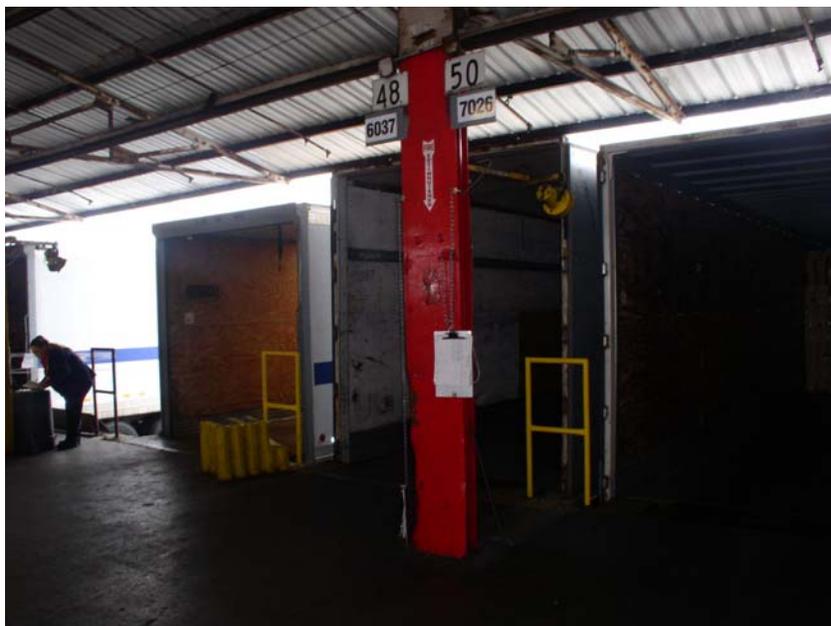
Exhibit 3. The work area where the incident took place showing the outbound trailers.

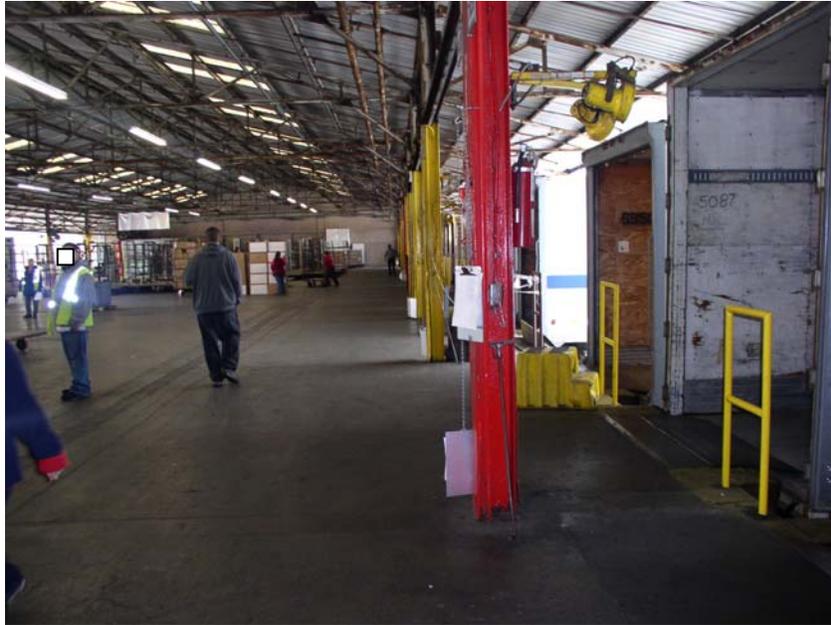
Exhibit 4. The warehouse showing the outbound trailers backed into the dock.

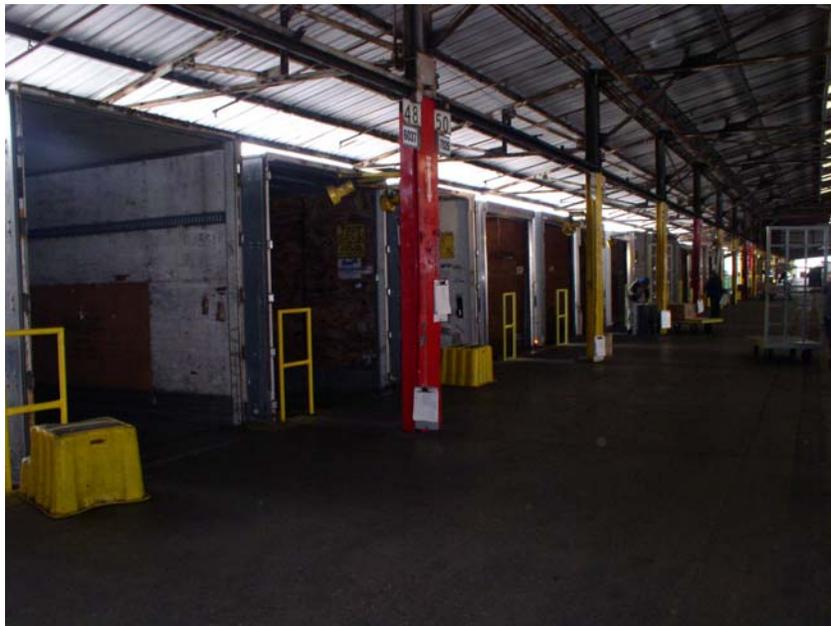
Exhibit 5. The receiving dock with trailers waiting to be loaded.

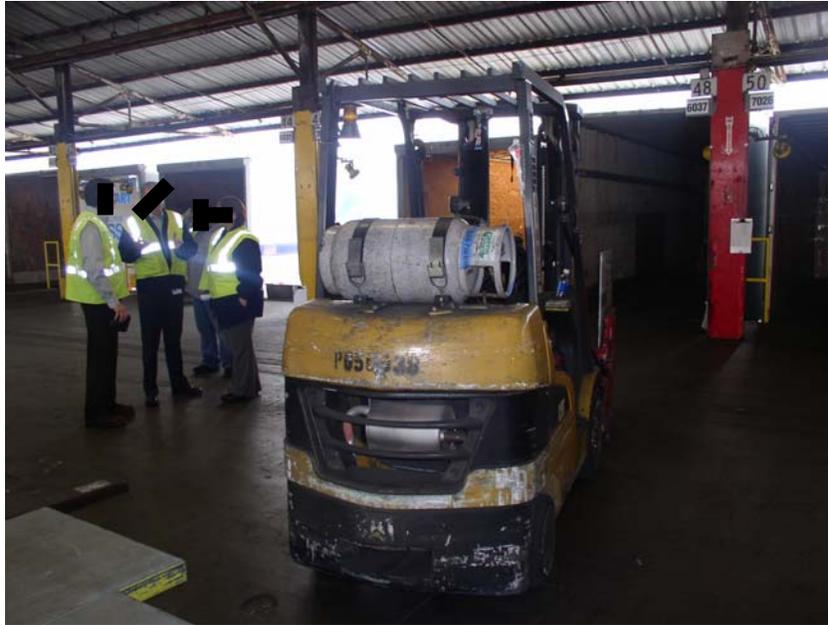
The site of the incident was a manual cross-dock warehouse operation. Trucks carrying containers from ocean carriers would dock on the inbound side of the warehouse and trucks carrying containers for transport to customers would dock on the outbound side of the warehouse. Merchandise from inbound trailers was placed in the warehouse and then packed in the outbound trailers depending on their destination. The material handlers packing the outbound trailers would log the packed material on a manifest that was placed on a podium attached to a support column on the dock. The forklift involved in the incident was a standard natural gas powered forklift that weighed approximately 8,800 pounds. The forklift was in good operating condition and the back-up alarm was working at the time of the incident. The forklift did not have any rear view mirrors.

Exhibit 6. The forklift involved in the incident.

Discussion: The standard sit-down type of forklift used in most industry is very versatile. However, one of the drawbacks of this type of machinery is that the operator sits in the direction of forward travel and the machine travels in reverse as much as it does in forward. Being able to see in the direction of travel at all times is essential to the safety of all workers in the area. When backing the standard sit-down forklift, the operator is required to look over either their right or left shoulder, depending on the direction of rear travel. In either case, the view is restricted and there will always be a blind spot, and a safety risk.

Forklift manufacturers make a variety of types of forklifts for warehouse and dock work. One type allows an operator to stand sideways on the machine, providing an unrestricted view of the direction of travel, both forward and reverse. Companies that own and operate warehouses and docks might consider changing to these types of forklifts as a matter of safety without sacrificing production.
