MIFACE INVESTIGATION REPORT: #09MI049

Subject: Commercial Roofer Died When Struck By a Falling Load of Palletized Roofing Material

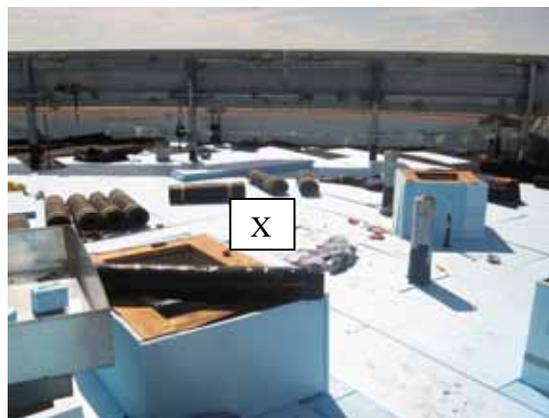
Figure 1. Configuration of the roof area. X indicates location of decedent.

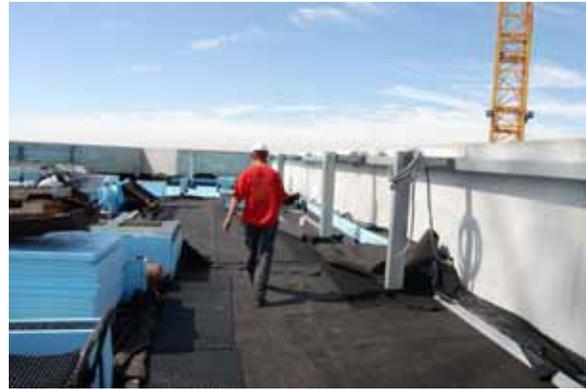
Figure 2. Position of tower crane in relation to roof area

The crane operator had performed at least eight lifts on the morning of the incident, six of which were for the decedent’s employer (sand and gravel). During one of these lifts, he indicated to the police that as he was lifting dirt to the roof in a 5-yard concrete bucket, he observed an unstable load: a hook shackle that was not sitting correctly (cocked). After setting the bucket on the roof, he informed the rigger, asking him to ensure rigging provided a stable load. Figure 2 shows the location of tower crane in relation to the work area of the six-person crew.

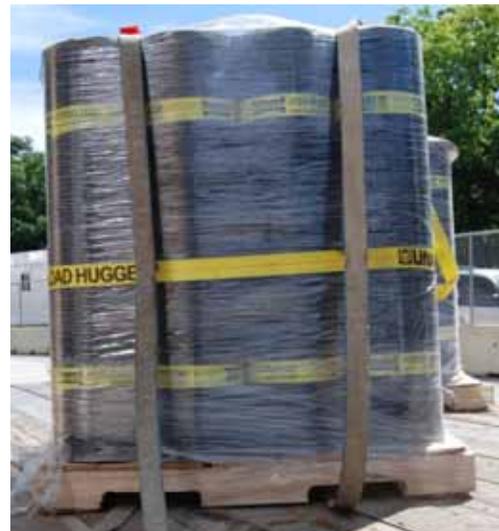
Figure 3. Shrink-wrapped roofing materials, with ratchet strap, on pallet on truck trailer

The Hydro-Flex roofing material was positioned upright (standing on end) on a 40-inch by 50-inch stringer-class wood pallet (Figure 3). Longitudinal stringers ran the length of the pallet on the outside and two stringers were equally spaced to further support the deck boards, which were flush to the outside stringers. The pallet load of 20 Hydro-Flex rolls weighed approximately 1,900 pounds. The rolls were individually bound with tape to keep their roll shape intact and stretch-wrapped to unitize (bundle) the rolls for shipping. The Hydro-Flex bundle was not centrally positioned on the pallet; the rolls were positioned toward both one side and the top of the pallet. The bundle was not secured to the pallet. Police pictures taken at the scene show a number of pallets/bundles with this shipping configuration.

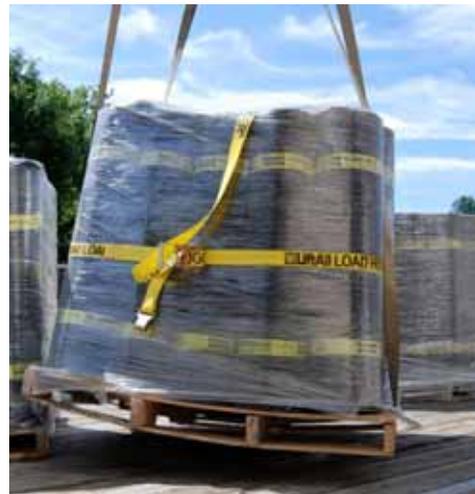
Figure 4. Police re-enactment of lift showing pallet bowing

The responding police department requested the rigger and crane operator to re-enact the rigging and lifting sequence followed for the previous load. The rigger placed the ratchet strap and slings in the same positions as the first load. The police department requested the crane operator to lift the palletized load from the trailer. This re-enactment load, once clear of the trailer, was found to be leaning and not centered with slings. The pallet was also bowing under the weight of the rolled roofing. The rigger stated that the previous load was not situated like this and if it was, he would not have allowed it to be lifted. One of the police officers returned to the roof near the incident site and instructed the crane operator to sound the horn and to shout out from the window. The horn sounded and was clearly heard as was the crane operator's voice as he shouted from the window

Figure 4 demonstrates that the rigged pallet was flexing under the weight of the roofing material, indicating stress on the pallet and potential load instability. Another safety action a crane operator must undertake is to ensure load stability. Although the crane operator may not have recognized the extent of flexing of the pallet due to his position in the cab when the load was rigged on the ground, after the load was hoisted, the flexing may have become more apparent as it was closer to his position. The crane operator however, now having the load hoisted, looking for the decedent's coworker at the landing spot and noting the workers in the travel path, may not have been observing the stability of the load once it was hoisted.

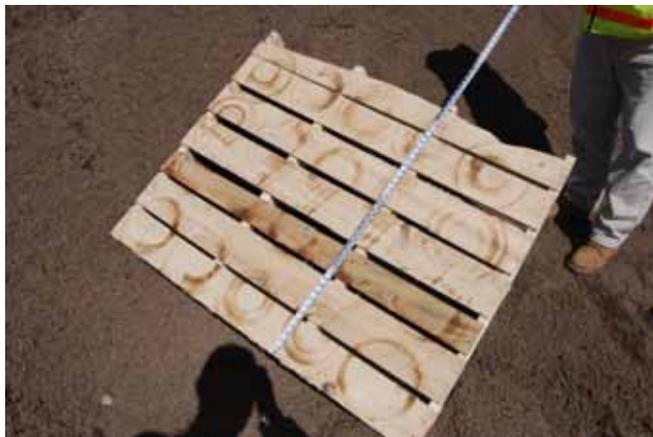
Figure 5. Pallet involved in incident

Additionally, the roofing material was not centered on the pallet thus the center of gravity of the load was not in the center of the pallet. When suspended, a load being raised tends to move so that the center of gravity is directly below the hoisting hook. This “shifting” of the load may have placed extra stress on the pallet deck boards, causing the pallet to tip and the outermost deck board to break, causing the roofing material to fall (Figure 5).

Although the rigger had received rigging training, he did not appropriately rig and secure the palletized load. The "strongest part of a pallet" when rigging a pallet for a crane lift is not the forklift runner, which is perpendicular to the deck board; it is the longitudinal direction of the stringer. Figure 4 shows the flexing of the pallet due to placing the rigging straps in the pallet runners. The horizontal forces acting on the pallet caused the pallet to flex. If using slings to lift the roofing rolls on a pallet, the ratchet straps should be placed on the outside of the sling, and should secure the rolls to the pallet after the crane operator placed tension on the slings. Another suggestion made by his colleagues was that if the rigger wanted to use the spreader, then one hook should have been used.

Other methods to rig and raise this load could include using a crane pallet fork to lift the palletized roofing materials. The pallet fork tongs, which can be adjusted, slide into the fork runners. As the material is raised, the center of gravity is automatically adjusted to be located under the hoisting hook. Another method would be to use a forklift to lift and place the palletized material into a wire basket to raise the material to the roof.
