FROM: Iowa FACE **Case No. 2010 IA 005** **Report Date: 10 October 2012**

SUBJECT: Special-needs sanitation route helper caught in tailgate of waste collection truck

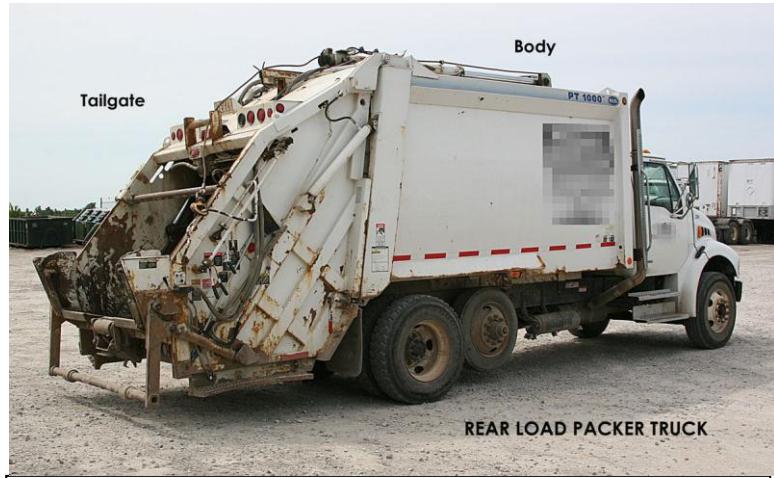
The victim and his partner conducted their pickup route in a 2004 rear load packer truck with 20 cubic yards capacity (Exhibit 1). On a rear load packer, the helper manually lifts and empties individual trash containers - or cardboard - into a 3-cubic-yard hopper in the tailgate of the truck. A hydraulic packer panel in the tailgate compacts the hopper contents and pushes them into the main body of the truck.

Exhibit 1: Rear load packer truck involved in incident

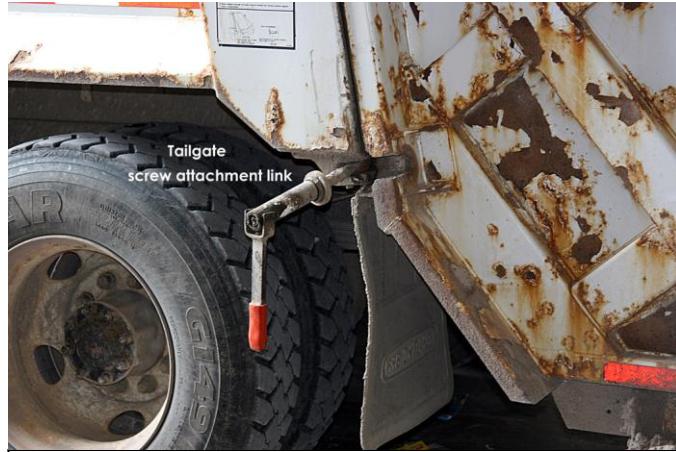
To unload the truck, two locking screw attachment links must be unsecured manually. The attachment links are located on the driver and passenger sides of the truck between the tailgate and main body (Exhibit 2).

Exhibit 2: Attachment link that secures tailgate in closed position

Recommendation 5. *Specify that only drivers are authorized to unsecure tailgate latches and operate tailgate mechanisms.*

Discussion: Prior to the fatality, helpers may on occasion have assisted drivers in unloading procedures at the recycling center. Following the incident, drivers were instructed that only they are authorized to prepare and operate their truck tailgate for unloading. With only drivers having authority to unsecure both tailgate latches, there is no need for helpers or other employees to be in restricted areas out of the driver's or spotter's line of vision, reducing the potential risk of their being injured by moving equipment.

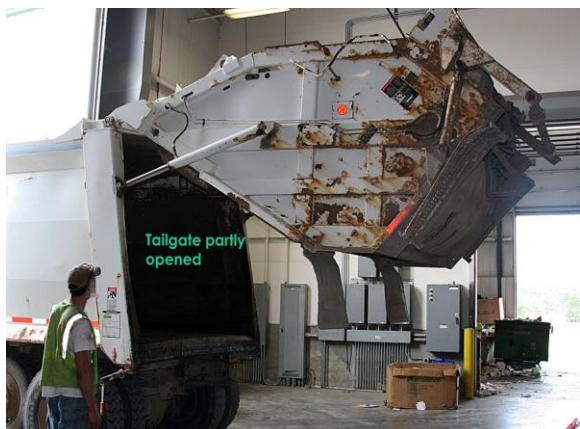
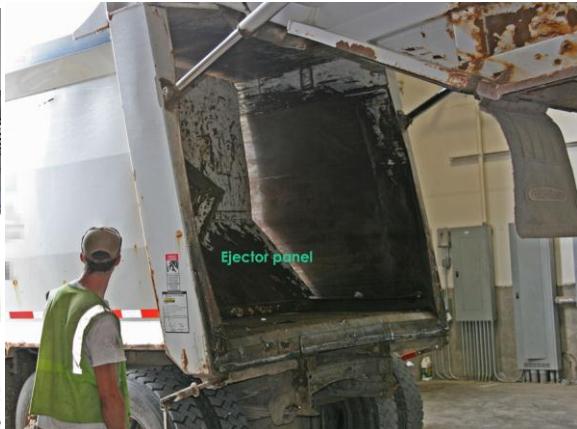
After the links are unsecured, the driver operates hydraulic controls that raise the entire tailgate, swinging it upward (Exhibit 3). The hydraulic tailgate controls are located on the exterior of the truck to the rear of the driver side of the cab. A vertical hydraulic ejector panel inside the front body of the truck then pushes contents out the back of the truck (Exhibit 3).

Exhibit 3: Rear-load packer truck with tailgate opened and ejector panel fully extended

Recommendation 6. *Require drivers to follow defined protocols for removing lodged materials from truck bodies or hoppers. These include using tailgate props to secure the tailgate in a supported open position, and shutting off the ignition and pocketing keys prior to clearing the tailgate or rear body of the truck.*

Discussion: Drivers must use lockout practices to safeguard against equipment starting or releasing hazardous energy. When it is necessary to clear material from the tailgate or truck body at the recycling center or landfill, drivers must now either a) enter the front of the truck body through an access door behind the cab, or b) use tailgate props which are standard equipment on the vehicles to support the opened tailgate in a fixed position with the engine off. In both instances, clearing the truck of lodged material is done only after the truck ignition has been turned off and the driver pockets the keys. This policy assures that the truck controls cannot be engaged, that the risk of injury from a moving tailgate is minimized or eliminated, and that *drivers only* are authorized to clear lodged materials.

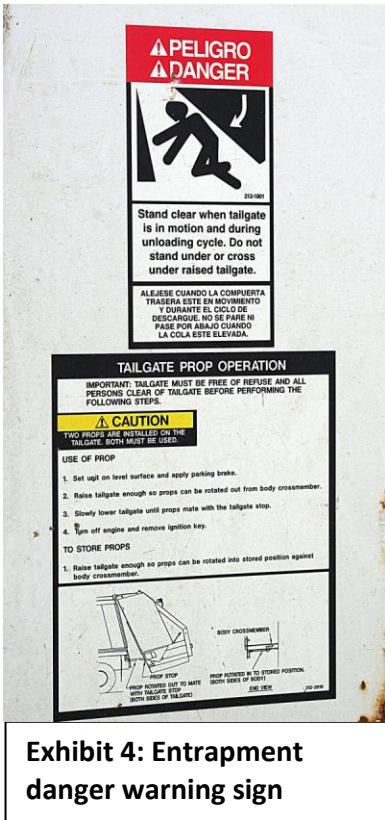
After the contents are emptied, the tailgate must be lowered to a closed position and the tailgate attachments must be re-secured. When the tailgate is in any position other than fully closed, an audible alarm sounds until the tailgate is returned to fully closed position. The sound of the alarm does not change based on the movement or position of the opened tailgate. Signage is present on both sides of the truck to the front of the tailgate warning of the danger of being caught or struck by the tailgate (Exhibit 4).

Exhibit 4: Entrapment danger warning sign

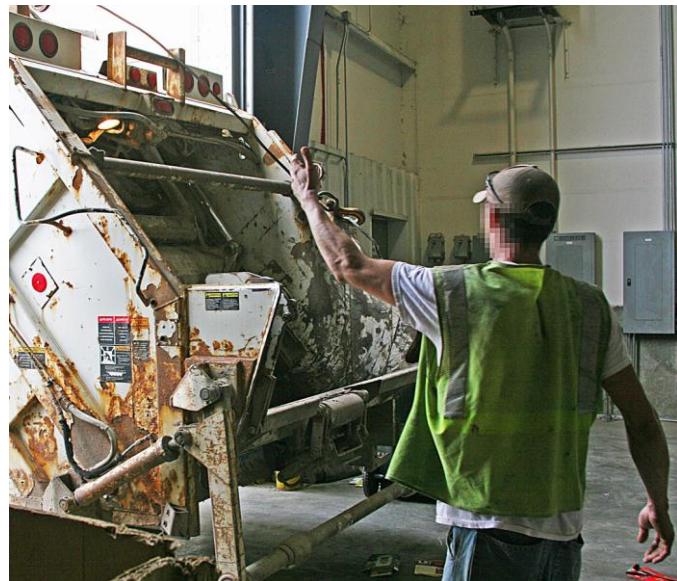
Discussion: The company implemented a new policy after the fatality requiring that all truck traffic into the facility be directed by spotters. Several recycling center employees were designated and trained as spotters. Drivers waiting to unload must wait outside the facility for a spotter to direct their truck into the building. Spotters assure that all persons are clear of the restricted area during unloading. Spotters give drivers clearance to proceed with all unloading activities and maneuvers using standard hand signals. They direct the driver in entry and exit from the facility, raising and lowering the tailgate, and ejection of a load (Exhibit 5). Spotters assure that only drivers operate latches and controls involving tailgate movement.

Exhibit 5: Spotter using hand signal to direct truck into recycling center

Recommendation 2. *Designate trained spotters to direct drivers entering, unloading, and exiting facilities where other employees or bystanders may be present.*
