SUBJECT: A Day Laborer Dies when He is Pinned Between a Loading Dock and a Backing Truck

SUMMARY
California FACE Report #12CA009

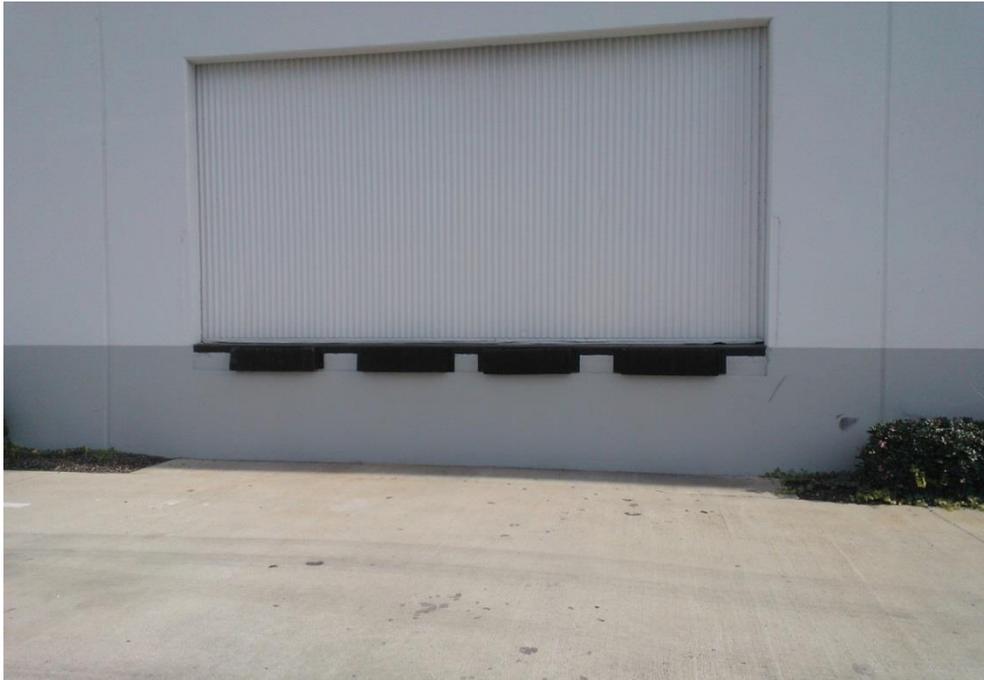
Exhibit 1. A truck loading dock identical to the one involved in the incident. Trucks back up to the dock in order to load and unload product.

- Install concave mirrors on the dock for drivers of backing trucks to see objects or individuals within their blind spots.
- Install other engineering controls on loading docks such as motion detectors, strobe lights, or gates which restrict access.
- Assign an employee as a spotter in clear view of the driver to direct the backing truck and to alert the driver whenever an obstruction occurs within the blind spot.
- Prohibit all foot traffic in the work area.
- Retrofit all trucks with cameras for the drivers to see their blind spots when backing.

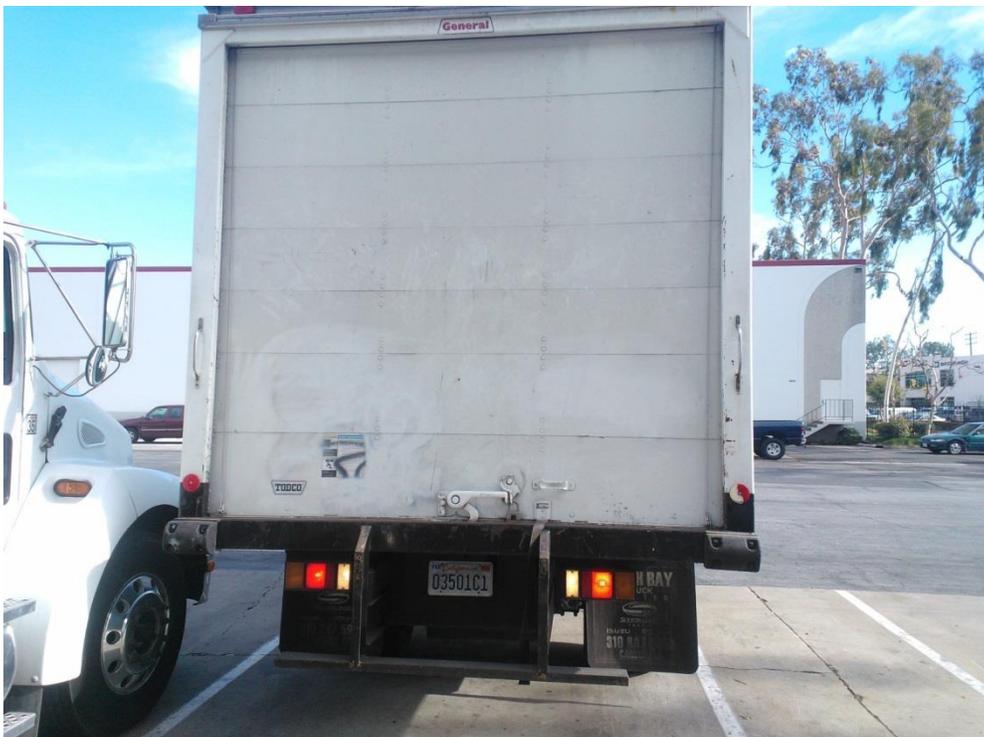
Exhibit 2. The rear of a truck similar to the one involved in this incident.

Discussion: In this incident, the victim was in the blind spot of the backing truck. The truck had the proper mirrors as well as a functioning back-up alarm; however there was still a blind spot directly behind the truck where the driver could not see. This was the area the victim placed himself as the truck was backing. The supervisor was observing the operation but didn't stop the truck driver when the victim jumped off the dock and entered the backing zone. In order to prevent these types of incidents from recurring, employers should consider the following options:
