Day Care Monitor Dies After Crash of 15-Passenger Van

Incident Number: 12KY026

**Kentucky Fatality Assessment and Control Evaluation (FACE) Program
Incident Number: 12KY026
Release Date: June 2013
Subject: Day Care Monitor Dies After Crash of 15-Passenger Van**

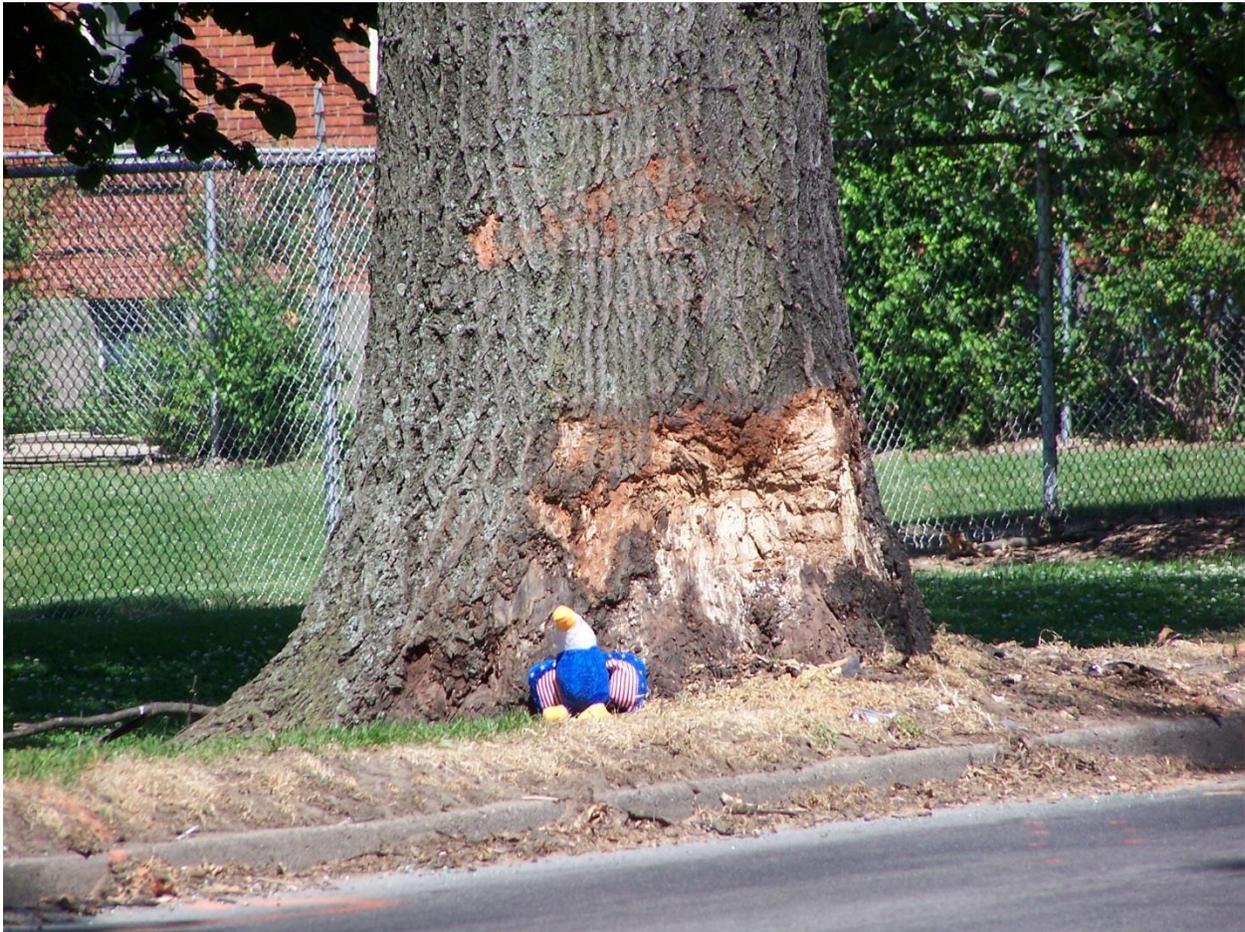
The tree involved in the crash. Photos included in this report are property of Kentucky FACE.

The driver proceeded out of the daycare's parking lot and dropped off two children at their residences, leaving 14 children and 2 adults still in the van. As they drove toward another child's residence, the van was in the left hand lane, traveling approximately 46-50 miles per hour, headed east on a straight stretch of a four lane road. East and westbound lanes were divided by a double yellow line. The roadway was flat and the pavement was dry; the speed limit was 35 miles per hour, and traffic was normal. It was approximately 5:10 p.m. when the right rear tire failed. Upon failure of the tire, the van became uncontrollable and it veered left, crossing both westbound lanes, striking a tree head-on and causing the front axle to break.

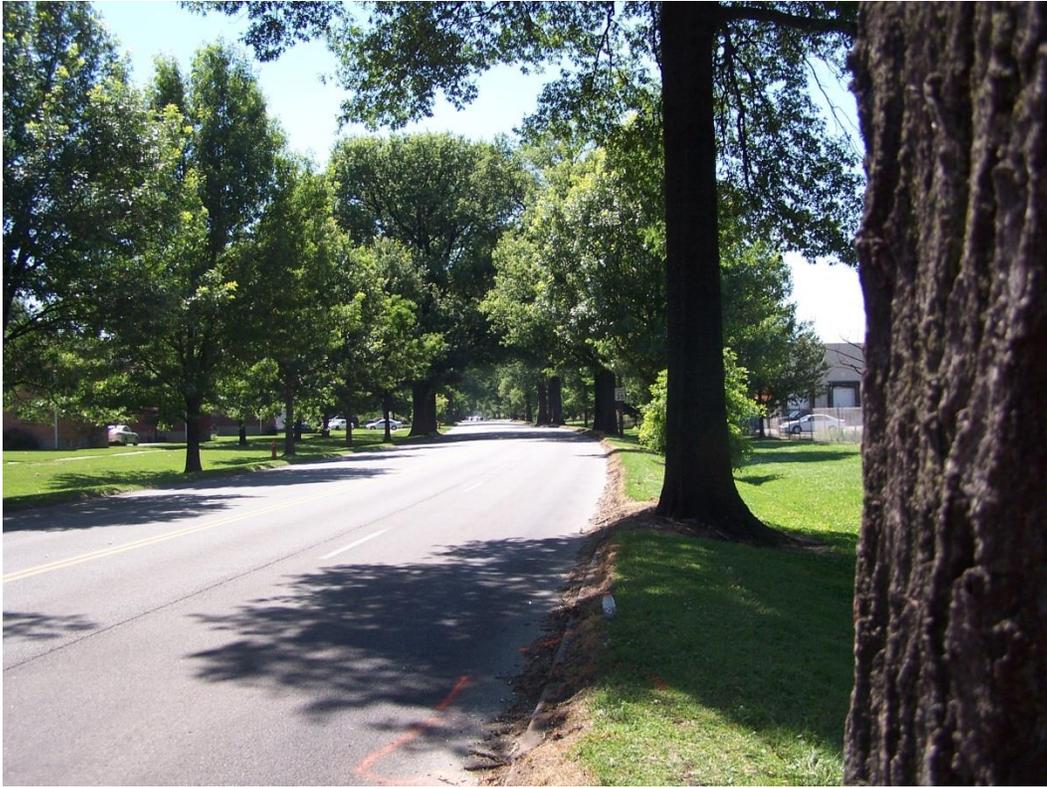
Street scene from the spot where the van crashed into the tree.

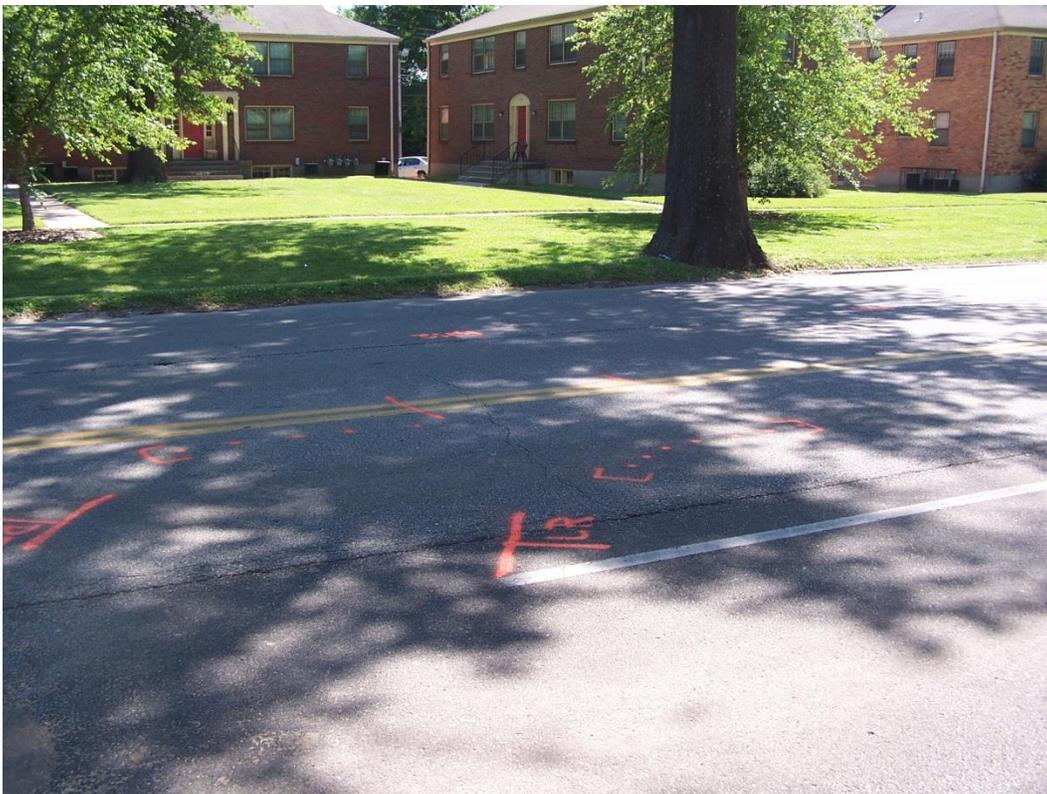
Markings show path of the van after the tire blowout, crossing into westbound lanes.

The reconstruction of the incident revealed damage had occurred in the middle of the rear right tire sometime prior to the crash and the interior tire belt had broken. Also, the tires on the van had less than 2/16" tread. There was no evidence of braking after the tire failed. Both front airbags were reported to have deployed upon impact with the tree. A passenger manifest was not located in the van, nor could one be found at the office of the daycare. It was reported by a witness that four children had been secured together with one restraint system. This would follow from the fact that the capacity of the van had been exceeded by 3 passengers at trip outset. The driving record of the van operator prior to the crash is unknown.
