## Occupational Fatality Report

### Truck Driver Fatally Injured When the Forklift He Was Operating Falls off a Loading Dock - Massachusetts

Release Date: February 29, 2016  
Investigation: # 13-MA-036-01

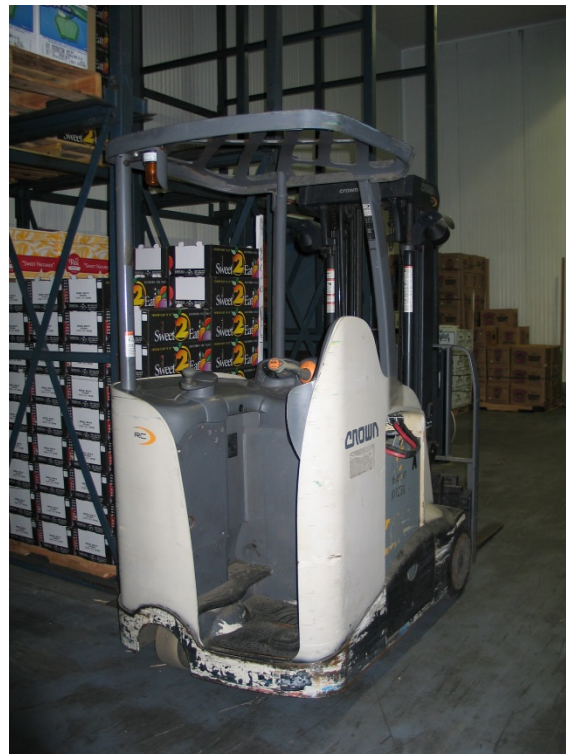
**Figure 2 – Similar stand-up counterbalanced forklift**

The vehicle involved in the incident was an electric, three-wheel, stand-up, counterbalanced forklift (Figure 2). The forklift was manufactured in 2013 and was being leased by the company. The overall dimensions of the forklift were approximately 3.5 feet wide by 7.3 feet high to the top of the overhead guard by 8.3 feet long, including the length of the 3-foot long forks. The maximum lift height to the bottom of the forks was about 13 feet and it had a load capacity of 3,000 pounds. The forklift weighed approximately 6,400 pounds. The operator's area was designed so the operator would be standing and facing towards the left side of the forklift. The operator's position would allow the operator to look in the direction of travel while operating the forklift with a load on the tines. The operator's area had an opening at the rear of the forklift, which was how the operator's area was accessed. The operator's area was not equipped with a door or some other kind of operator restraint system for when the forklift was in use.

The forklift operator's area had two main hand controls, a multi-task handle and a steering handle, and two foot pedals, a brake pedal (left foot) and a power-on pedal (right foot). The multi-task handle controlled the travel direction and speed. When the multi-task handle was pushed away from the operator, the forklift traveled forks first and when the handle was pulled towards the operator, the forklift traveled with the forks behind the forklift (power unit first). The multi-task handle also controlled all of the fork movements. The steering handle rotated 360 degrees and controlled which direction the forklift turned. The manufacturer's operator's manual for the forklift contained multiple warnings. One warning listed in the operator's manual was to stay away from the edge of docks and ramps.

It appears that most new stand-up counterbalanced forklifts are being designed and manufactured with at least three overhead guard support posts in an attempt to prevent the under-ride hazard. The forklift involved in this incident was manufactured with three supports for the overhead guard, but the design still leaves one corner of the operator's area potentially vulnerable to intrusion. If the overhead guard was designed with four posts or a support structure protecting the operating area, then the intrusion hazard would be eliminated.

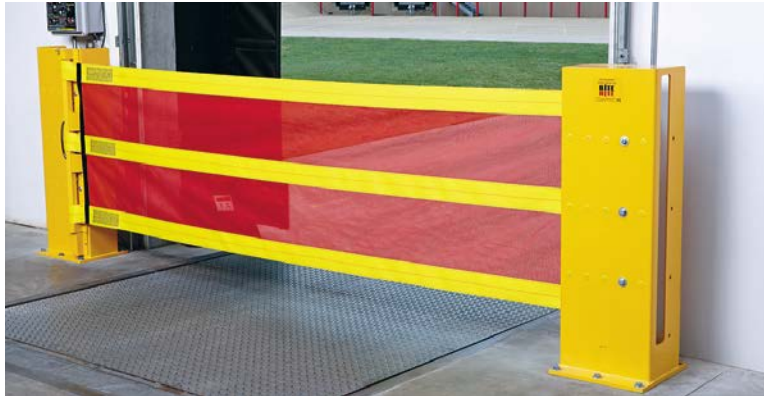
**Figure 3 – Example of a protective fabric barrier**

There are a wide variety of products available to provide protective edge barriers for loading docks, including dock guard posts with a protective heavy duty fabric barrier. The protective fabric barrier is bright in color and designed to withstand, depending on the barrier, up to 30,000 pounds. The fabric barrier is anchored by two posts and can be manually retracted into one of the posts when access is needed to the loading dock section.

In this case, one possible option would be to first create designated locations for trucks to back up to the loading docks. On each of these designated locations a post would be installed with a fabric barrier to span across the posts. Guardrails can be installed at the locations of the loading dock that are not designated as loading areas (Figure 3). Any loading dock safety improvements performed at the incident location should also be implemented throughout the entire produce distribution center where appropriate.
