Volunteer Fire Fighter Electrocuted by Downed Power Line Following Severe Weather – North Carolina

Executive Summary

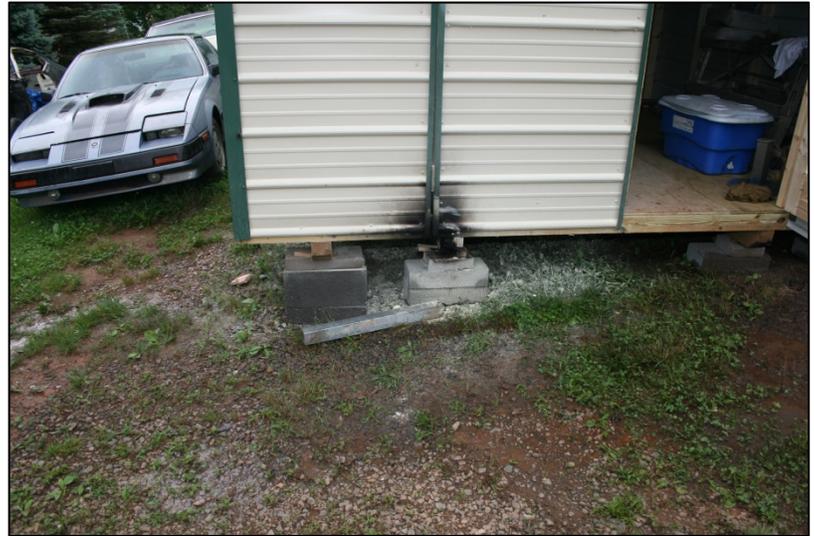
Metal storage building that victim was investigating. Note burn marks at bottom.
(Photo courtesy of County Fire Marshal)

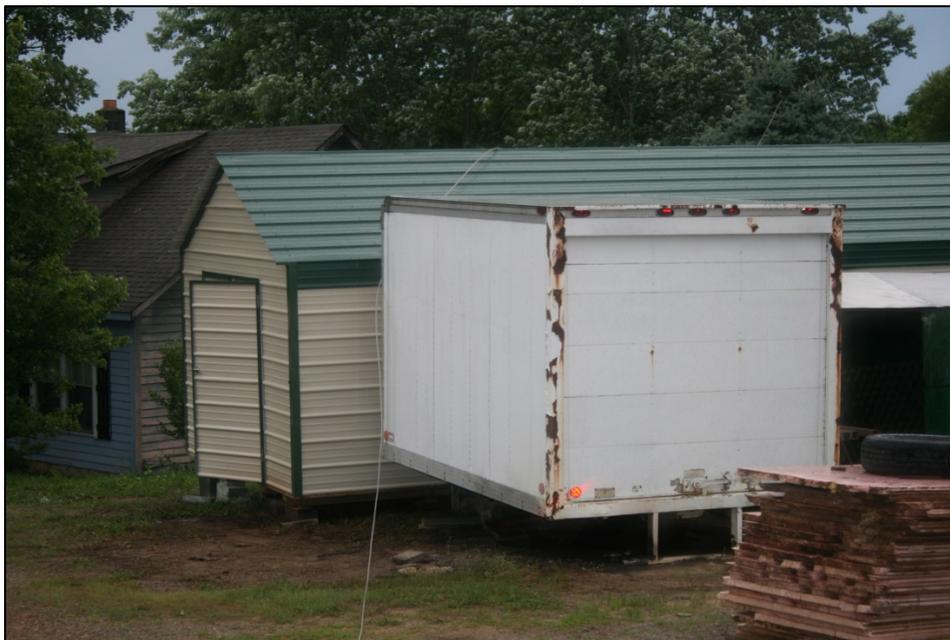
**View of metal building with downed power line in contact with roof.
Photo taken looking down driveway as seen by approaching fire
fighters.**

In this incident, the victim approached the metal storage building to investigate the source of smoke and flames coming from underneath the building. The victim may not have been aware of the downed power line in contact with the roof of the metal building. An eye witness reported that the victim knelt down as if to look under the building but did not appear to touch the building when he suddenly fell to the ground. He was found lying approximately three feet from the front of the building when other fire fighters came to render aid. The first fire fighter to reach the victim reported that he felt an electrical shock when he touched the victim’s neck to check for a carotid pulse. Rescuers dragged the victim approximately 30 feet away from the building and began to administer cardio-pulmonary resuscitation (CPR). The fire fighters administering CPR reported feeling electrical shocks as they attended to the victim. Rescuers need to protect themselves whenever the risk of additional injuries is present by moving farther away and making sure clothing and personal protective equipment is rated for electrical work. While rescuers took measures by moving the victim some distance from the electrical source,

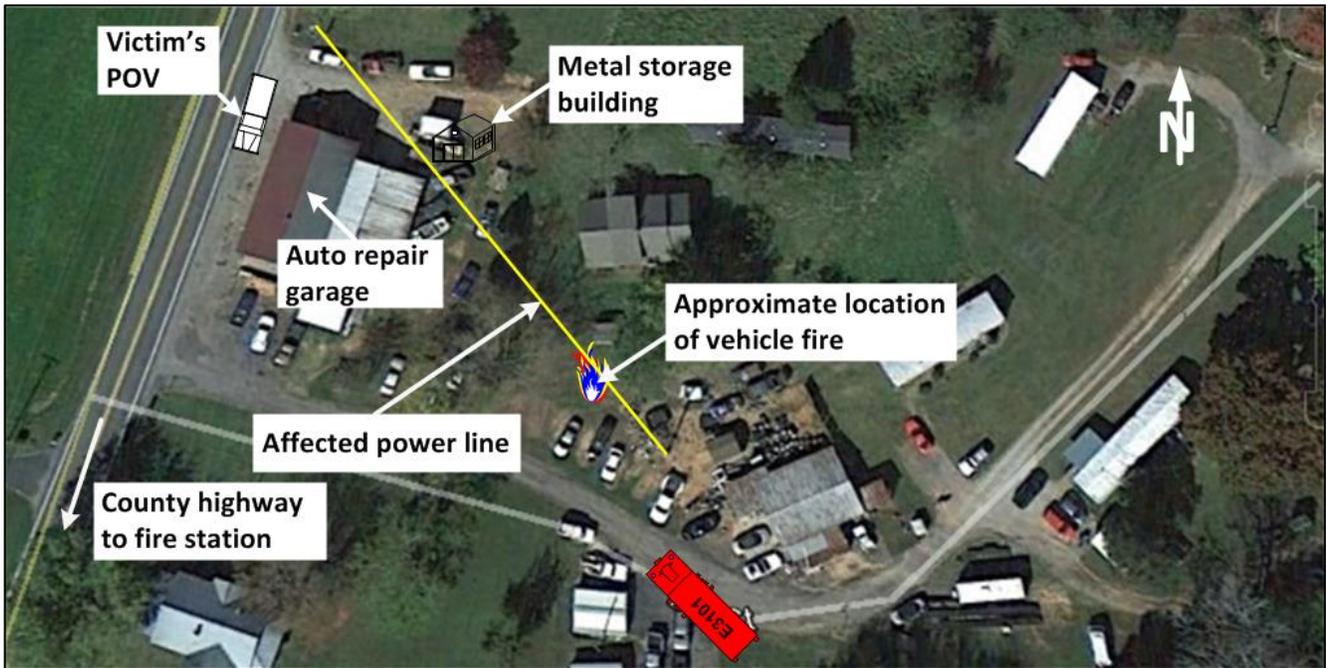
Diagram 1. Overhead view of incident site. Diagram adapted from Google Earth satellite image dated 10/20/2012. Note that the metal storage building was not present at the time the image was collected.

The incident occurred on a sloping hillside directly behind a commercial automotive repair garage that fronted a two-lane paved county highway (see Diagram 1 and Photo 1).

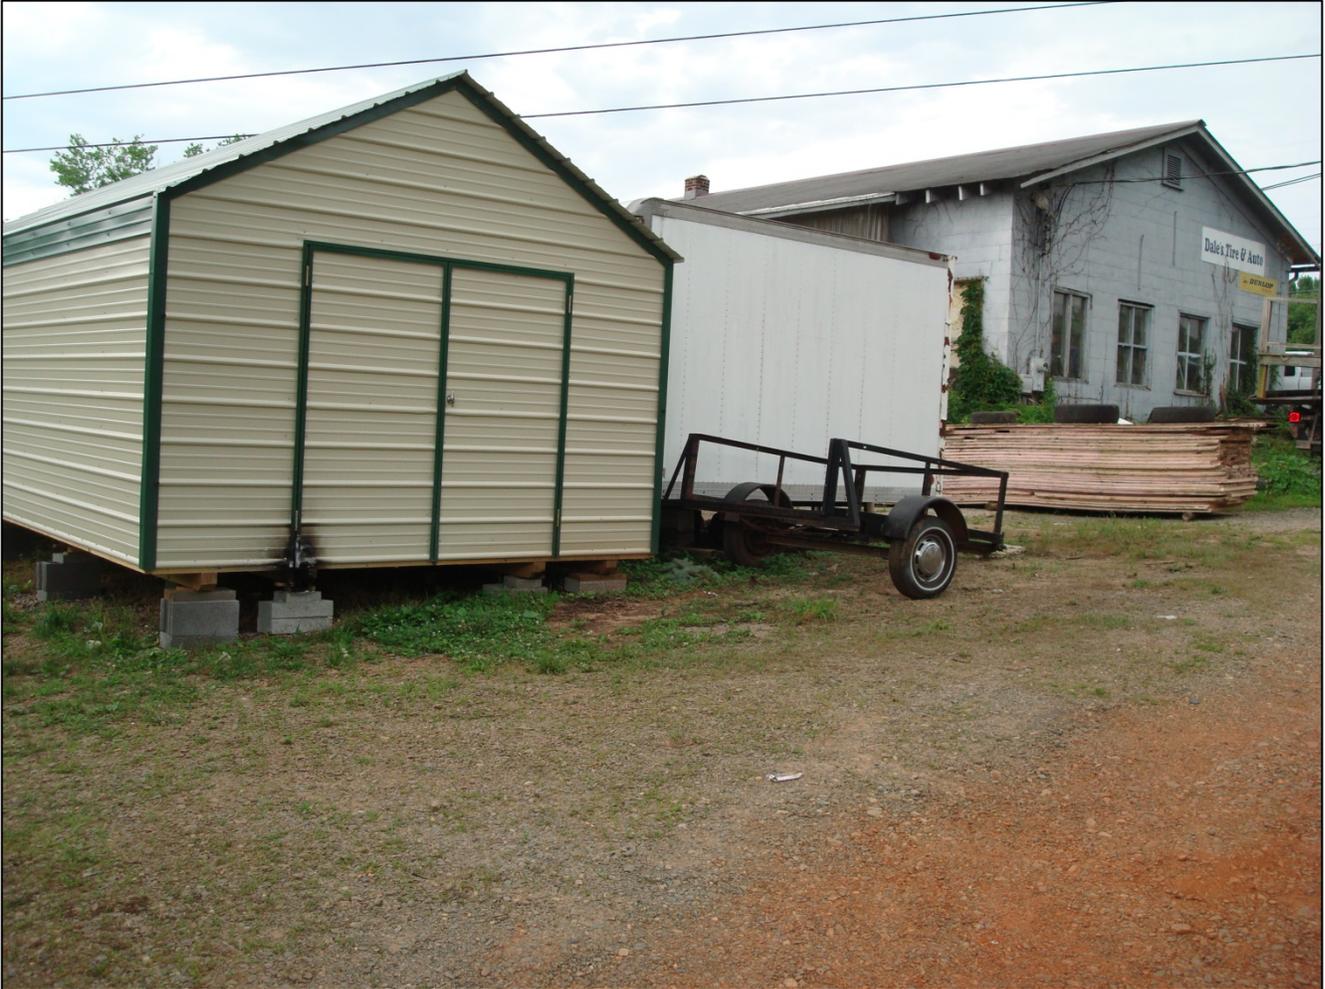
Photo 1. Incident scene looking up gravel and dirt driveway toward county highway. Automotive repair garage is seen in the background. Repaired power lines can be seen at top of photo over the metal storage building.

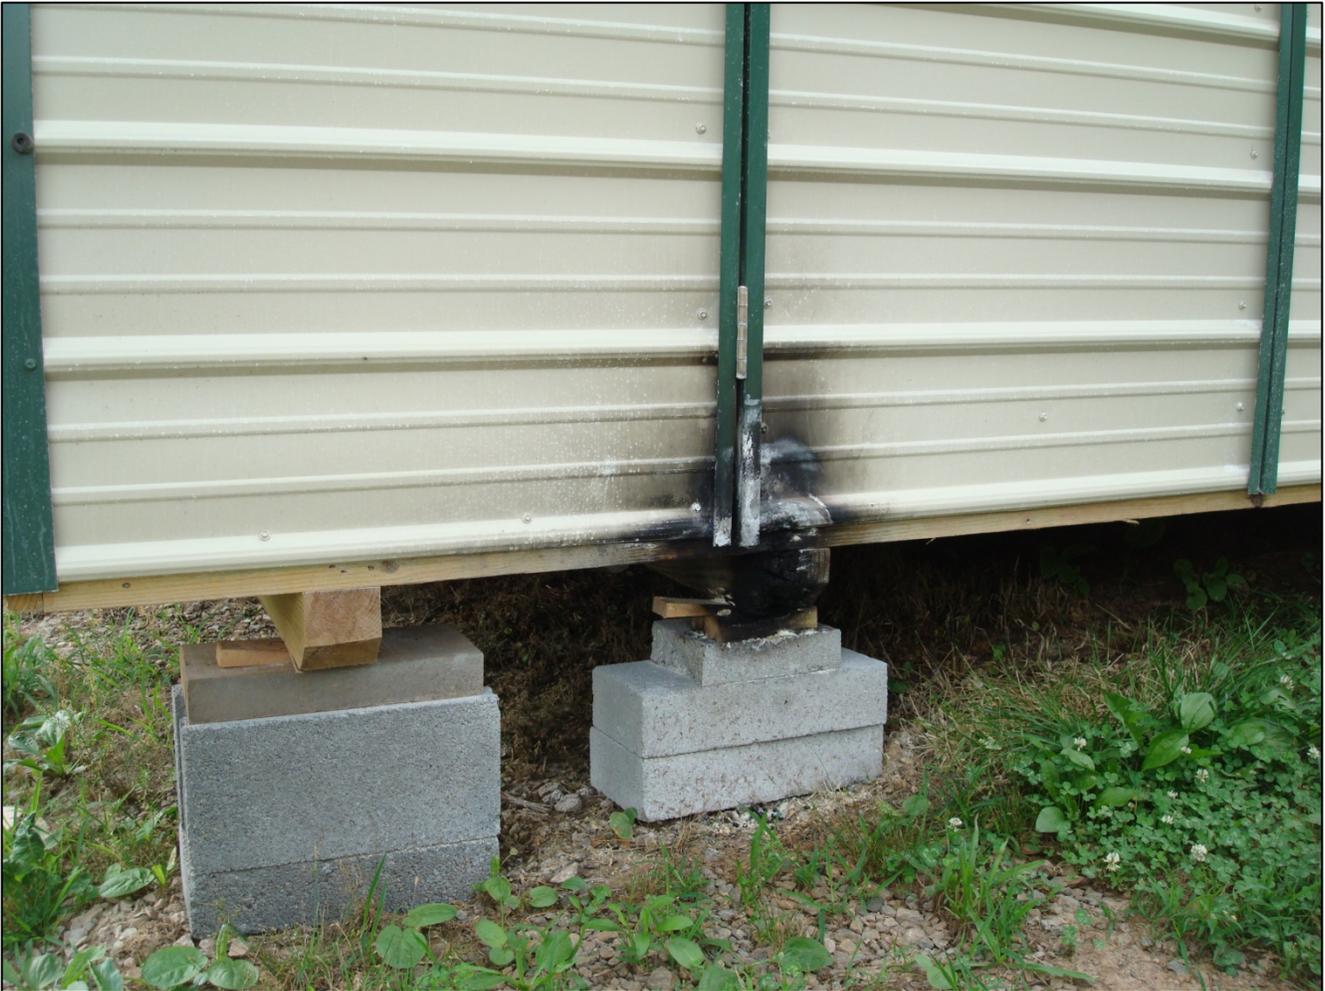
Photo 2. Close-up of metal storage building showing the support structure and location where electrical current went to ground, causing wooden supports to catch fire.

After responding to a report of downed power lines with a vehicle on fire, by-standers notified the arriving fire department members that a structure was on fire. Fire and smoke was observed coming from underneath a 12 foot by 16 foot metal storage building. The un-grounded building was supported by concrete blocks and 4-inch by 4-inch wooden posts (see Photo 2).

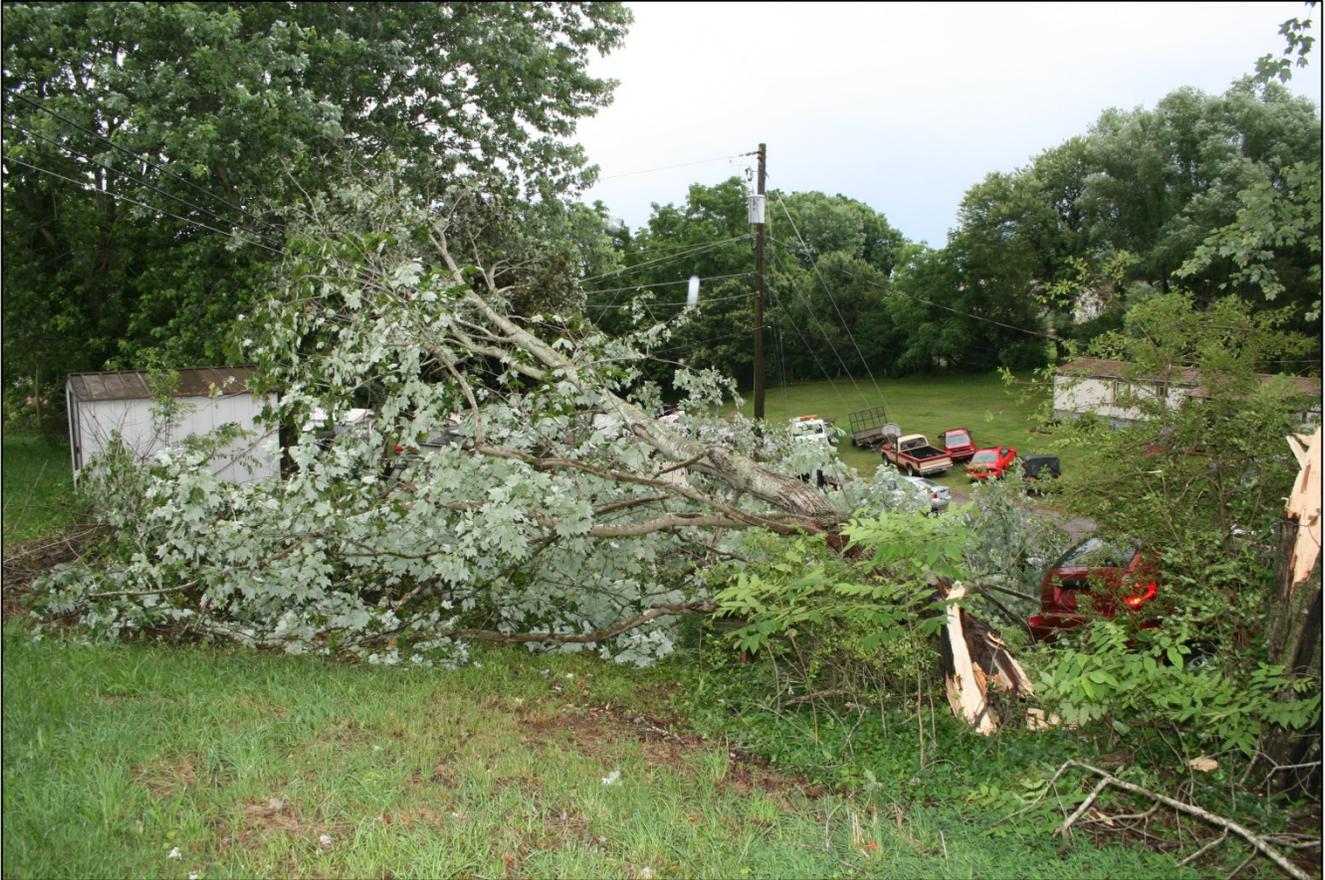
Photo 3. Tree branch resting on powerlines downhill from the incident site near metal storage building. The automobile fire was further down the hill and below the tree.
(Photo Courtesy of County Fire Marshal)

A rain storm with high winds passed through the area just prior to the incident, causing a large branch on a maple tree to break off and pull down an electrical service line, reported to be carrying 7200 volts of alternating current (AC). The downed wire came into contact with an automobile below the broken tree branch and the metal storage building above the broken tree branch (see Photo 3 and Photo 4).

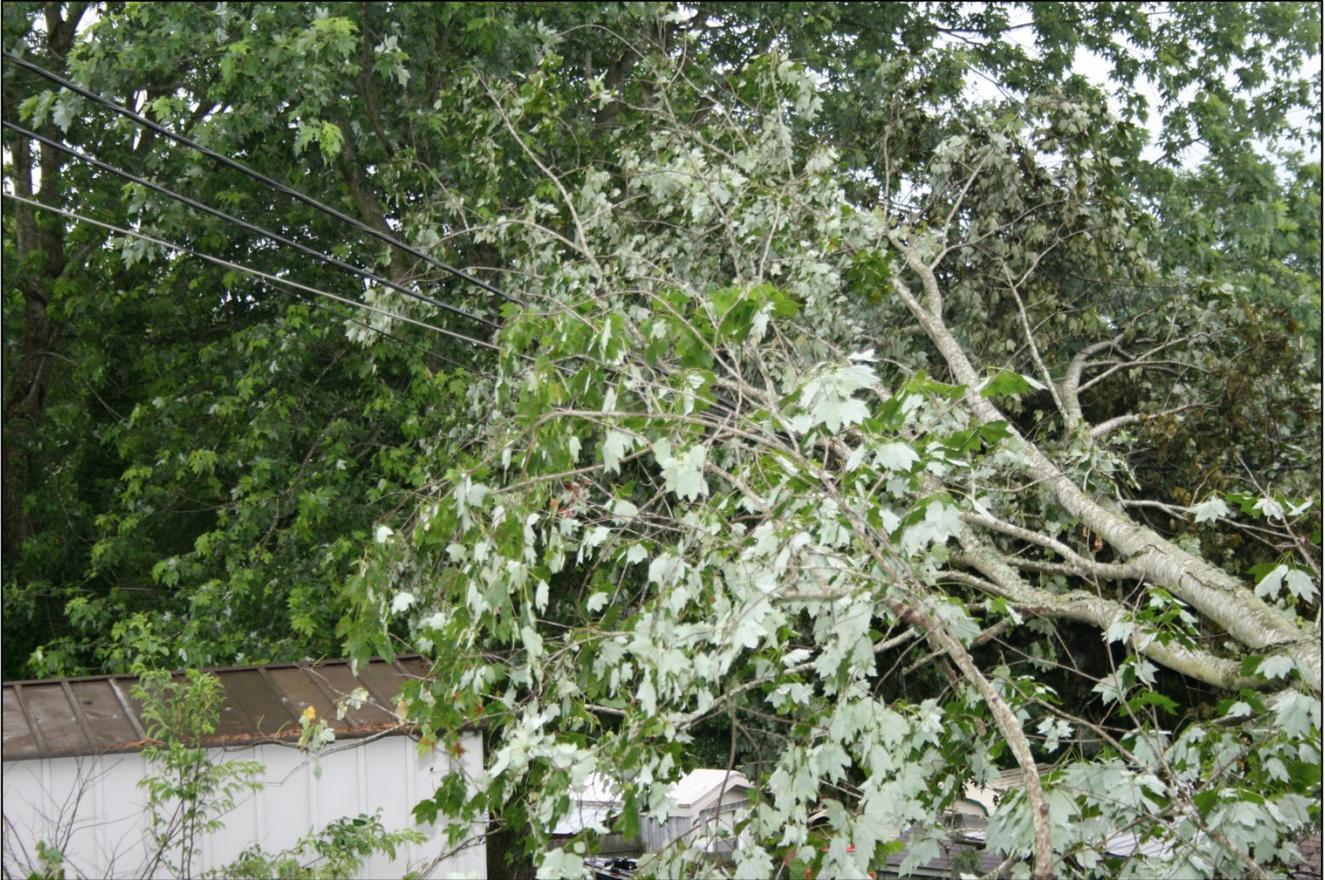
Photo 4. Close-up showing tree branch on power lines.
(Photo courtesy of County Fire Marshal)

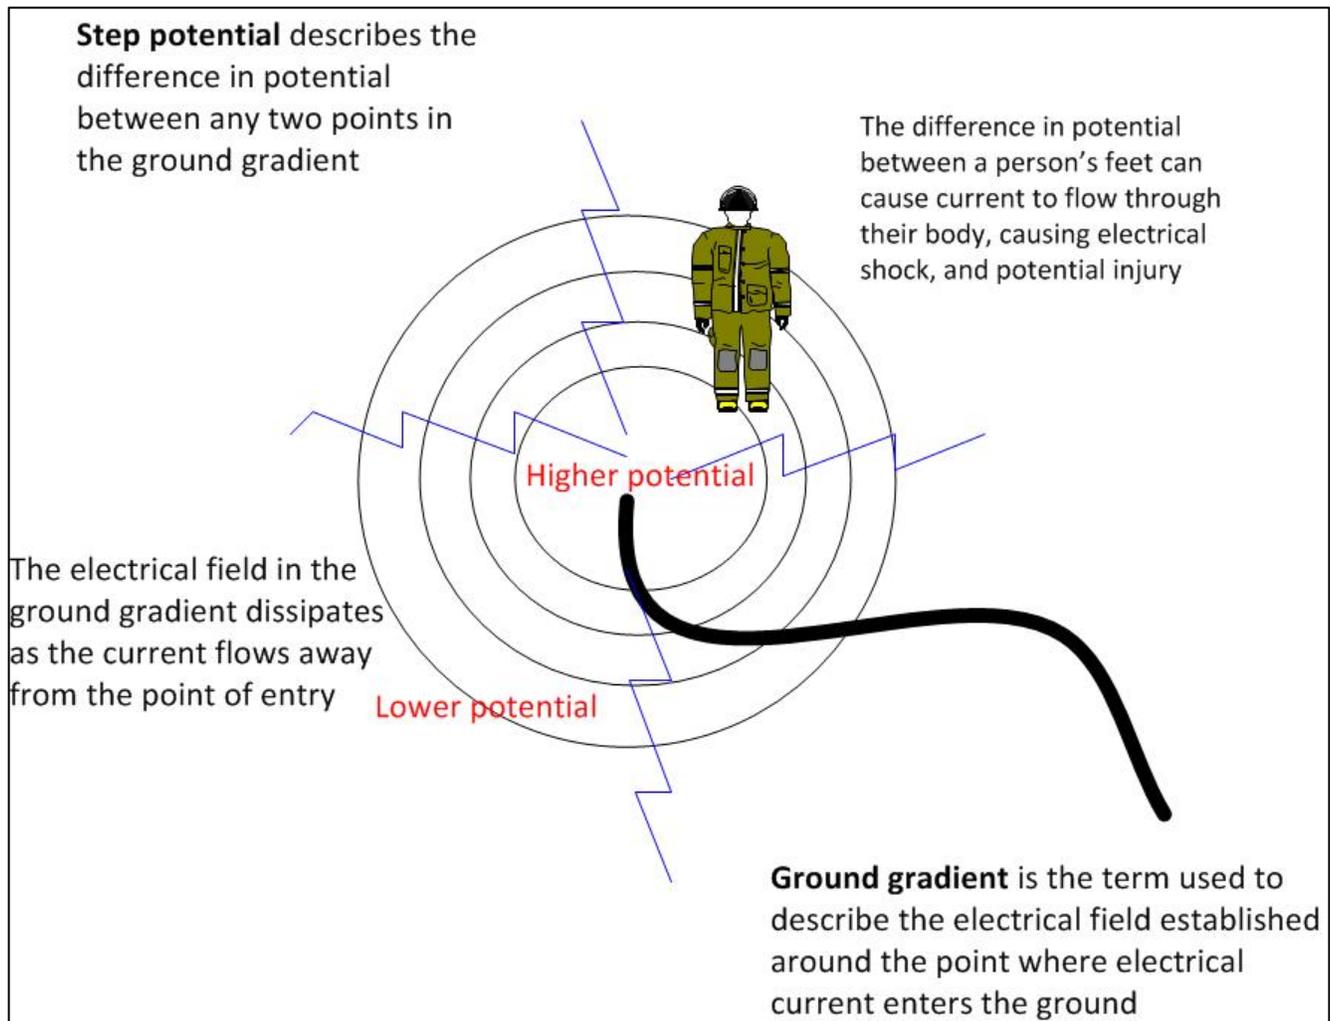
Figure 1

The electrical field established around a downed power line. The electrical field is stronger and the ground gradient higher near the point the electrical current enters the ground.

ground can cause electrical current to flow through the fire fighter's body. Step potential can be reduced or eliminated by wearing the appropriate non-conductive footwear, keeping the feet together or shuffling the feet in small sliding motions. The presence of water or moist damp conditions can increase the size of the ground gradient.

electrocution. Fire fighters attempting to approach downed power lines or compromised electrical equipment may feel a tingling sensation in their feet, legs or body. This is a danger sign known as ground gradient. Ground gradient is electrical energy that has established a path to ground through the earth and is energizing the earth around the point where the electrical current enters the earth. A downed power line can energize the ground in concentric rings of decreasing energy of up to 30 feet or more, depending upon the voltage of the electrical source and environmental conditions such as rain or snow. A fire fighter who feels a tingling in their boots must back away in a shuffling motion keeping both feet in contact with the ground at all times. In some cases, the electrical system can still be intact and pose a hazard to fire fighters, particularly when aerial apparatus and aluminum ground ladders are used near energized power lines and electrical equipment. Although it rarely happens, electricity can “jump” conductors, if a conductor comes close to the exposed wire or power connection.⁴ Fire departments should train all fire fighters on the potential hazards associated with ground gradients and step potentials.

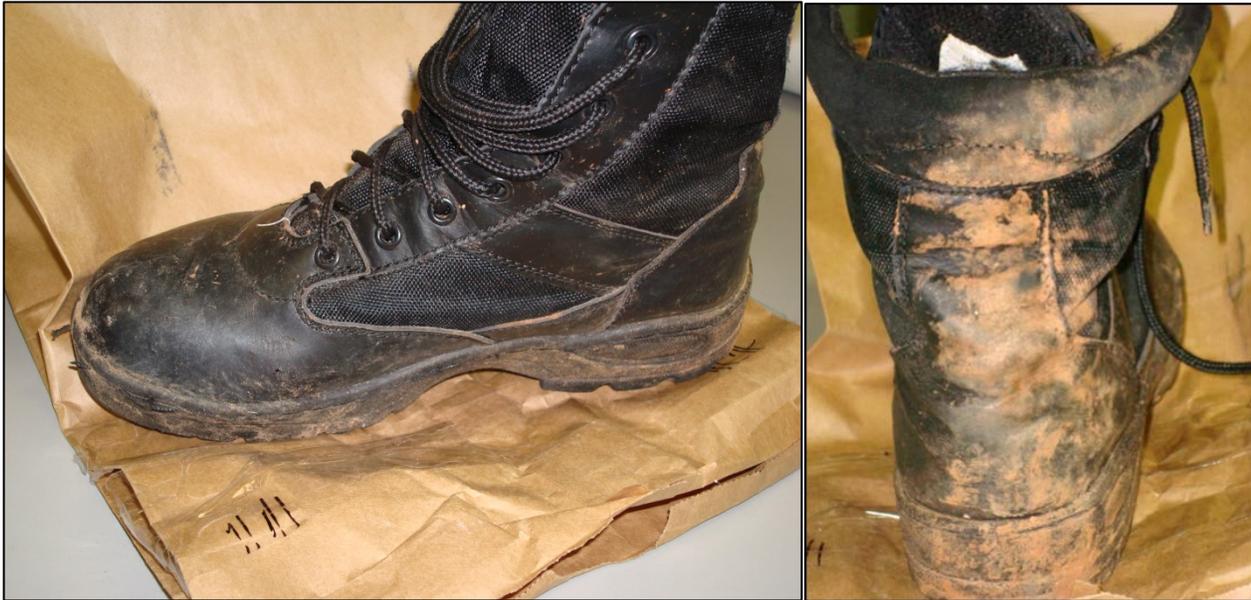
**Photo 5 (left) and Photo 6 (right). Photos show right boot worn by victim at time of incident.
Note mud on boot, indicating boot was worn in a wet, muddy area
(NIOSH photos.)**

At the time of the incident, the victim was wearing blue jeans, a tee shirt and lightweight boots similar to station duty boots (see Photo 5 and Photo 6). The victim was carrying a portable radio which was found on the ground after the victim was transported to the hospital. The fire department had a standard operating procedure for vehicle fires stating that before entering the danger zone, all fire department personnel shall have complete protection in the form of turnout pants, boots, properly closed coat, helmet, hood, gloves and SCBA. It was reported that the victim’s fire fighting turnout clothing was found in his personally-owned-vehicle (POV) after the incident. The right boot was examined by the NIOSH Investigators at the County Fire Marshal’s office. The left boot was not available for examination. Small burn marks were noted near the toe of the right boot (see Photo 7 and Photo 8). There was no evidence the boots were rated for electrical work.

In this incident, the victim was wearing street clothes and lightweight boots that were not rated for electrical work. The ground was reported to be saturated with rainwater at the time of the incident. It was reported that the victim's structural fire fighting personal protective clothing and equipment were found in his personal vehicle after the incident. The use of the appropriate personal protective clothing and footwear may have provided better protection to the victim, possibly resulting in a different outcome.

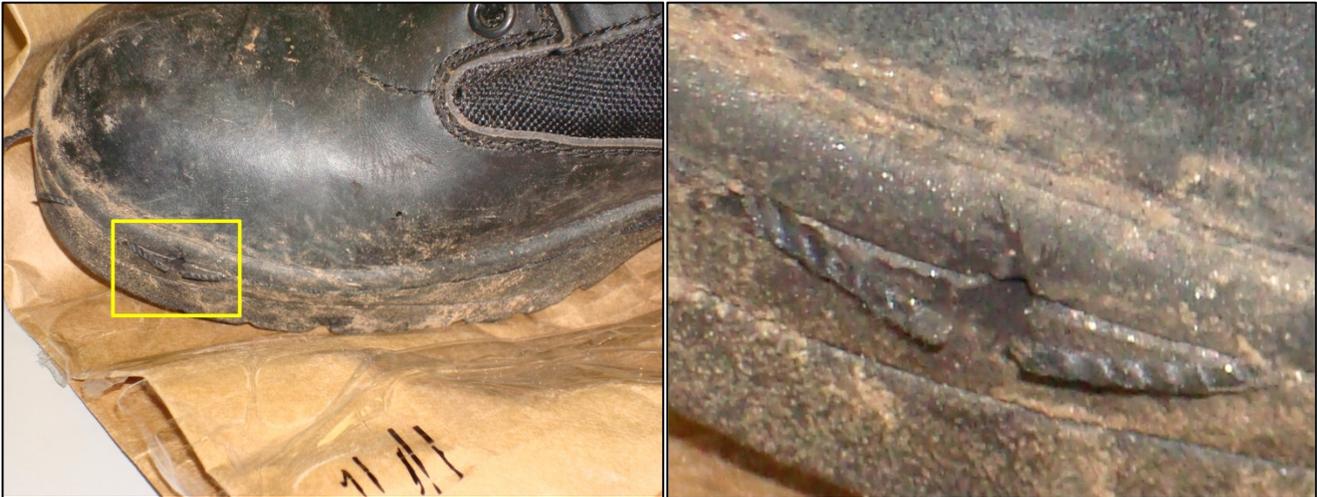
Photo 7 (left) and Photo 8 (right – enlarged). Right boot worn by victim. Note hole near toe – probable exit hole where current exited body. This area of boot corresponds with burn injuries identified in coroner’s report.
(NIOSH photos.)

The autopsy report noted burn injuries on both of the victim's feet and the left forearm that likely marked the flow path of the electrical current. The victim was dressed in street clothes, lightweight boots, and the ground was reported to be saturated from the recent heavy rainstorm.
