ORAU TEAM Dose Reconstruction Project for NIOSH

Document Title: Pinellas Plant – Site Description	Document Number: ORAUT-TKBS-0029-2 Revision: 01 Effective Date: 10/04/2006 Type of Document: TBD Supersedes: Revision 00
---	---

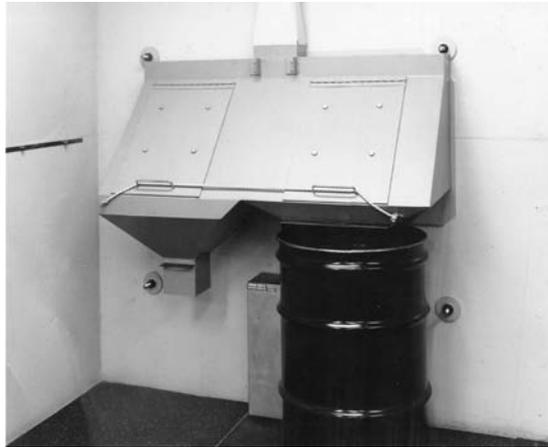
Figure 2-5. Boom box and collection container (ORAUT-2006-0163).

The radioactive waste would have been comprised of the generator remains, Styrofoam pieces and particulates, plywood, cables and connectors. This would be collected in the container as shown in Figure 2-5. (ORAUT-2005-0272)

For the "Boom Boxes", a special treated plywood barrier was installed inside of the chamber doors to deflect some of the detonation. They were rotated 90 degrees after each generator test, allowing for four tests. Particles of the generator would imbed into these boards.
