**SUBJECT:** A Construction Worker Dies When a Fully Extended Scissor Lift Falls Over

**SUMMARY**  
**California FACE Report #10CA008**

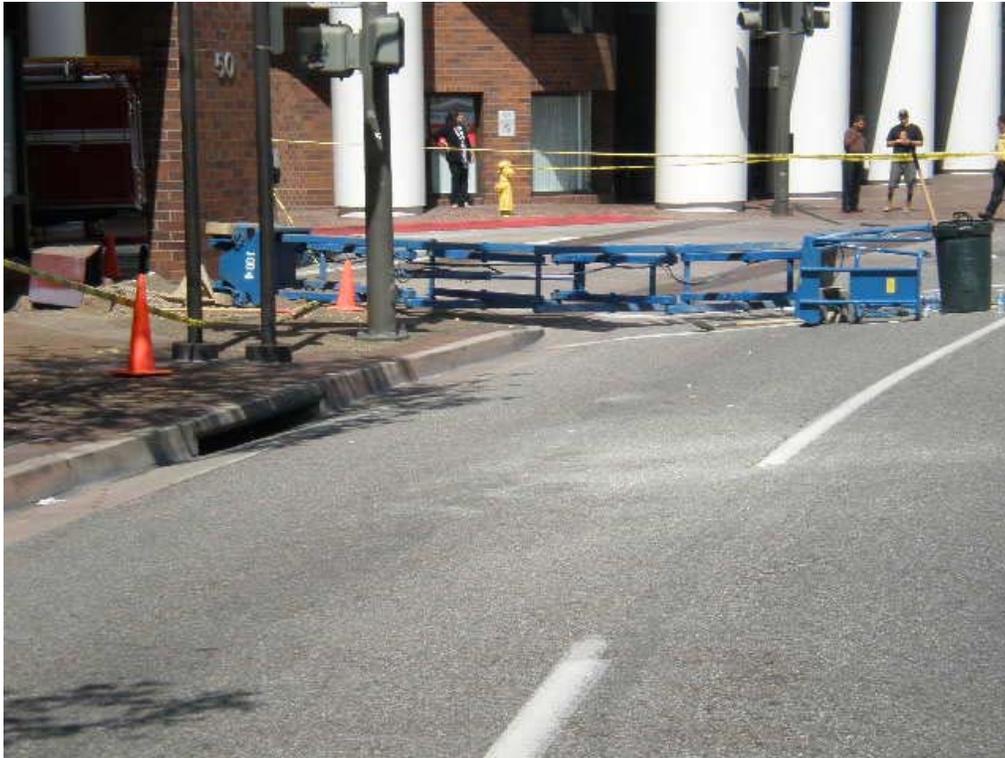
**Exhibit 1. The toppled scissor lift.**

Discussion: In this incident, the superintendent rented a scissor lift that was too small for the job. A larger lift was to be delivered to the job site later that day, but the work crew proceeded to use the smaller one that had already been rented. In so doing, they most likely exceeded the maximum load capacity, creating an unstable condition. When the planter box was shifted onto the platform, the combined weight caused the scissor lift to topple. In using scissor lifts, it is necessary to assess the work process to ensure that the load movements do not exceed the equipment's capacity. In this incident, the load capacity of the smaller scissor lift was 500 pounds and was probably exceeded by the weight of three workers and the materials handled. If a larger scissor lift with outriggers or an industrial forklift had been used on this job, the planter box could have been removed safely.

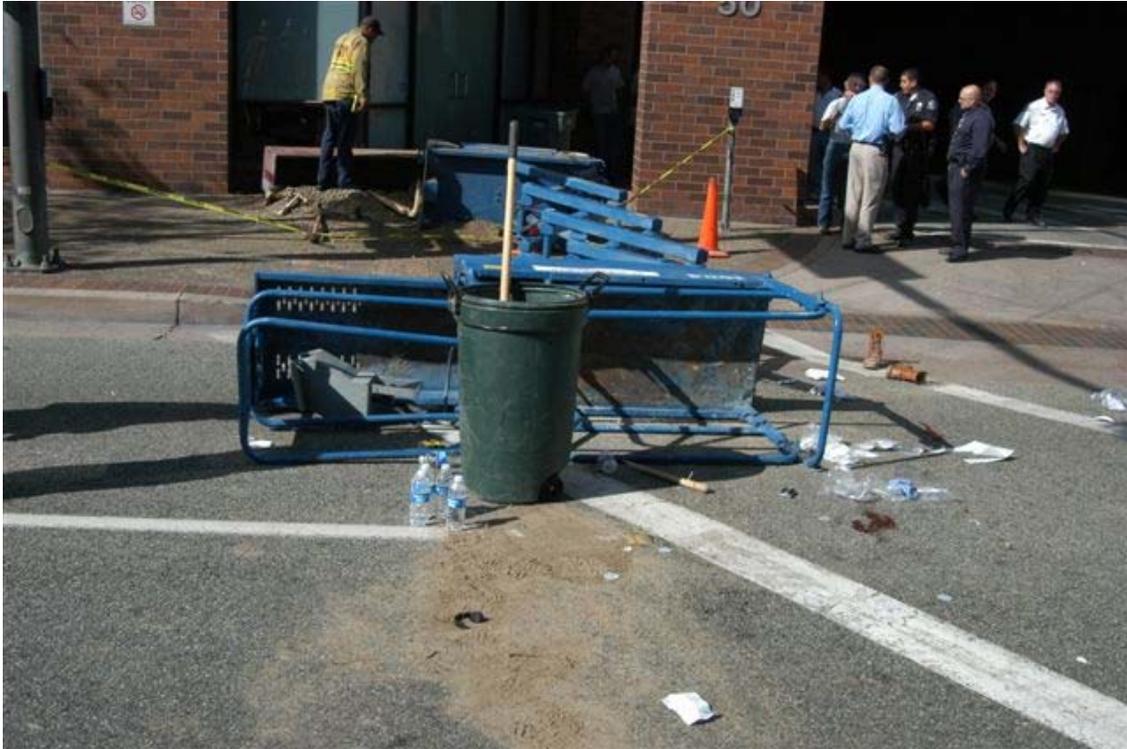
**Exhibit 2. The work platform on the toppled scissor lift.**

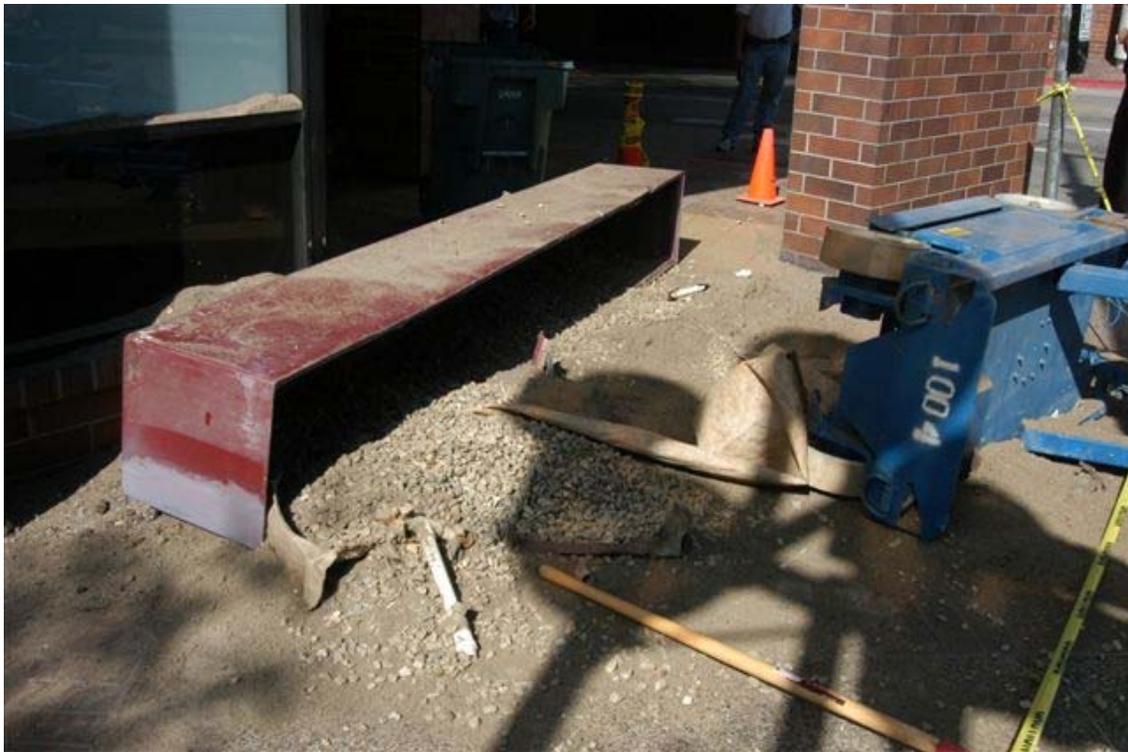
**Exhibit 4. The planter box that knocked over the scissor lift.**

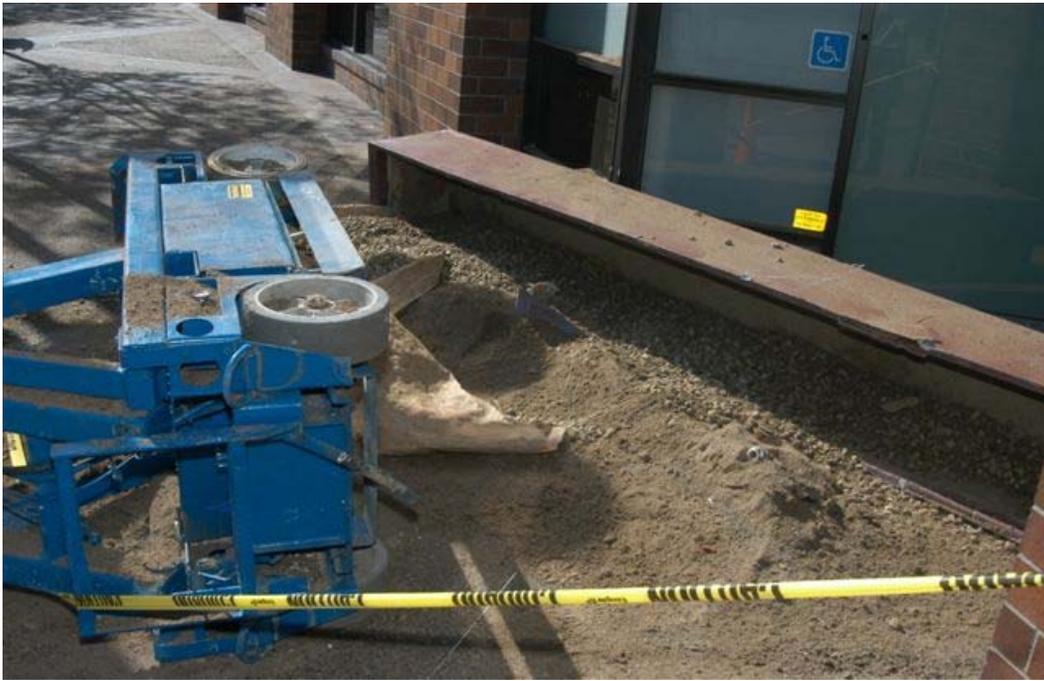
**Exhibit 6. The dirt and gravel that was in the planter box when it fell off the ledge.**
