Semi Tractor-Trailer Driver Dies in Median Crossover Crash; 10 Others Die

Incident Number: 10KY008

Kentucky Fatality Assessment and Control Evaluation (FACE) Program

Release Date: March 30, 2012

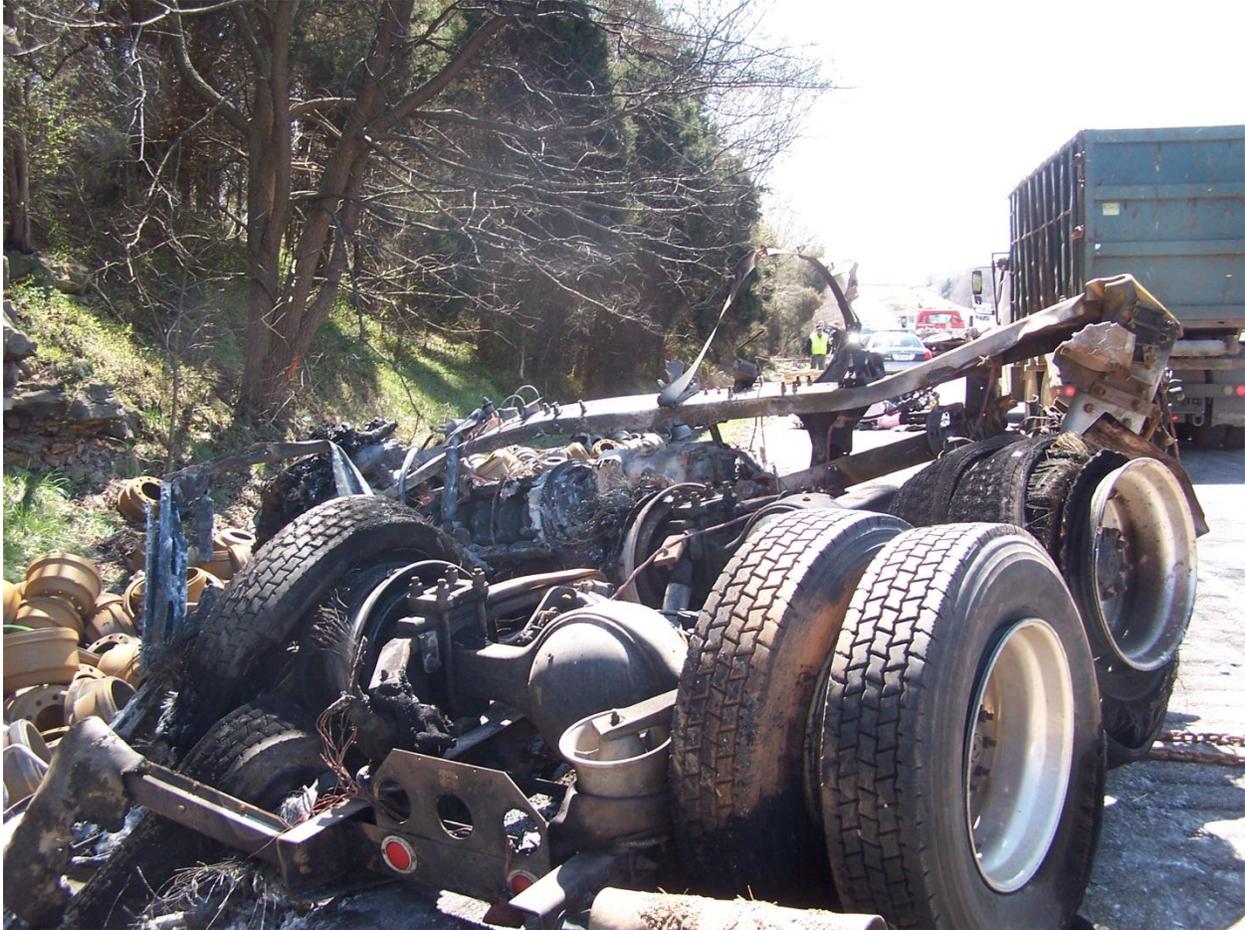
Picture of semi involved in median crossover crash. Picture property of KY FACE.

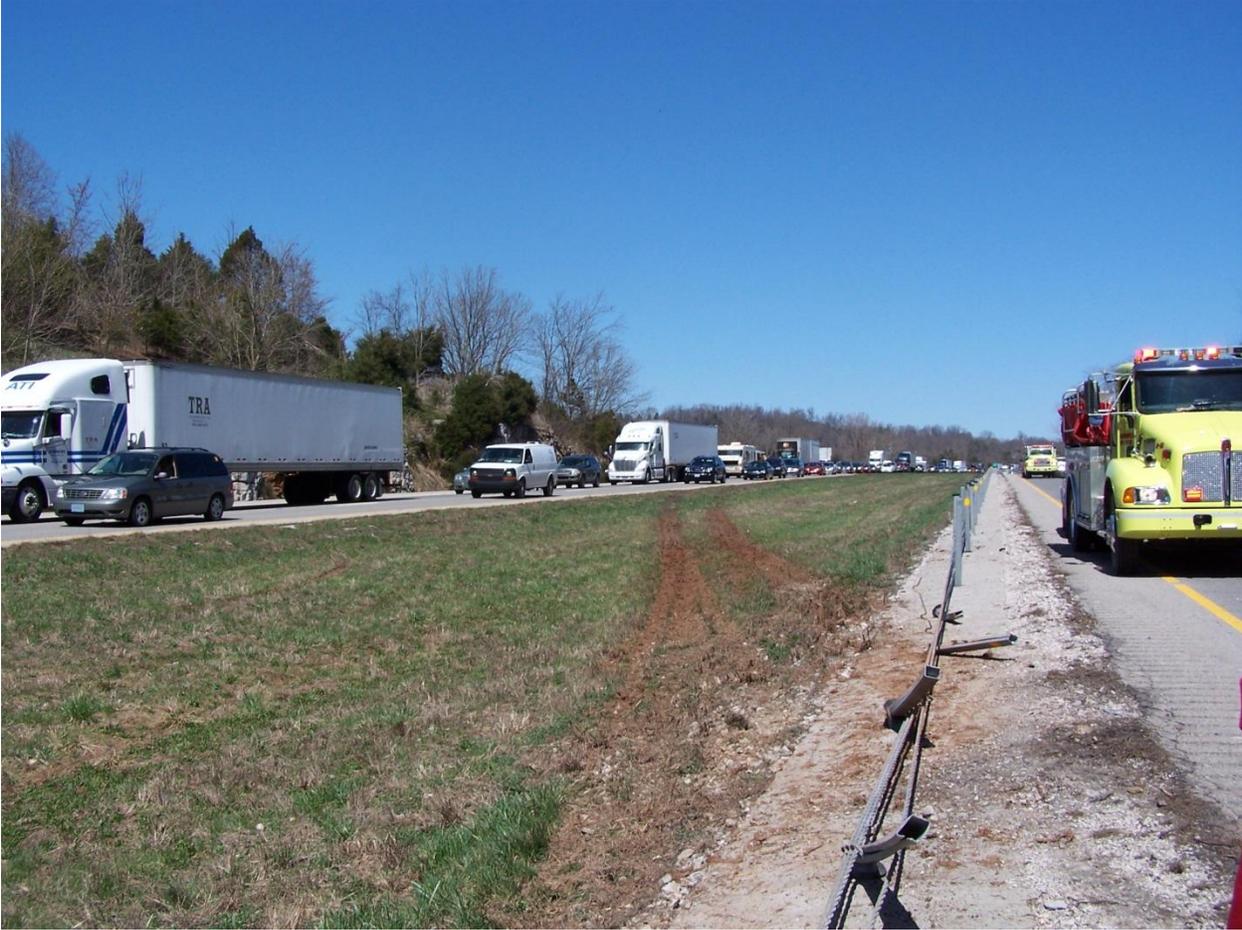
the left travel lane. A 60-foot wide grass median, depressed in the middle, separated the north and south travel lanes. Each travel lane was 12' wide. Both directions had 11' wide right-hand shoulders. The southbound direction had a 3.5' left-hand shoulder, and the northbound side had a 4' left-hand shoulder. Each shoulder had rumble strips and were delineated with yellow stripes. Travel lanes in both directions were separated with dotted white lines. There was a 4 strand Test-Level 4 cable barrier eight feet from the northbound left travel lane. Due to the slope where the cable barrier was located, it met Test-Level 3 criteria.

At approximately 5:14 am the driver was talking on his cell phone when the call was dropped. The recipient of the call made several unsuccessful attempts to reconnect with the driver. As the cell phone call dropped, the driver of the semi drove out of the left southbound travel lane, over the left side rumble strip, through the median where he applied his brakes, ran over the four-strand cable barrier, crossed the two northbound travel lanes and right shoulder, and traveled across a ditch and into a cut rock wall. The semi tractor-trailer turned onto its right side and the semi and trailer caught fire. Brake drum parts spilled from the trailer into the ditch along the cut rock wall.

Picture of semi truck path through median. Picture property of KY FACE.

Interstate medians are designed and constructed to drain water away from road surfaces, to give errant drivers space to regain control of their vehicles, to provide space for emergencies, and to help prevent crossover median crashes. The median in this crash was narrow (60’ wide) and had a four-strand cable barrier (test level 4) eight feet from the left hand northbound travel lane. This type of barrier is not designed to stop a 80,000 pound or more semi truck. Cable test level 4 barriers are capable of preventing passenger vehicles and cargo trucks (up to 18,000 pounds) from crossing medians by stopping or deflecting the vehicle back onto the side of the interstate the vehicle was traveling. It is recommended that test level 5 barriers be installed on interstate highways with narrow medians and high volumes of truck traffic. A 42-inch test level 5 barrier is capable of containing and redirecting an 80,000 semi truck.

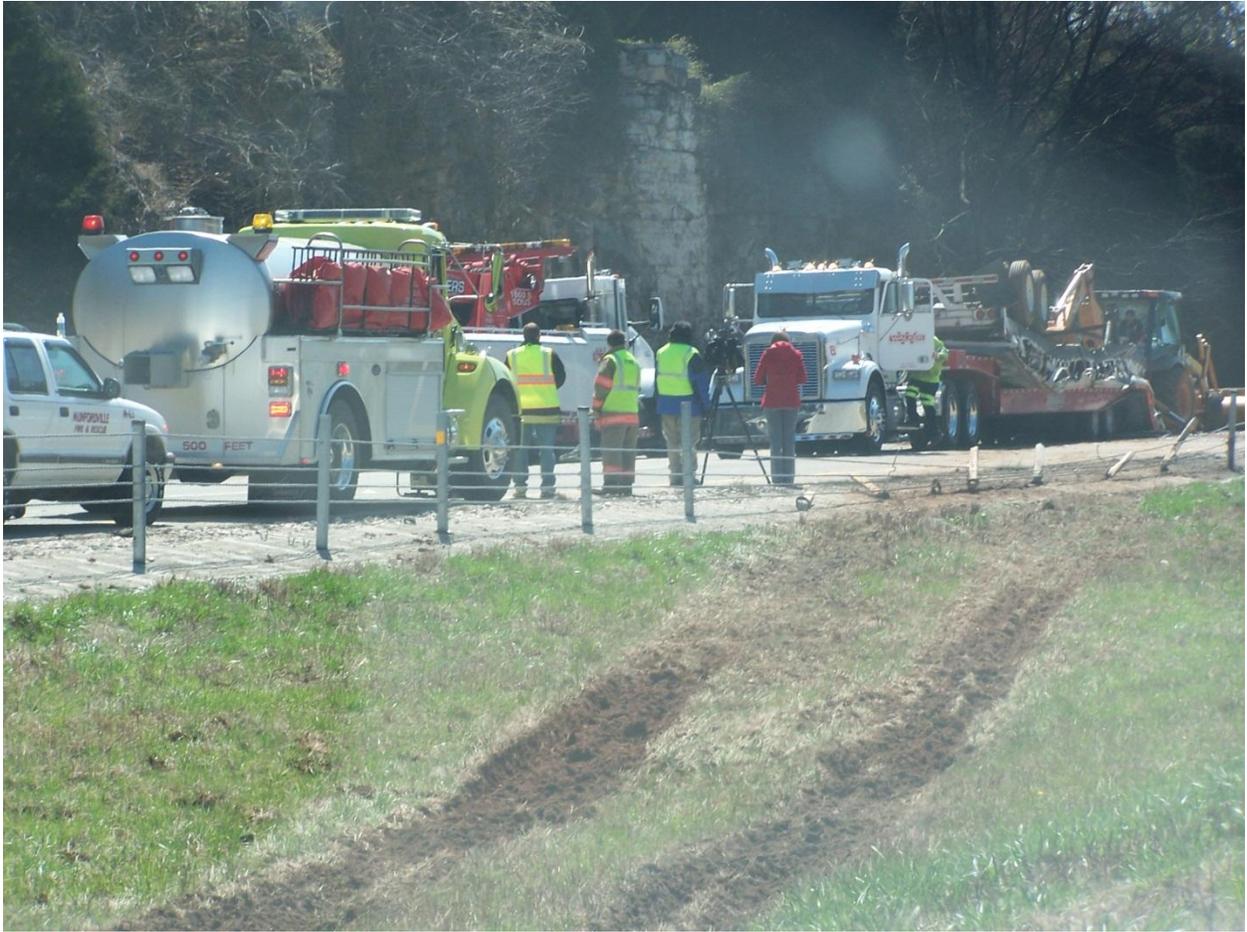
Picture of brake marks in median. Picture property of KY FACE.

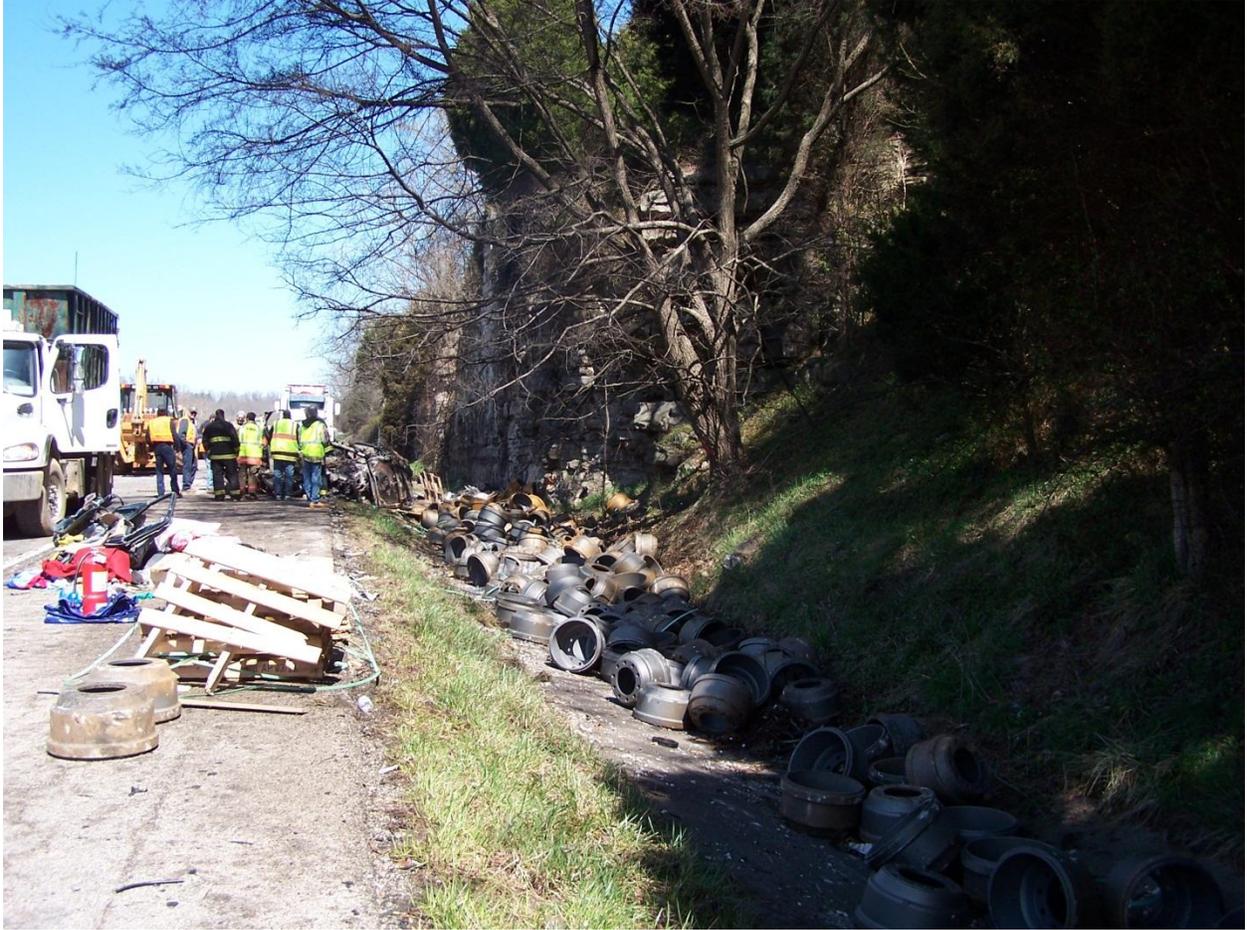
Picture of ditch, cut rock wall, and truck brake drums. Picture property of KY FACE.
