Operator Dies after Being Caught between Bulldozer's Track and Fender

Investigation: # 10WA015
Release Date: September 14, 2012
SHARP Report: # 52-26-2012

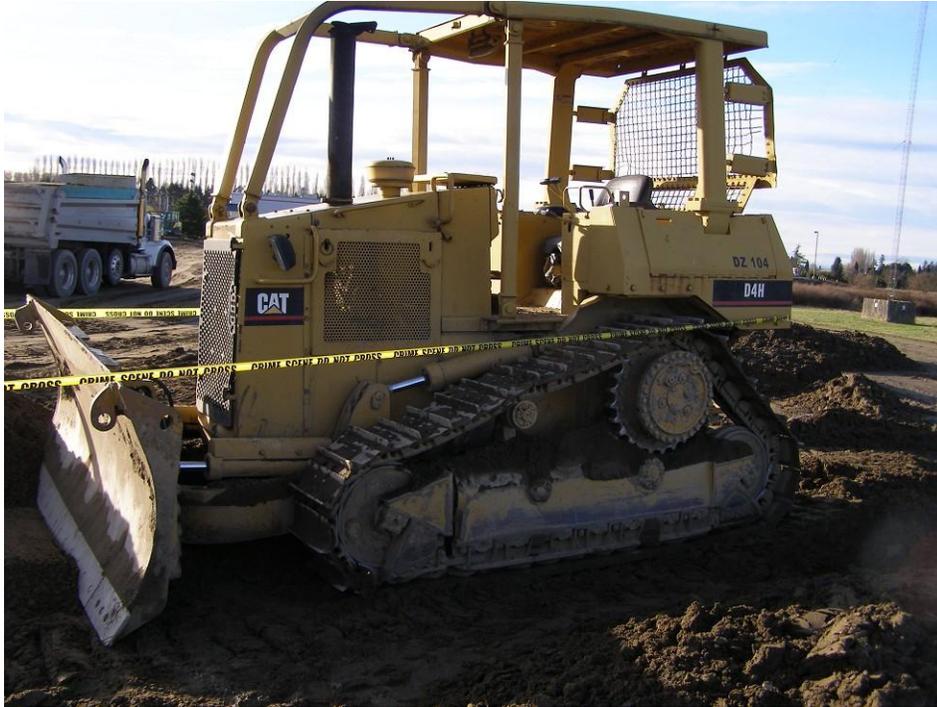
The equipment involved in the incident is a 1991 Caterpillar D4H Series II track-type tractor, also known as a bulldozer. The employer purchased the bulldozer used about eight years previous and made no modifications to it. The bulldozer is powered by 4-cylinder turbocharged diesel engine rated at 95 hp at 2,200 rpm (see photo #1).

Photo 1: Caterpillar D4H bulldozer at incident site.

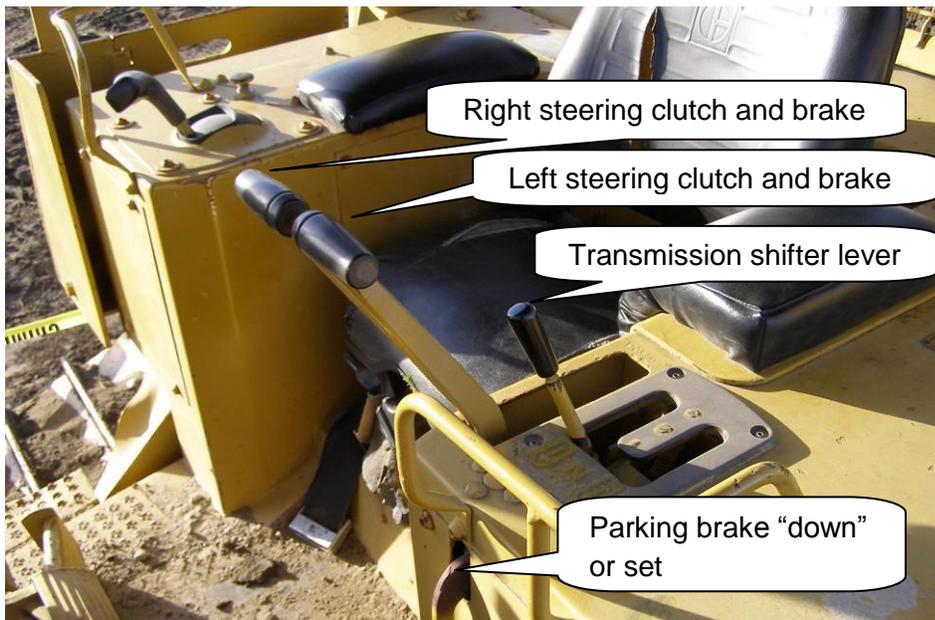
The transmission is engaged by a planetary power shift with three gears forward and three gears in reverse (see photo #2). It is a type of bulldozer known as a “high track.” The high track type of bulldozer has a high sprocket configuration for the track and the cab is higher from the ground than other bulldozers of comparable size.

Photo 2: Cab and operator controls. Note: the parking brake is in the “down” position, which locks the transmission in neutral, thereby preventing movement of the equipment.

On this type of bulldozer, if the parking brake lever (also known as the safety lever) is set, then the transmission shifter lever is locked in neutral, preventing the equipment from movement. If the parking brake is not set, then the equipment is able to move when in gear. The parking brake is engaged by a lever to the left of the operator's seat. If the brake lever is in the engaged position, the lever is in the "down" position, which

allows the operator to safely exit the cab on the left side (see photo #2). If the brake is not set, the lever is in the “up” or horizontal position, which obstructs the operator from easily exiting (without having to step over the lever) from the left side of the cab (see photo #3).

On this bulldozer when the parking brake control lever is in the “down” position the parking brake is set and the machine will not move (See photo 2). Unfortunately, in this incident, the operator left the parking brake lever in the “up” position when he left the cab, and when he attempted to return to the cab he inadvertently moved the transmission shifter lever from neutral to reverse, causing the machine to move (See photos 3).

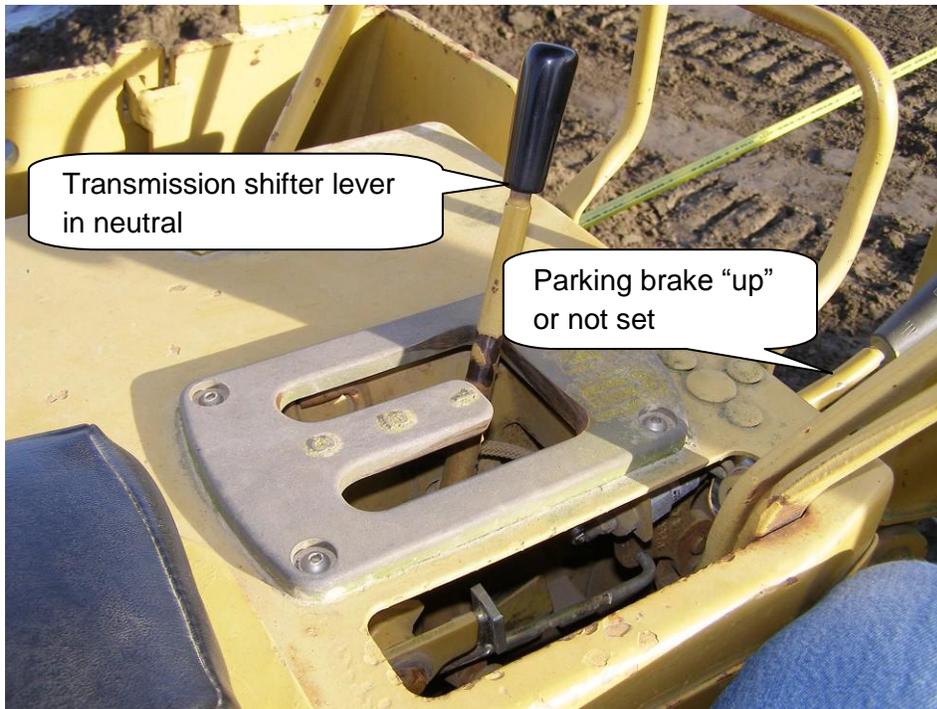
Photo 3: The parking brake is in the “up” or not set position and the transmission is in neutral and unlocked, as viewed from the operator’s seat. The transmission lever may now be shifted into “forward” or “reverse”, allowing for movement of the bulldozer.

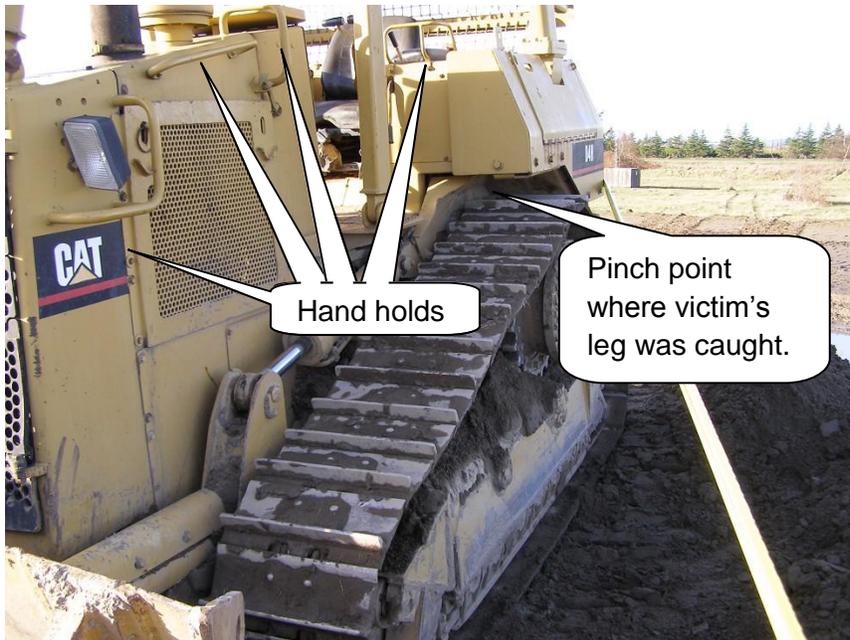
The operator exited the right side of the cab and walked a few feet over to the driver’s window of the truck to speak with the driver. After giving instructions to the driver as to where to dump the fill, the operator walked to the left side of the bulldozer and walked up its left track, starting at the front of the track. There are several handholds positioned on the bulldozer to aid in climbing up and down from the operator’s cab. As he was standing on the top of the track and about to enter the cab, he reached with his left hand toward the support handhold near the transmission shifter lever and his elbow hit the transmission shifter lever, knocking it out of neutral into reverse, causing the bulldozer to start moving backward. When the track started to move his left foot became caught between the track and the underside of the fender (behind which is the battery box). His

left leg was pulled in and crushed between the track and the underside of the fender and he was thrown on his back, landing on the track (see photos #4 and #5). He was carried away by the dozer and was ejected from the equipment and landed on the ground about 5 to 6 feet in front of the truck.

Photo 4: Left side of bulldozer showing track, access system handholds, and pinch point between track and fender where the victim's left leg was caught and crushed.

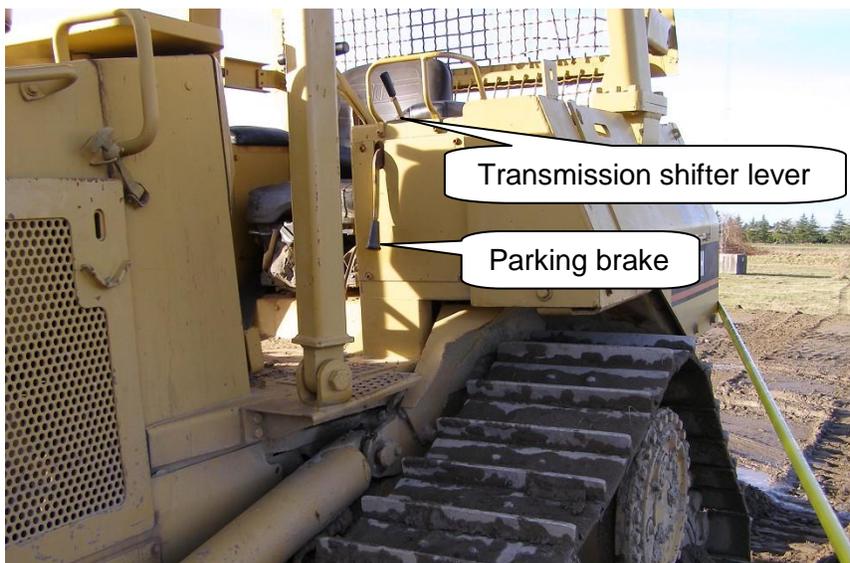
Photo 5: Left side of bulldozer where the victim's left leg was caught between the track and fender. Note that the parking brake lever is in the "down" position, which locks the transmission shifter lever in the neutral position, thus preventing unintended movement of the bulldozer. In this incident, the parking brake lever was in the "up" or horizontal position and the bulldozer's engine was running, so that when the victim attempted to re-enter the cab he inadvertently knocked the transmission shifter lever into reverse, causing the bulldozer to move.

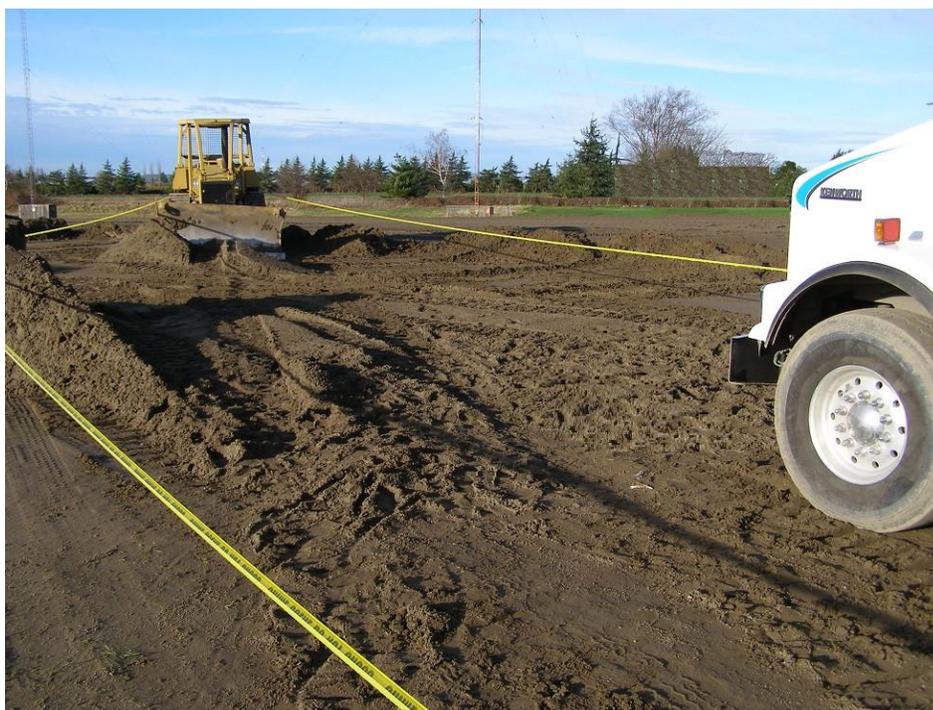
The truck driver with whom the operator had just spoken made a call from his truck radio to a second driver who was on site to call emergency medical services (EMS) and then he went to aid the operator. Another truck driver went to stop the bulldozer that had continued to travel in reverse (see photo #6). The employer's safety officer, who also works as an emergency medical technician at the local fire department and was on duty, heard the call over his radio and arrived at the scene within three minutes, just ahead of the fire department EMS responders. The operator was taken by ambulance to a hospital where he died of his injuries 15 days later.

Photo 6: Incident scene showing where the bulldozer came to rest after an employee turned it off.

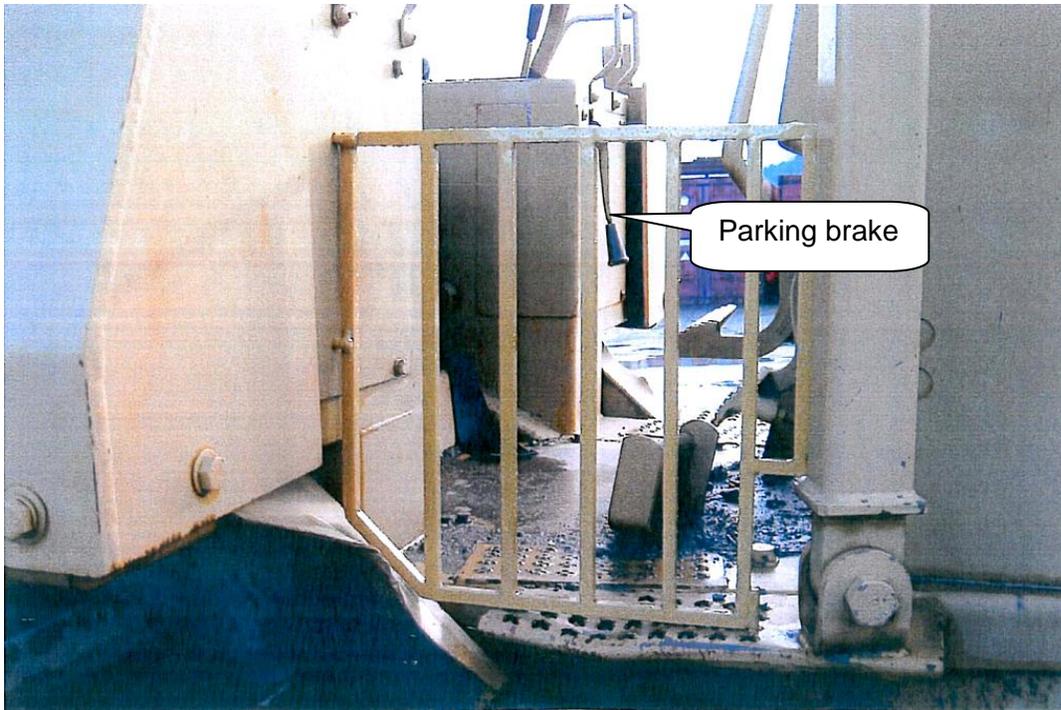
Photo 7: Post incident the employer added this barrier to the right side of the bulldozer cab so as to restrict the operator from exiting on this side. Photo shows the parking brake in the “down” position which locks the transmission in neutral, preventing the machine from moving. The operator can now properly exit by the left side of the cab. If the parking brake is not set the lever is in the “up” or horizontal position which restricts the operator’s path of exit from the left side of the cab, thereby serving as a reminder to set the parking brake.

After the incident, the employer fitted a metal barrier to the right side of the cab so as to restrict the operator from exiting on that side (see photos #7). This design modification to the cab does not necessary solve the problem of an operator leaving the cab without following proper safety procedures for parking the bulldozer. However, at best, it potentially channels the operator to exit to the left and hopefully set the parking brake.
