SUBJECT: A Day Laborer Dies When He Falls Off a Scaffold

SUMMARY
California FACE Report #11CA002

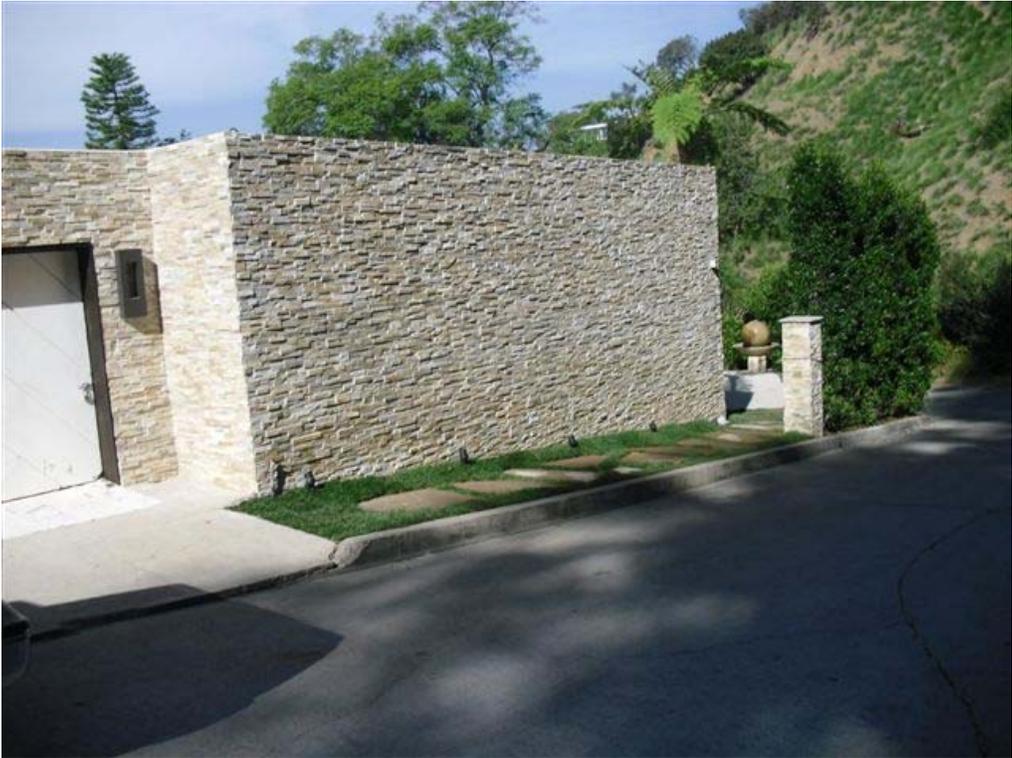
The site of the incident was a private residence. The home owner had asked his gardener if he knew anyone who could reface the exterior of his home with a stone and stucco facade. The gardener hired the victim from a street corner to perform the work. The victim rented a scaffold from a local home improvement store and used it to access the exterior of the house. The victim rented five-foot scaffold frame sections, diagonal braces (two for each section), a walk board, and a side and end panel that were to be used as guard rails on the top section of the scaffold.

Exhibit 1. The stone and stucco work at the incident site.

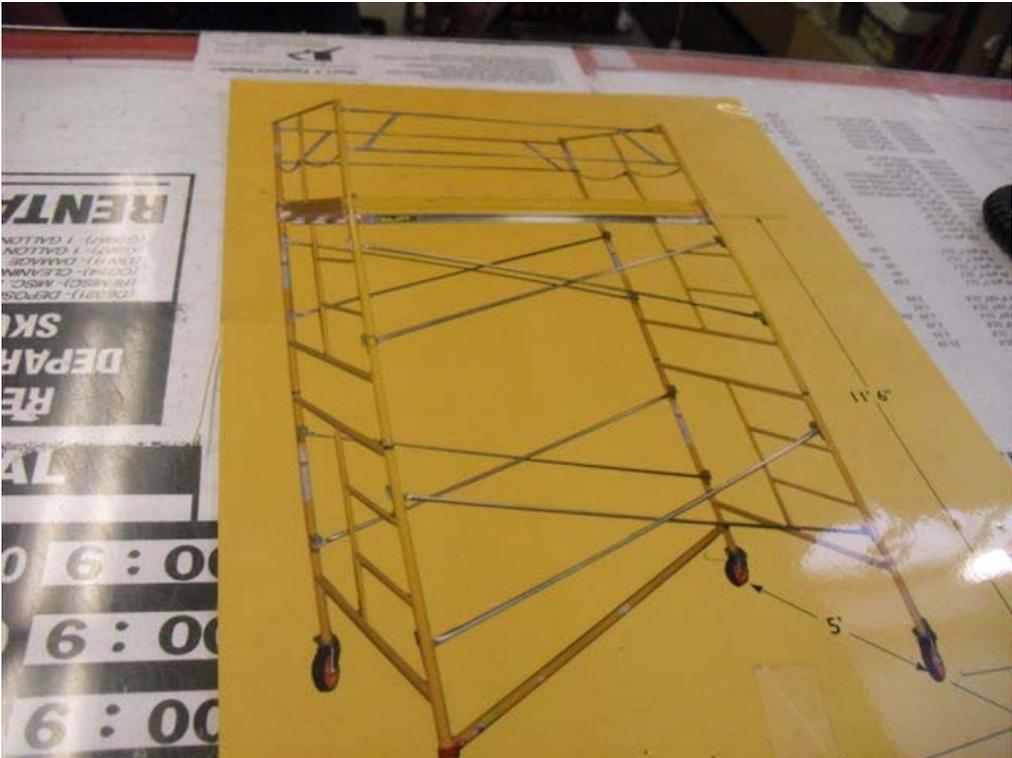
The victim erected the scaffold but it was leveled using improper methods. The walk board was not properly secured, and the guard rails on the top portion were not attached. He then used the scaffold to gain access to the upper portions of the home's exterior wall. The victim was working alone off the scaffold walk board, approximately 12 feet above ground level and was not wearing any fall protection devices. The victim worked for two days performing the job. On the third day, he continued applying the stucco and stone façade. At one point, the victim reached for a cell phone that was being handed to him by the homeowner's gardener. The walk board shifted and he fell off the scaffold to the ground below. The homeowner's gardener immediately came to his assistance and called 911. Paramedics responded within minutes and treated the victim and then transported him to a local hospital where he died from his injuries.

In this incident the unstable walking board, lack of guardrails and fall protection allowed the victim to fall off the scaffold to the ground below. In California, workers who are elevated more than 7 ½ feet off the ground are required to use fall protection. In this case the use of guard rails would have been adequate fall protection. In lieu of guard rails, the victim should have worn a personal fall arrest or personal fall restraint system. In either case, the use of fall protection would have prevented this incident from occurring. Had the victim been properly trained and made aware of the safety hazards associated with the job, he might have assembled the scaffold correctly and secured the walk board, installed guard rails, or worn a personal fall arrest or restraint system.

Exhibit 2. A schematic of the scaffold involved in the incident.

Recommendation #1: Ensure they receive training and are competent in the use of scaffolds and fall protection.
