Career Fire Fighter Dies After Being Trapped in a Roof Collapse During Overhaul of a Vacant/Abandoned Building—Michigan

Fatality Assessment and Control Evaluation Investigation Report # F2008-37 MI

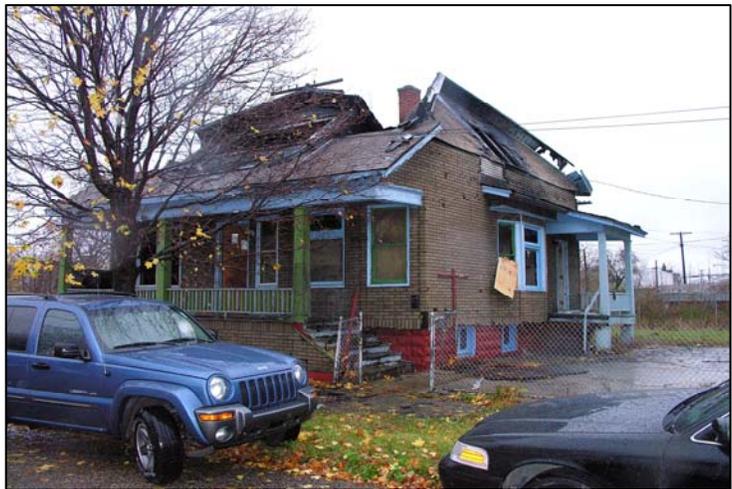
(Photo courtesy of the fire department arson unit.)

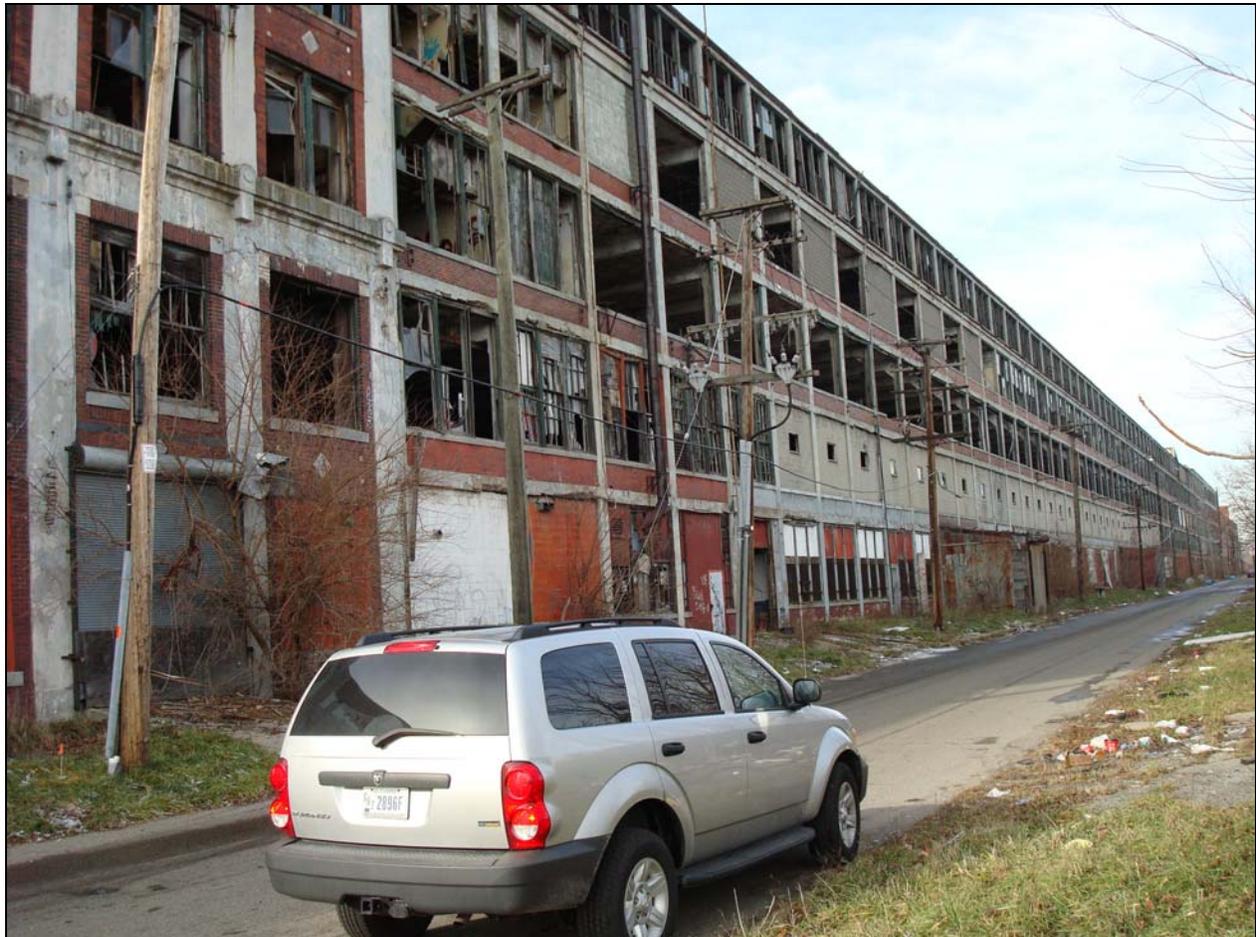
Photo 1. Vacant/Abandoned industrial building.
(Photo by NIOSH.)

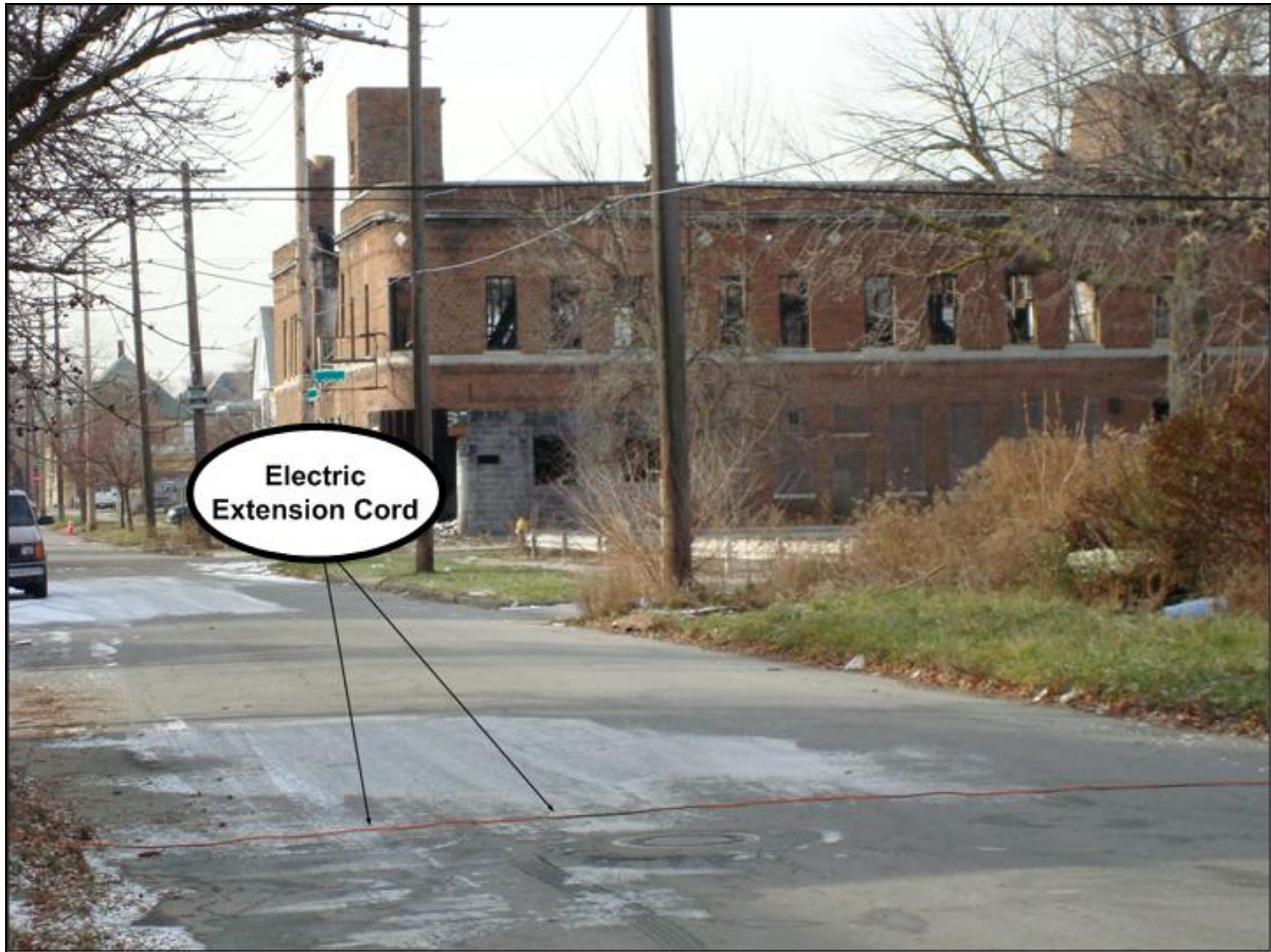
Photo 2. Abandoned factory that experienced a previous fire approximately 10 years ago. Note the power cord in the street. Fire Fighters reported that it was not uncommon to find an alternate power source such as this that provided power to another structure.
(Photo by NIOSH.)

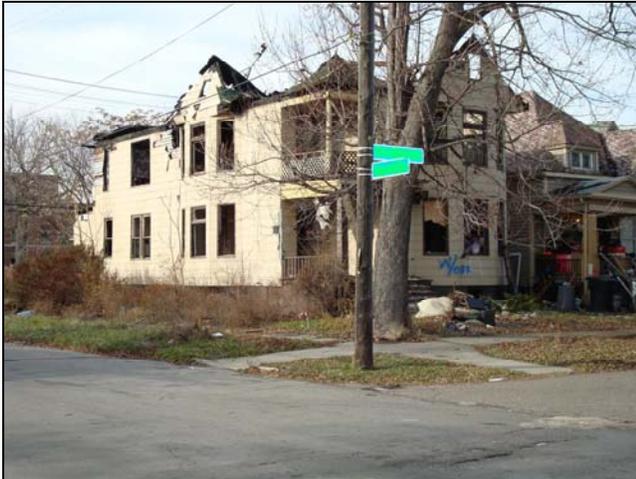
Photo 3. Abandoned/Derelict residential structure that has experienced a previous fire and collapse.
(Photo by NIOSH.)

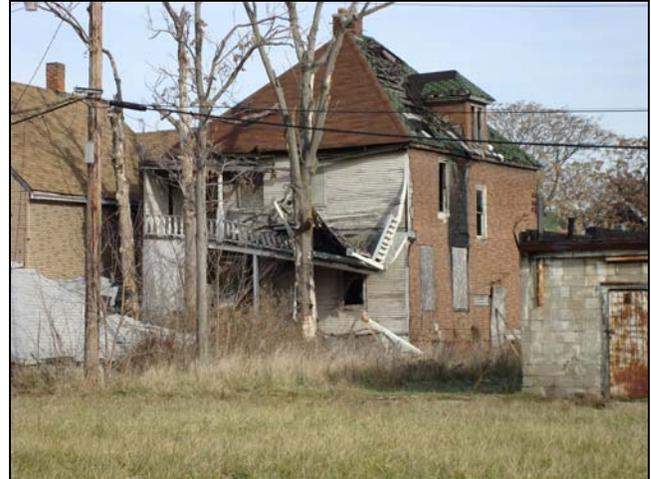
Photo 4. Abandoned/Derelict residential structure that has experienced a previous fire.
(Photo by NIOSH.)

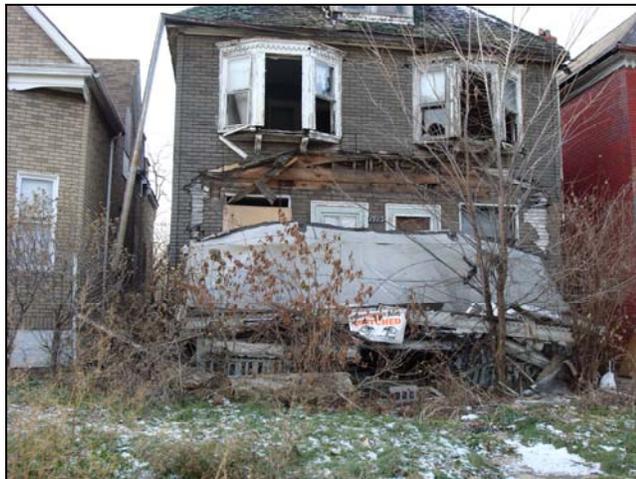
Photo 5. Abandoned/Derelict residential structure that has suffered extreme decay.
(Photo by NIOSH.)

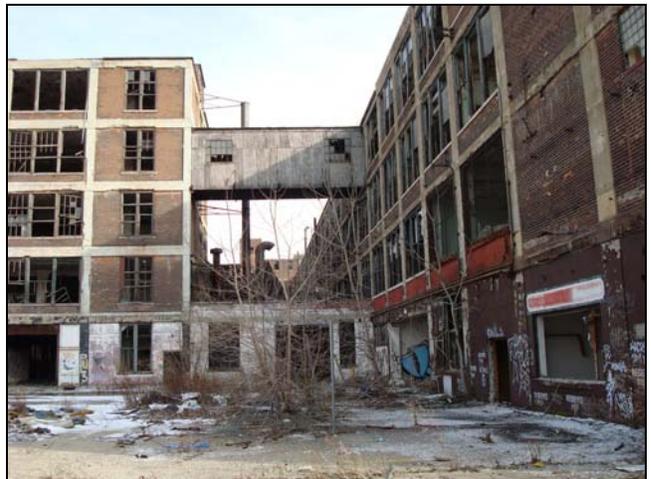
Photo 6. Vacant/Abandoned industrial building. The building has reportedly experienced several fires and has numerous hazards such as open floors and areas that have been vandalized by persons seeking scrap metal and fixtures.
(Photo by NIOSH.)

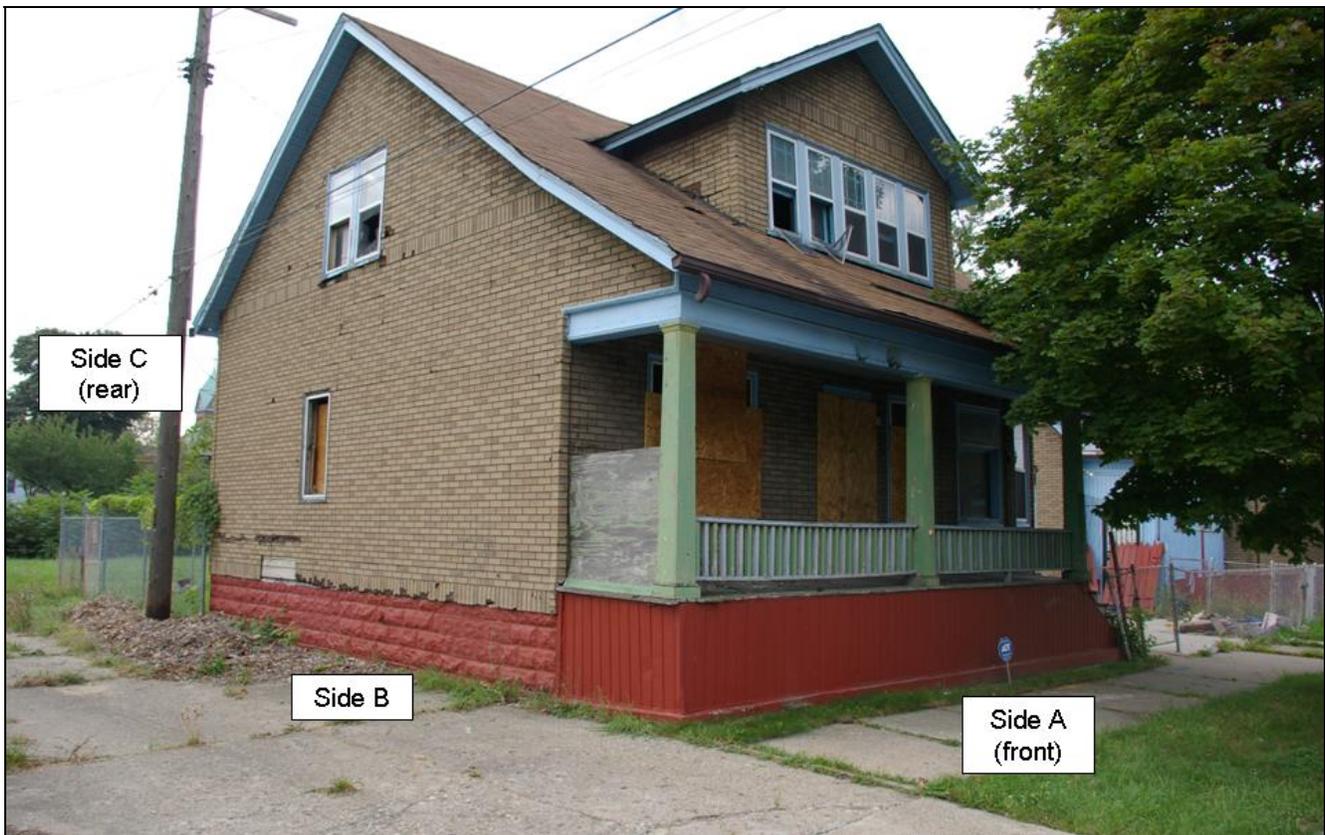
The structure involved in this incident was a 1,200-square-foot, 2-story, vacant, unsecured bungalow-style residence with a gable roof, which had experienced a previous incendiary fire while being renovated approximately one year before this incident (see Photos 7–12). The previous fire did not extend into the structural elements of the house, and the fire damage had not been repaired and no further renovation took place. The house was boarded up and was not re-occupied. The house was not repaired and remained in the same condition with large areas of exposed wall and roof assemblies. Collar beams^b were not present and were possibly removed to increase head room in the second-floor space (see Photo 8). The fatal fire on November 15, 2008 (this incident), was also reported to be incendiary. The fire investigators determined that the fire originated in multiple areas on the second-floor south wall (Side C) in vapors of a flammable liquid distributed in the interior and ignited with an open-flame device.

Photo 7. Involved structure, after a previous room and contents fire. Photo taken approximately one year prior to the fatal incident. (Photo courtesy of insurance company.)

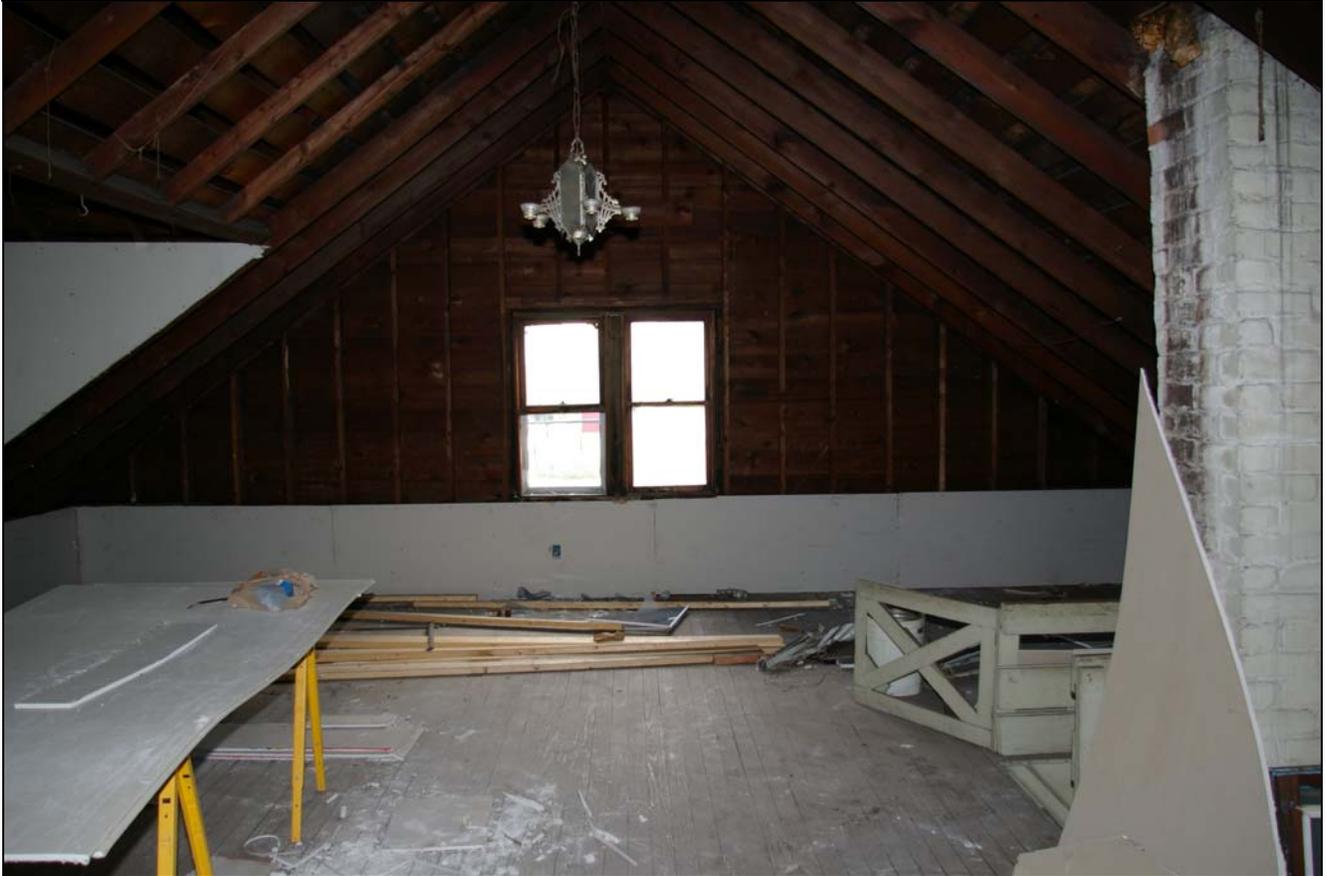
Photo 8. Room where collapse occurred killing the fire fighter, looking toward the interior of Side B. Photo taken approximately one year prior to the fatal incident. Note the unprotected roof rafters. Fire investigators determined the fire originated on Side C, the south wall on the right of photo.

In this incident, the structure had suffered a previous incendiary fire approximately one year prior to this fire. The previous fire involved a first-floor, room-and-contents fire, which had multiple points of origin, and fire damage was confined to the fire floor. The fire did not extend into the structural elements of the house, and, after the fire, the house was boarded up. The house was not repaired and remained in the same condition with large areas of exposed wall and roof assemblies. Collar beams were not present and were possibly removed to increase head room in the second-floor space (see Photo 8).

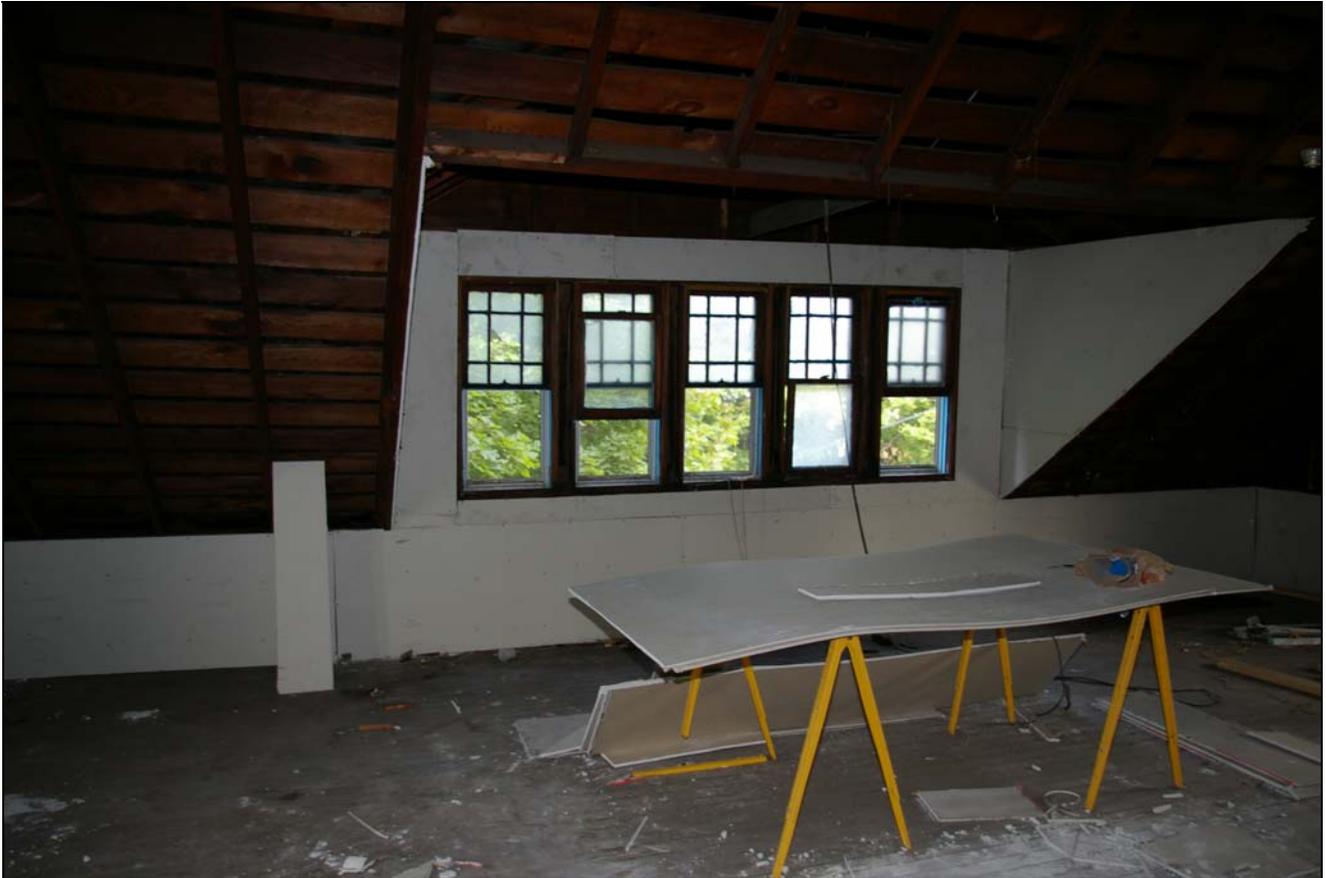
Photo 9. Room where collapse occurred, looking at the interior of dormer window on Side A. Photo taken approximately one year prior to the fatal incident. Note: this was the dormer where crews from Squad 3, E-23 and E-46 entered with a second 1 1/2" hoseline.
(Photo courtesy of insurance company.)

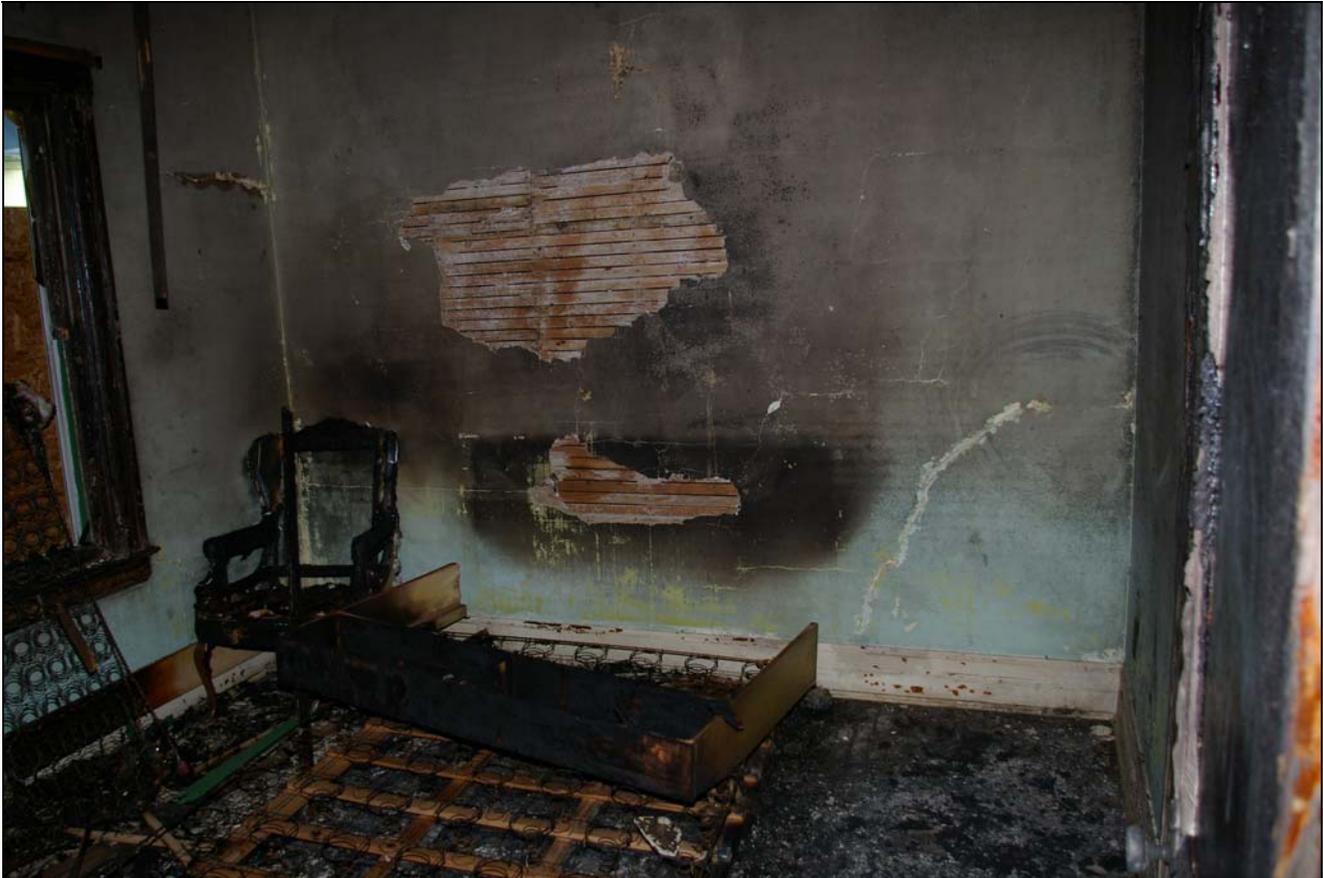
Photo 10. First-floor bedroom, damaged from previous fire, with no extension beyond room.
(Photo courtesy of insurance company.)

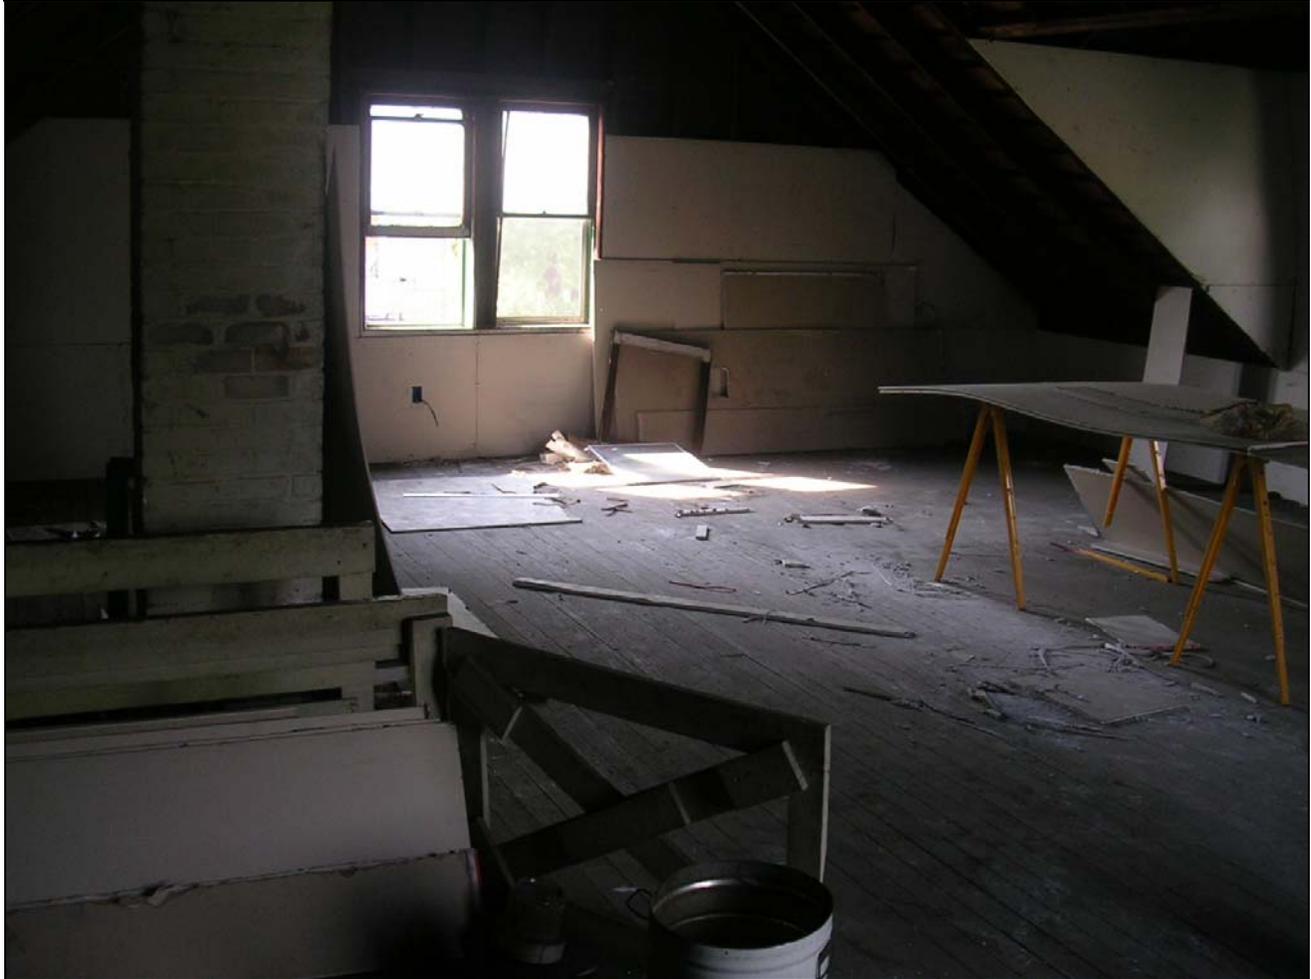
Photo 11. Second floor, looking toward Side D. Photo taken approximately one year prior to the fatal incident. Note: This was the staircase that crews from E-23 (including the victim who was third on the hoseline), Squad 3 and E-46 used to stretch a 1 ½” hoseline to the second floor.
(Photo courtesy of insurance company.)

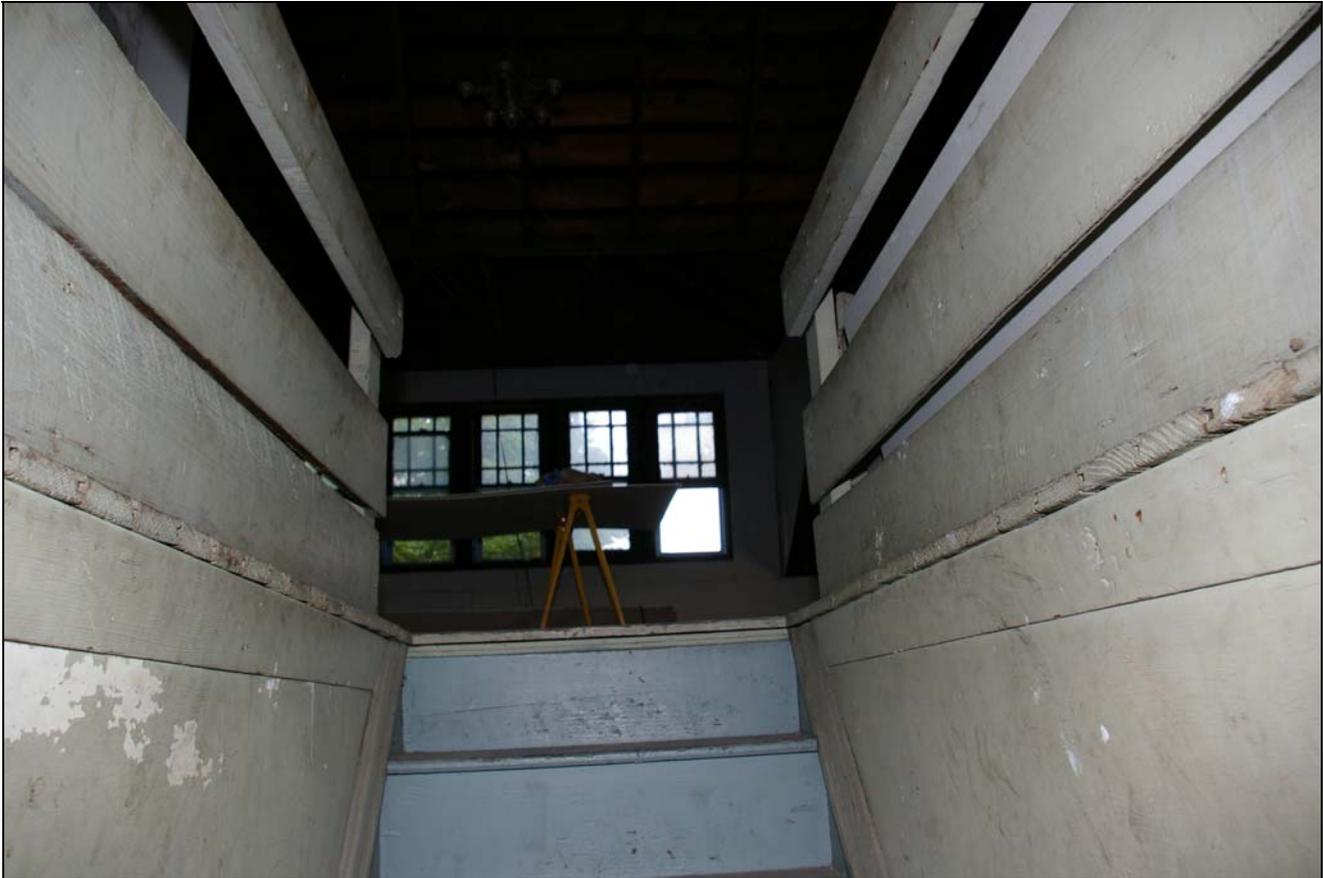
Photo 12. Interior stairs leading to second floor. Photo taken approximately one year prior to the fatal incident. Note: E-23's lieutenant and other fire fighters reported being forced down this staircase when the roof collapsed.

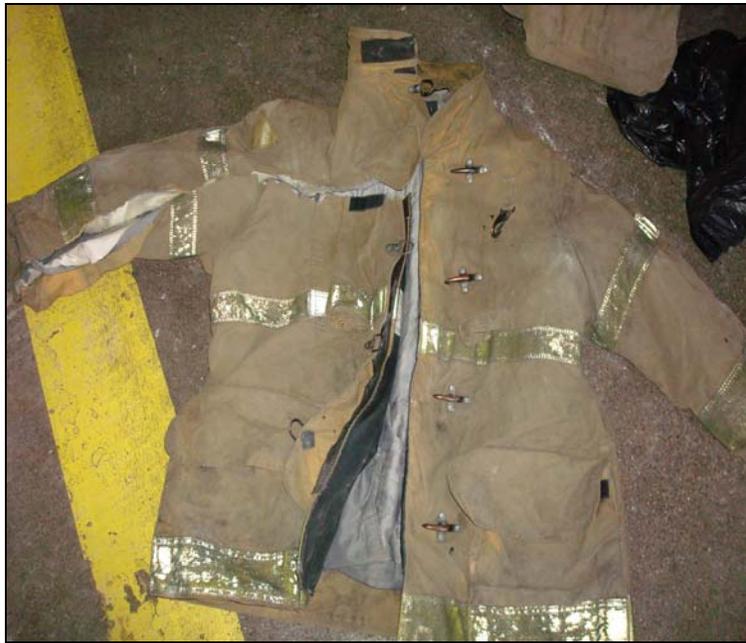
Turnout gear examined by NIOSH investigators included a fire coat and pants manufactured in August 19, 2004, and listed as compliant with NFPA 1971–2000 standards. The turnout coat and pants were well worn with much of the reflective material worn away and repair patches covering large areas (see Photos 13 and 14).

Photo 13. Turnout jacket shell and liner worn by victim.
(Photo by NIOSH.)

Recommendation #8: Fire departments should develop inspection criteria to ensure that all protective ensembles meet the requirements of NFPA 1851, Standard on Selection, Care, and Maintenance of Protective Ensembles for Structural Fire Fighting and Proximity Fire Fighting.

NFPA 1851 *Standard on Selection, Care, and Maintenance of Protective Ensembles for Structural Fire Fighting and Proximity Fire Fighting*²³ provides specific requirements for the retirement of gear. Fire departments should develop specific criteria consistent with manufacturers’ recommendations for the removal of protective gear and clothing from service. Conditions that should be considered to retire protective gear or clothing include, but are not limited to the following:

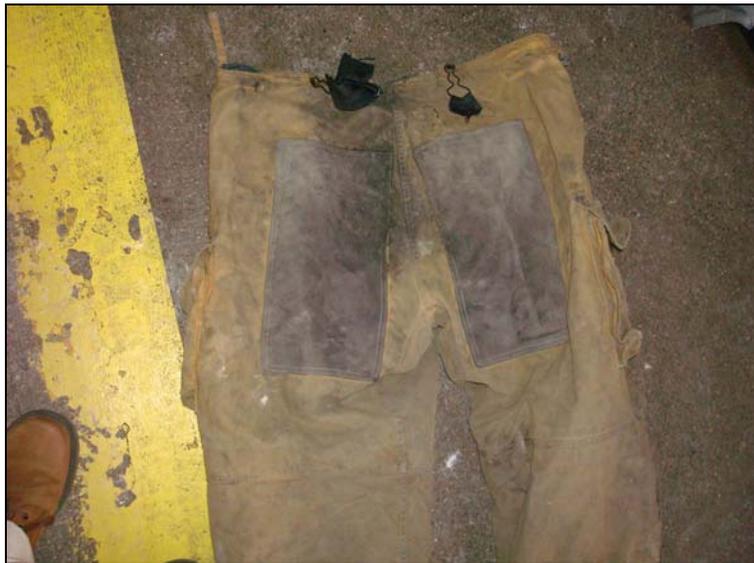
Photo 14. Repaired areas of the turnout pants shell.
(Photo by NIOSH.)
