Paid-on-call Fire Fighter Killed by Exterior Wall Collapse during Defensive Operations at a Commercial Structure Fire – Illinois

Executive Summary

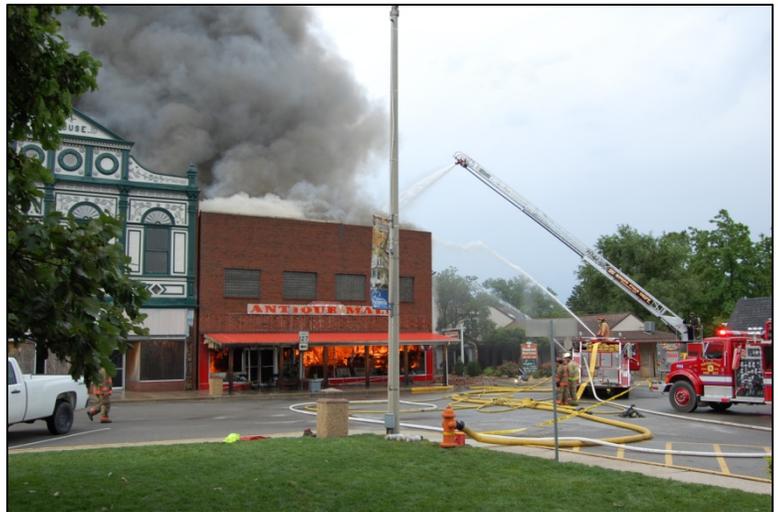
Defensive operations at commercial structure fire just after the collapse.
(Photo courtesy of local newspaper)

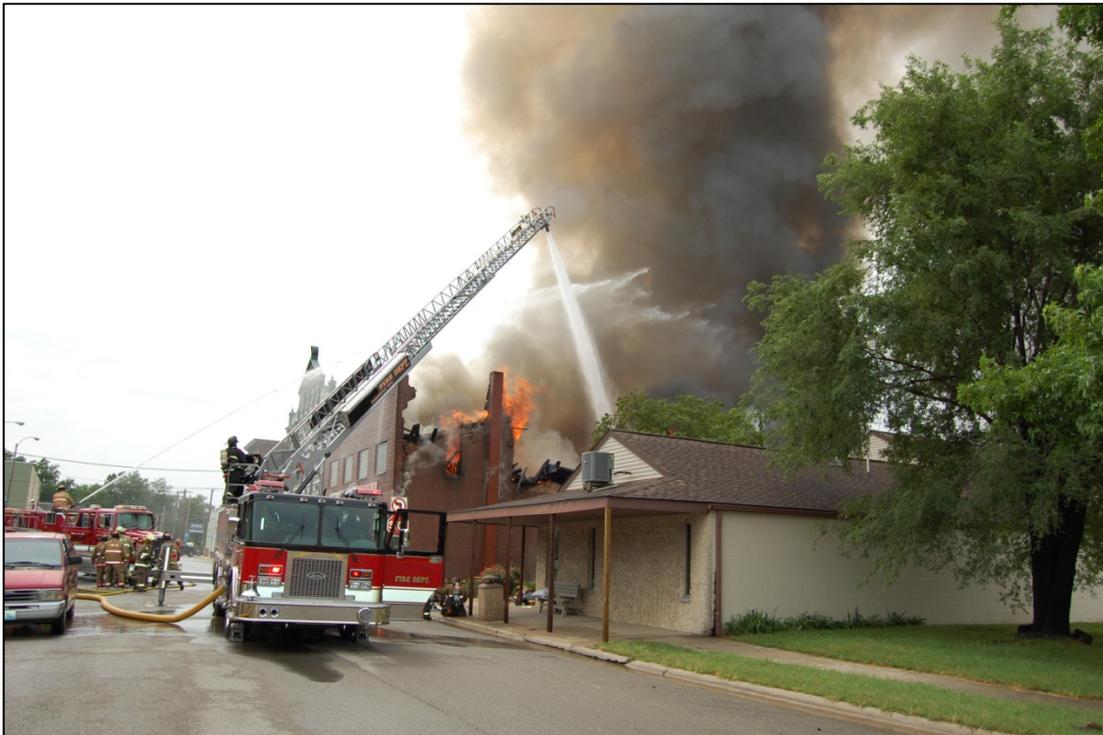
Collapsed portion of D-side wall can be seen in center of photo.

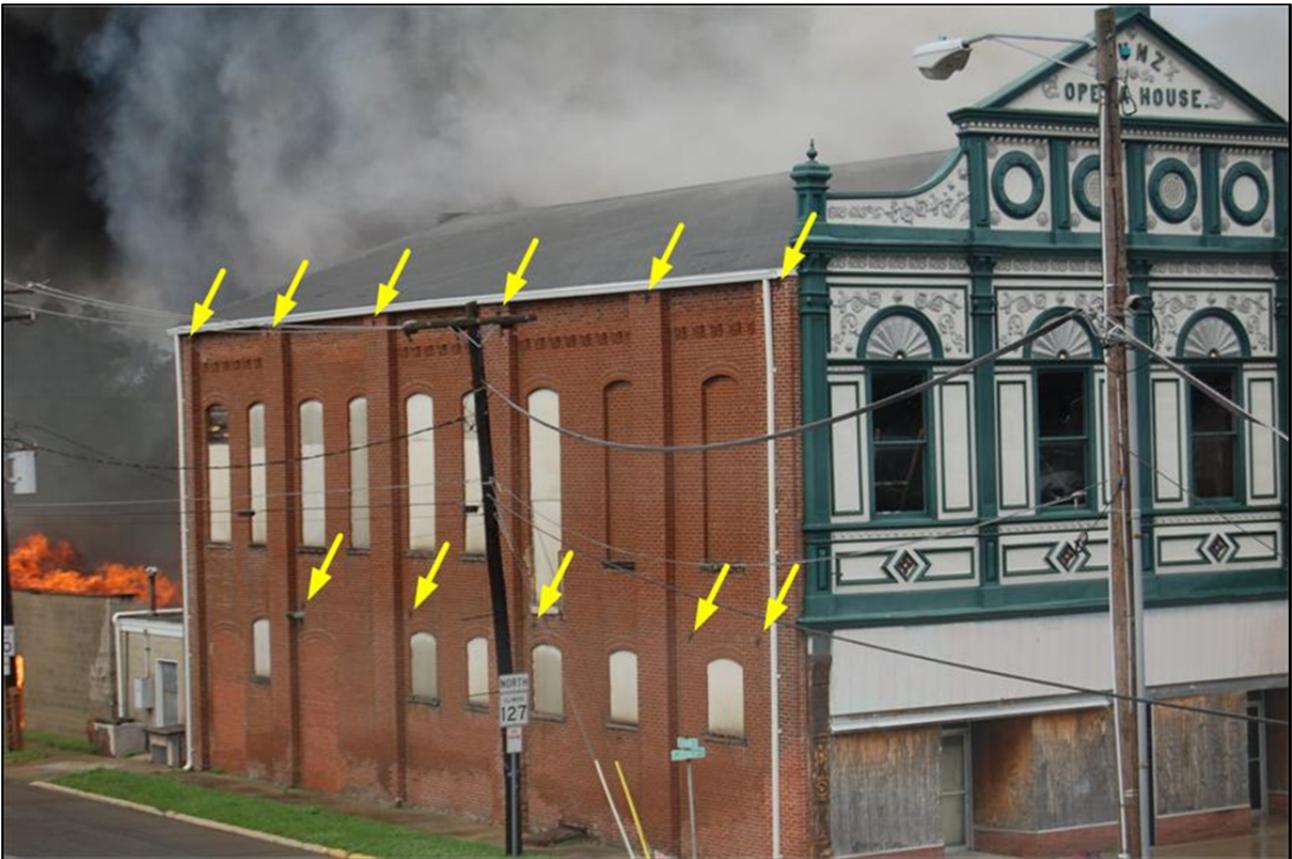
Photo 1. Arrows mark locations where star-shaped anchor plates were located on the west-side of the theater building that was adjacent to the fire building. The anchor plates appear to have been attached to the ends of the heavy timber roof trusses supporting the roof and also to some of the second-floor joists. See Photo 4 and Photo 5 for more details.

The exterior walls on both the fire structure and the adjacent theater contained star-shaped anchor plates (see Photo 1 and Photo 2). Anchor plates were used for structural reinforcement on buildings in the 18th, 19th and early 20th centuries. These anchor plates were typically made of cast iron and were used as tie plates serving as the washers for tie-rods on brick or other masonry-based buildings. The

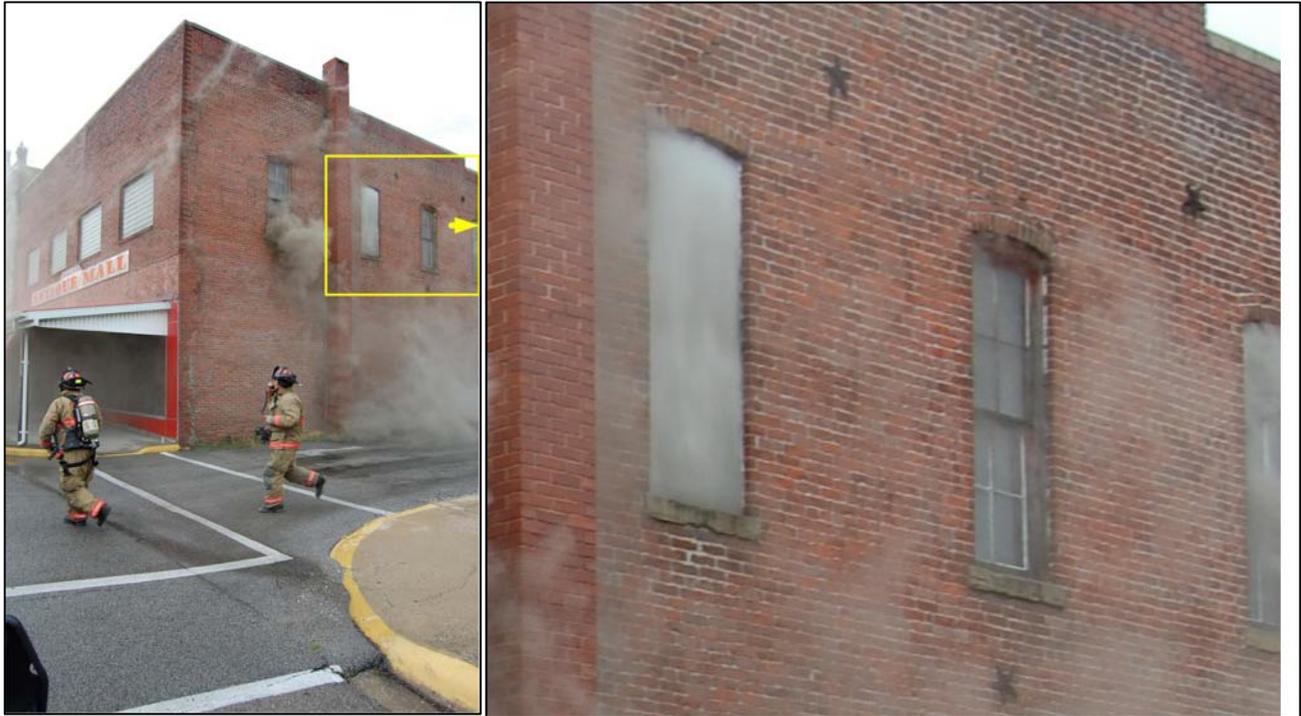
Photo 2 (left) and Photo 3 (enlarged – on right). Photos show star-shaped anchor plates located on the D-side wall in the area that collapsed, injuring the Victim.
(Photo 2 courtesy of the local newspaper. Photo 3 edited by NIOSH)

observe anchor plates in the remains of the fire building but did observe them in the remains of the adjacent theater. The anchor plates used on the D-side of the fire structure were likely attached in a similar manner as those that were observed in the remains of the theater. While the presence of anchor plates may not necessarily be an indicator of structural instability, fire fighters need to be aware that these anchor plates are used to provide lateral support to help prevent bowing of exterior walls. Collapsing roofs typically exert outward pressure at the top of exterior walls supporting the roof. When weakened by fire degradation, the possibility of exterior wall collapse should be considered. As seen in the following photos, star-shaped anchor plates were present in the area of the D-side wall that collapsed during this incident.

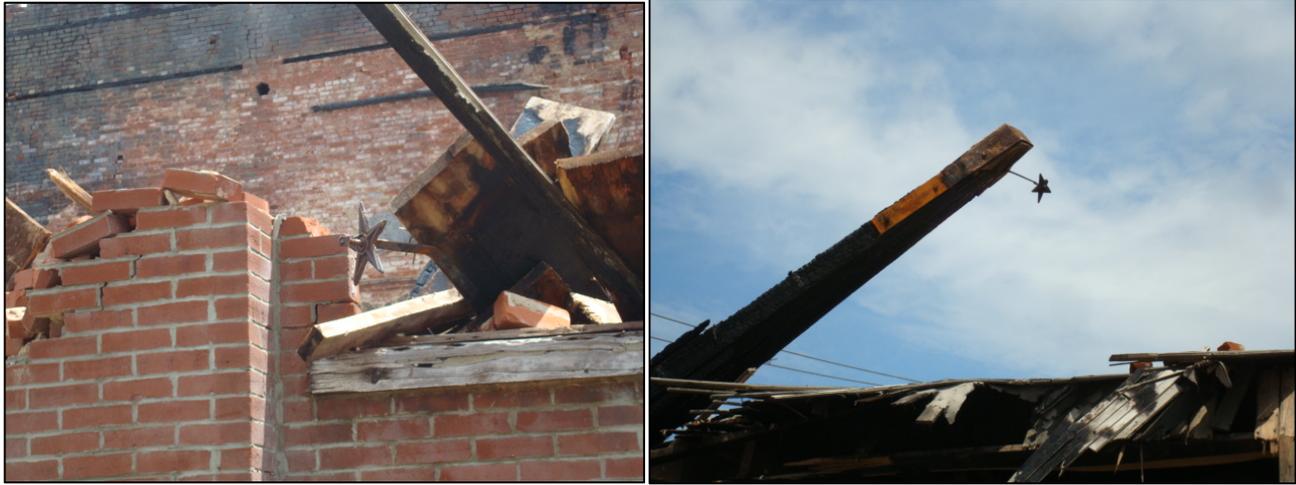
Photo 4 (left) and Photo 5 (right). Photo 4 shows star-shaped anchor plate attached to end of floor joist. Photo 5 shows star-shaped anchor plate attached to end of heavy timber roof truss. Both photos are of the theater adjacent to the fire structure.
(Photos courtesy of the local newspaper)

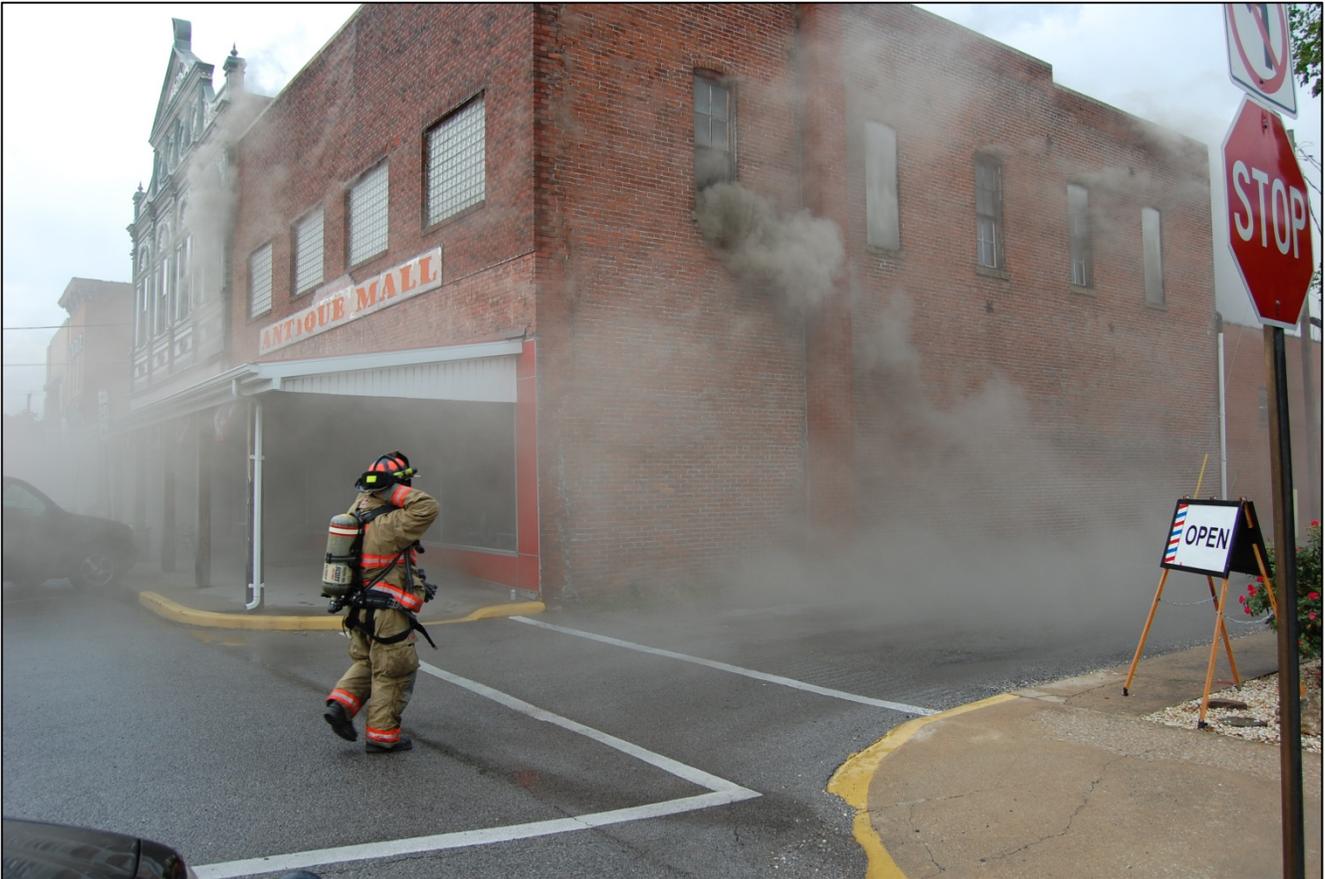
Photo 6. Conditions seen by first arriving fire fighters. Note that no fire is visible but smoke can be seen pushing out cracks near the windows and vertical cracks in the brick masonry walls.
(Photo courtesy of the local newspaper)

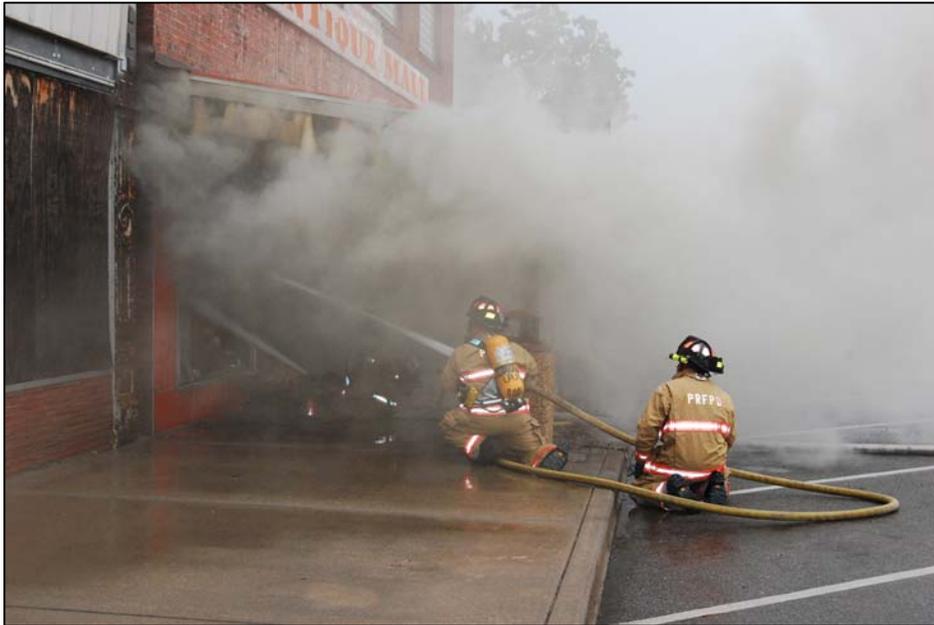
Photo 7. Early fire attack at Side A (front) of structure. Note the overhead awning.
(Photo courtesy of the local newspaper)

A 2½ inch hose line was pulled from E-43 to the front of the structure and put into operation. Initially, the hose lines were operated from the sidewalk directly in front of the structure. An overhead awning covered the front of the structure. Due to the collapse hazard, the fire fighters operating the hose lines under the awning were directed to move back into the street (see Photo 7 and Photo 8).

Discussion: Although there is no evidence that the following recommendation would have prevented this fatality, it is being provided as a reminder of a good safety practice. The proper selection and use of personal protective equipment (PPE) is required by OSHA regulations, recommended in NFPA standards, and is good safety practice. Chapter 7.1.1 of NFPA 1500, Fire Department Safety and Health Program, 2007 Edition, states “the fire department shall provide each member with protective clothing and protective equipment that is designed to provide protection from the hazards to which the member is likely to be exposed and is suitable for the tasks that the member is expected to perform.” Chapter 7.1.2. states “protective clothing and protective equipment shall be used whenever a member is exposed or potentially exposed to the hazards for which the protective clothing (and equipment) is provided.”²⁵ The incident commander should establish the level of protective clothing necessary to enter the fire zones (hot, warm, and cold). The OSHA Respirator Standard Title 29, Code of Federal Regulations (CFR) 1910.134 lists requirements for SCBA use in immediately dangerous to life or health (IDLH) atmospheres.²⁹ While the lack of personal protective equipment (PPE) and clothing did not contribute to the fatality that occurred at this incident, it is generally recognized that SCBA should be worn and used at all times when fire fighters may be exposed to smoke and other hazardous atmospheres. Photos taken during the incident show fire fighters working in close proximity to the burning structure who were not wearing proper respiratory protection (see Photo 7, Photo 8 and Photo 11).

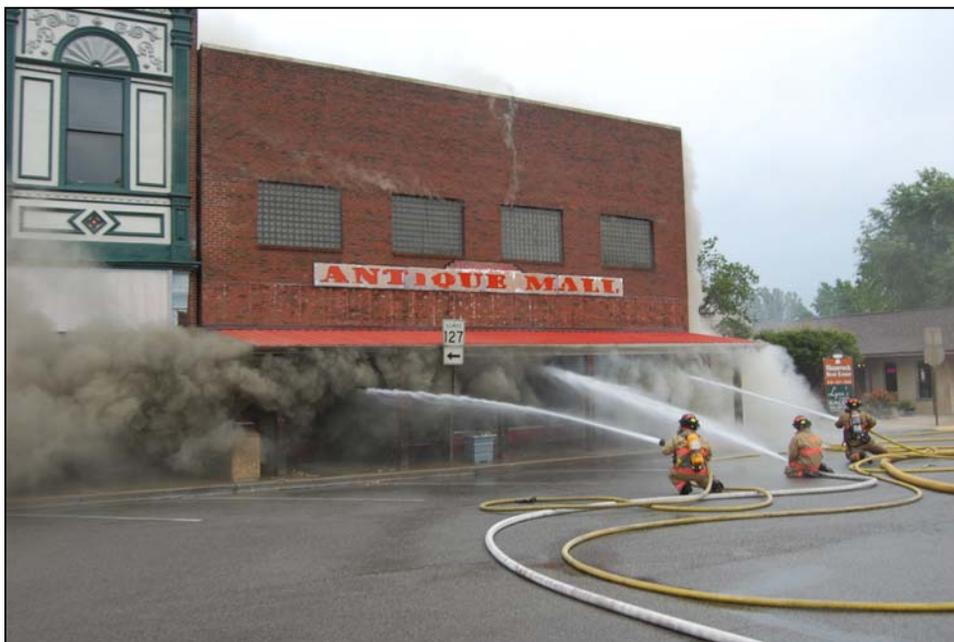
Photo 8. Three hose lines from Engine 43 in operation at front of structure. Note the smoke pushing out cracks near the windows and vertically along the A/D corner.
(Photo courtesy of the local newspaper)

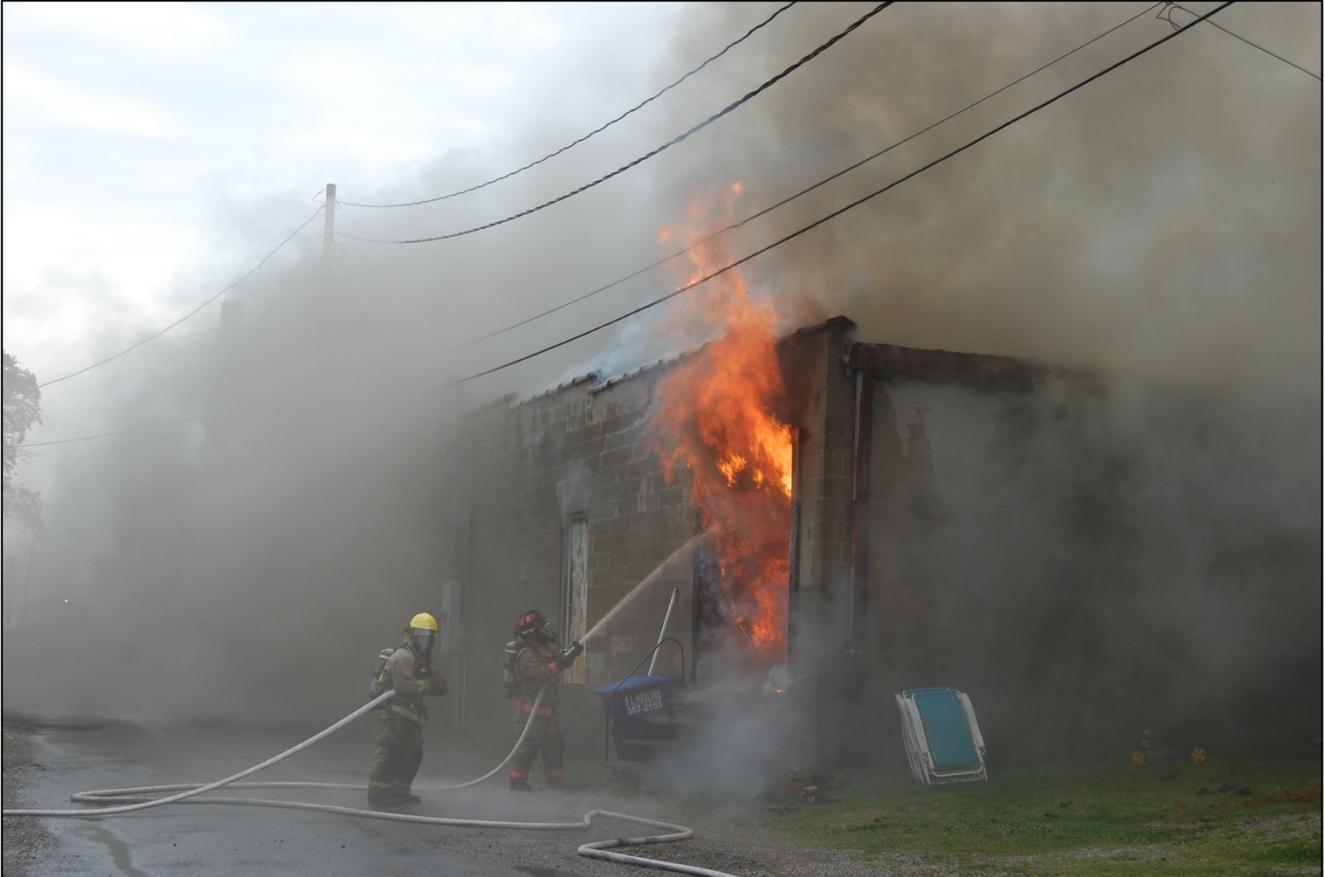
Photo 9. Fire fighters attack the fire through the open overhead roll-up door located on Side D at the C/D corner (rear of structure). Note that the flames are impinging on the overhead wires and the wire insulation has started to burn. The utility pole seen in the background later caught on fire. Also note how smoke obscured visibility toward the front of structure.

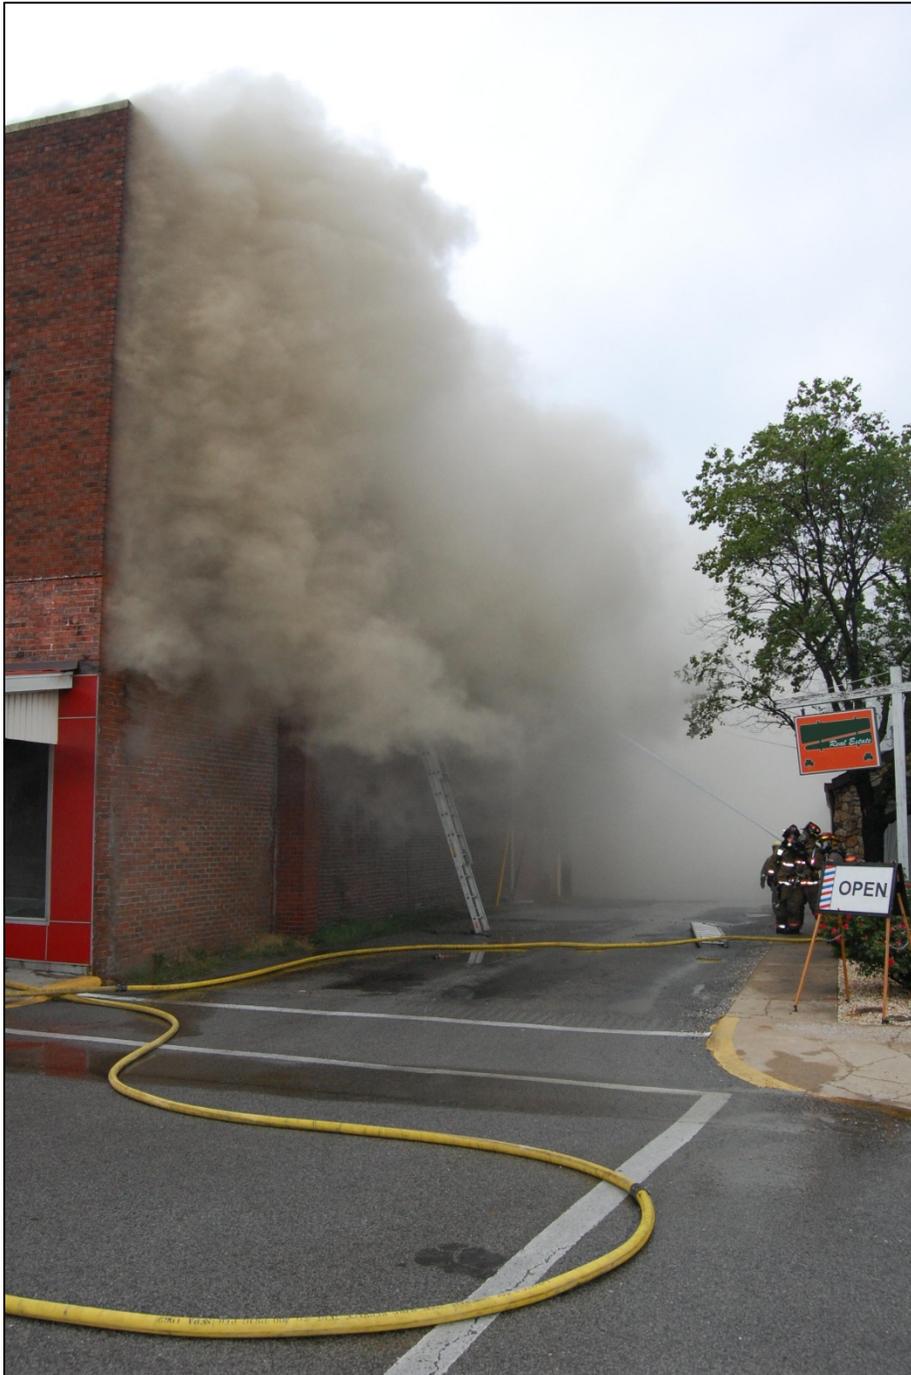
Photo 10. Ladder can be seen positioned against the Side D wall before the collapse occurred. Note how smoke is pushing out through the masonry joint at the A/D corner. The smoke obscures a clear view of the exterior wall, possibly hiding cracks and other signs of structural deterioration.

One of the Chiefs noticed the ground ladder positioned against the Side D wall and stated that the ladder was in a bad position and should be moved away from the burning building (see Photo 10). The Victim and a fire fighter from Fire Department A standing nearby overheard the comment and quickly moved to retrieve the ladder. The Victim positioned himself between the ladder and building with his back to the building while the other fire fighter stood on the other side of the ladder to brace it. They raised the ladder vertically and the Victim was using the ladder's rope to lower the ladder's upper section when the top portion of the exterior wall collapsed outward. Several fire fighters working in the immediate area near the A/D corner witnessed the collapse. Other fire fighters reported that they felt a shaking or vibration and heard the sound of the collapse. Someone yelled that the wall was coming down. Bricks and falling debris struck the Victim from behind as the other fire fighter grabbed for the Victim and simultaneously spun around and moved across the alley to get clear of the collapse. Witnesses reported that the Victim attempted to run toward the front of the building (parallel to the wall) while the Department A fire fighter moved perpendicularly away from the wall. The Victim was knocked down and partially buried by the falling debris. The other fire fighter moving the ladder was not struck.

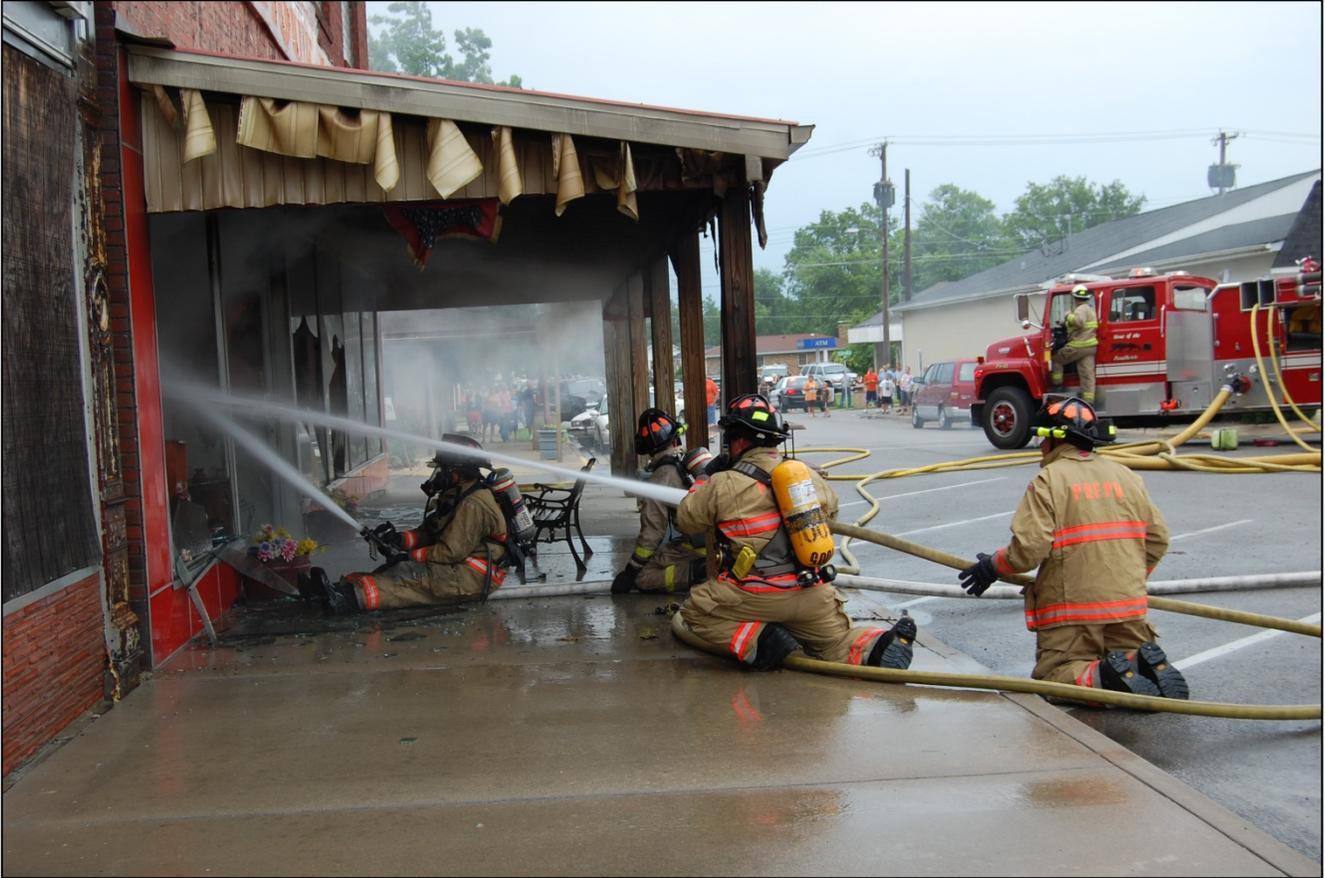
Photo 11. Hose lines in operation at front of structure prior to the collapse. Photo shows awning at front of the structure and also how smoke conditions changed shortly after storefront windows were taken out for ventilation (in contrast to Photo 7) .
(Photo courtesy of the local newspaper)
